DOT HS 812 995

# Special Crash Investigations: Remote Child Restraint System Crash and Fire Investigation; Vehicle: 2003 Ford F-250 Super Duty; Location: New York; Crash Date: August 2015

Special Crash Investigations Remote Child Restraint System Crash and Fire Investigation Case Number: CR19038 Vehicle: 2003 Ford F-250 Super Duty Location: New York Crash Date: August 2015

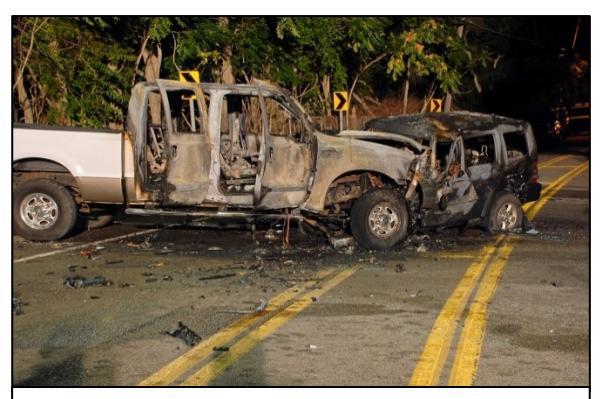
**Figure 1**. View of the Ford and Jeep at final rest (on-scene law enforcement image).

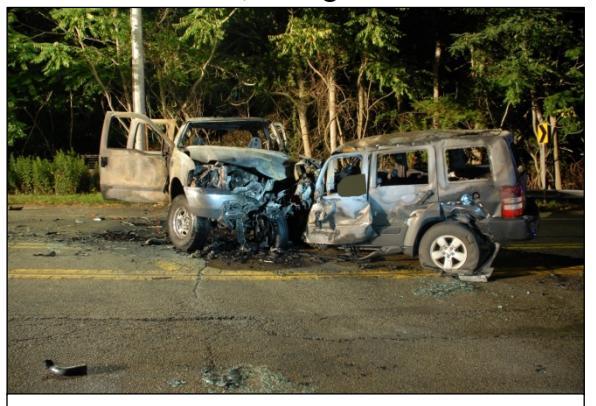
**Figure 5**. Southerly view of the final rest positions of the involved vehicles (on-scene law enforcement image).

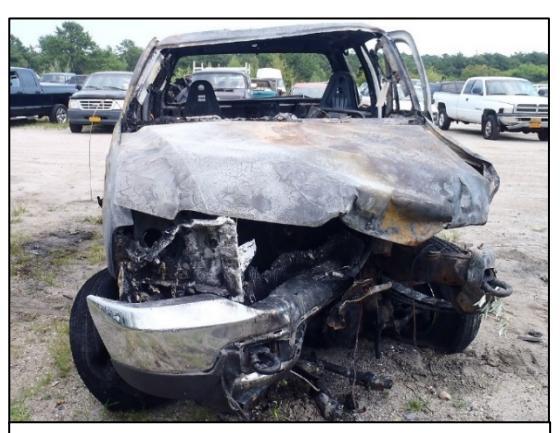
The exterior crash damage to the Ford involved the front plane, the left front fender and its structure, and the left front tire/wheel/driveline and suspension (Figures 8 and 9). Directly involved were the left and center aspects of the front plane, with vertical involvement from the bumper/frame to the hood. The bumper was crushed and buckled at the centerline with lateral displacement to the right, indicative of an 11 o'clock direction of force. The left front tire and wheel of the Ford were displaced rearward by the engagement, reducing the left wheelbase by an estimated minimum of 25 cm (10 in). The estimated maximum bumper beam crush was 51 cm (20 in), located adjacent to the left frame rail. An estimated collision deformation classification (CDC) of 11FYEW3 was assigned to the Ford for the front plane damage pattern.

**Figure 8**. Front plane damage to the Ford (law enforcement inspection image).

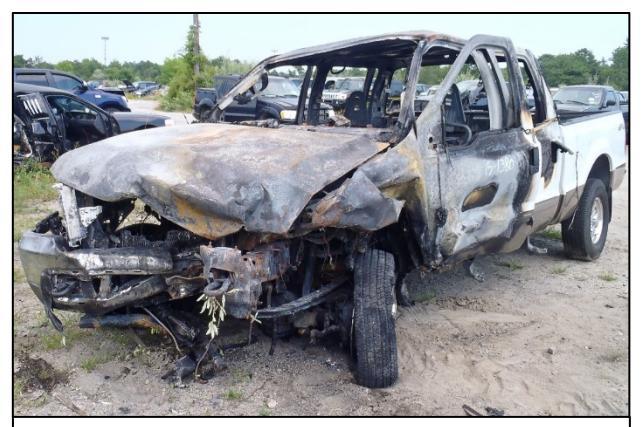
Minor intrusion of the front left occupant space of the Ford was identified in the available law enforcement images. The left Apillar was displaced rearward, which had effectively jammed the left front door closed. The left corner of the instrument panel and the

**Figure 9**. Front left oblique view of the crash and fire damage to the Ford (law enforcement inspection image).

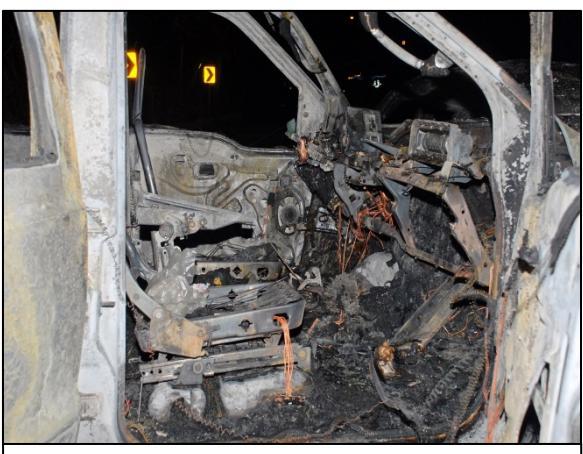
toe pan also appeared to have intruded rearward. The post-crash fire consumed nearly all the combustible material in the Ford's interior (**Figures 10** and **11**). As a result of the fire, any

**Figure 10**. Fire damage to the front row of the Ford (law enforcement image).

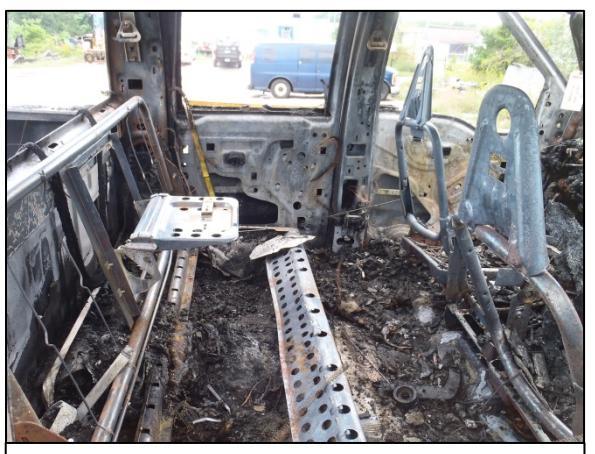
**Figure 11**. Fire damage to the second row of the Ford (law enforcement image).

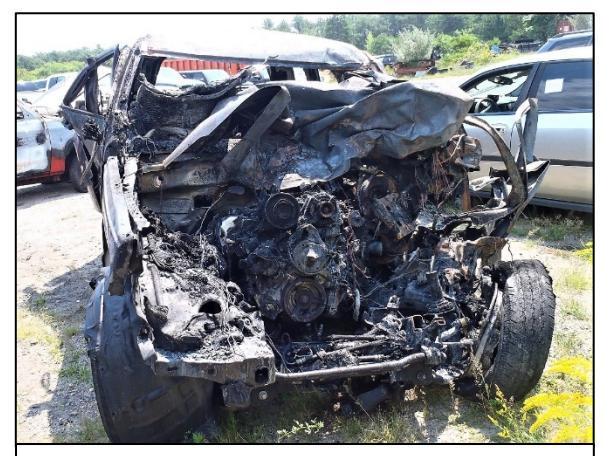
Based on a review of the available law enforcement images, the direct contact damage to the Jeep from the front plane impact with the Ford primarily involved the left and center aspects. The bumper beam and its mounting brackets appeared to have separated from the frame rails, or were consumed by the fire. All components forward of and surrounding the engine block were displaced and/or consumed by the fire. The hood separated from the radiator support-mounted latch assembly and was crushed upward and rearward, and the left front fender was also crushed rearward. The left front axle position was displaced rearward, which had visibly shortened the left wheelbase. There was rearward displacement of the left A-pillar, with corresponding compression of the left front door. Due to the severity of the damage and separation of components, a crush profile could not be estimated for this damage. However, the estimated CDC for the Jeep's front plane damage pattern, associative to the frontal impact with the Ford, was 12FYEW4.

**Figure 13**. Front plane damage to the Jeep (law enforcement image).

The crash-induced fire consumed the entirety of the combustible materials in the engine compartment and interior of the Jeep. The exterior fire damage to the Jeep involved all four planes and the roof. The burn pattern was indicative of a fire that probably originated in the engine compartment area of the Jeep and proliferated rearward to the occupant compartment. All four tires remained largely intact, with less exterior fire damage to the back plane. **Figures 13** and **14** depict the crash and fire damage to the Jeep.

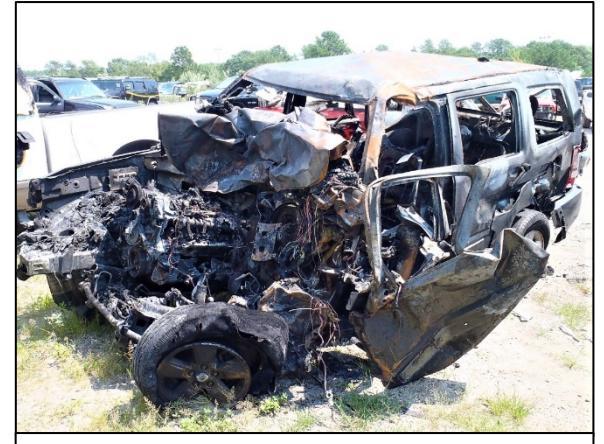
**Figure 14**. Front left oblique view of the damage to the Jeep (law enforcement image).
