U.S. Department
of Transportation

**National Highway
Traffic Safety
Administration**

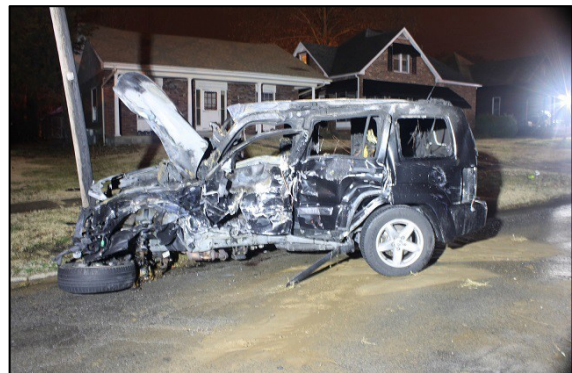
Figure 3. Left side view, the 2011 Jeep Liberty (police photo).

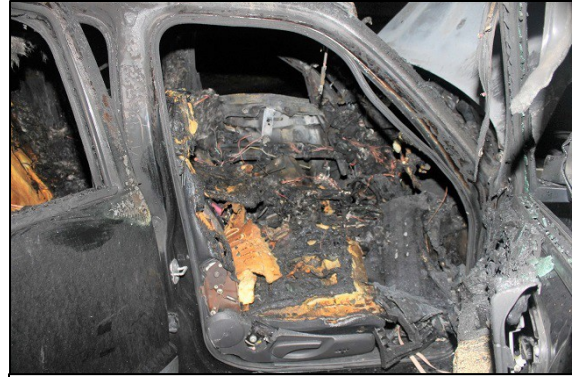
Figure 5. Front row fire damage, the 2011 Jeep Liberty (police photo).

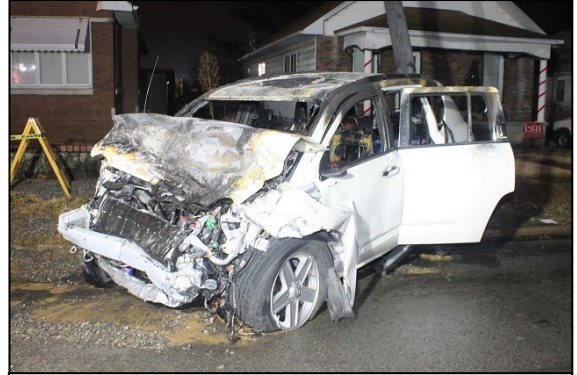
Figure 6. The 2009 Jeep Compass (police photo).
