U.S. Department
of Transportation

**National Highway
Traffic Safety
Administration**

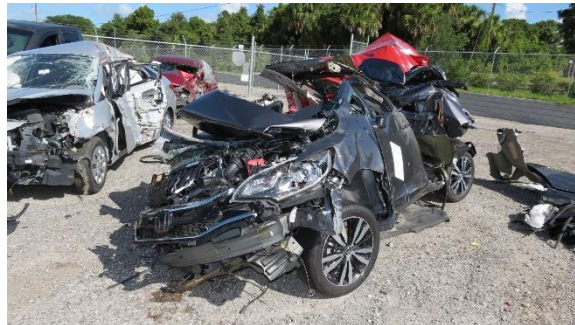
Figure 1. Front left oblique view of the 2019 Honda during the SCI investigation

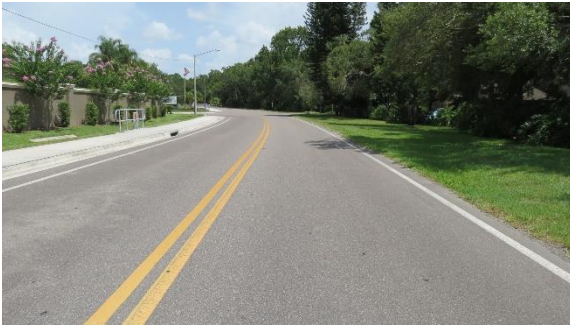
Figure 2. Southbound view of the Honda's pre-crash approach to the crash site

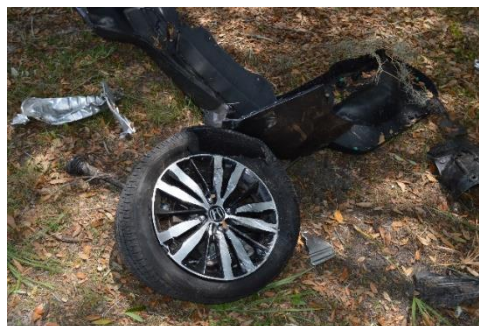
Figure 6. Right front wheel from the Honda as found at the crash scene (police-provided image)

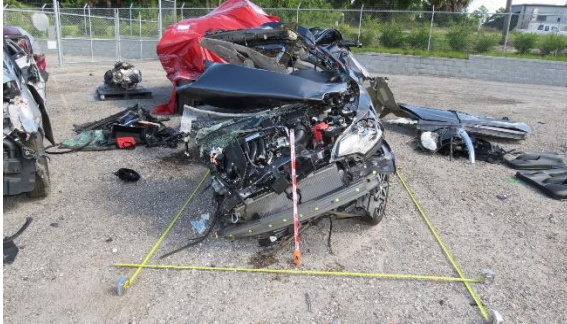
Figure 7. Front plane damage to the Honda as documented during the SCI vehicle inspection

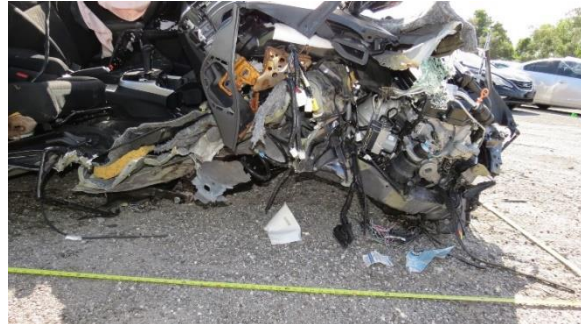
Figure 8. Damage to the right front axle resulting in separation of the right front tire due to Event 2 impact with tree

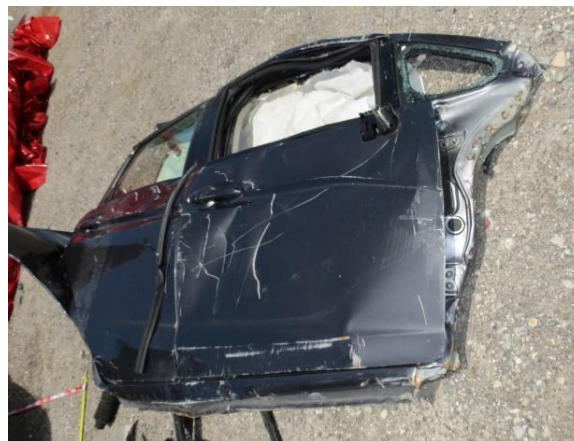
Figure 9. View of right side doors of the Honda at the time of inspection

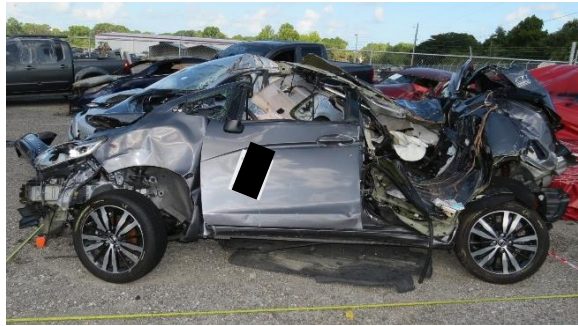
Figure 10. The Honda's minimal left plane damage from the rollover (Event 3)

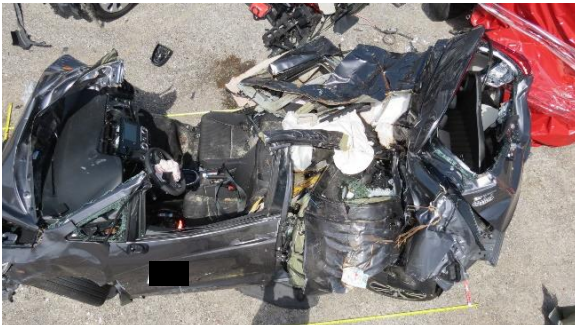
Figure 11. The Honda's top plane damage from the impact with tree two (Event 4)

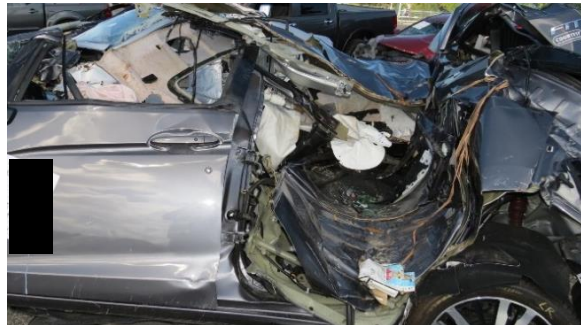
Figure 12. View of the max crush from the impact with tree two (Event 4)

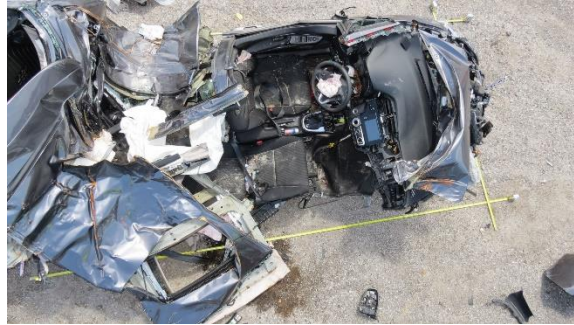
Figure 13. Top view of the Honda depicting the integrity loss

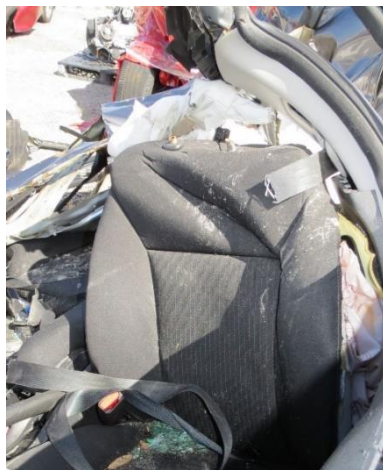
Figure 14. View of the Honda's deformed driver seatback, cut driver's seat belt, and B-pillar

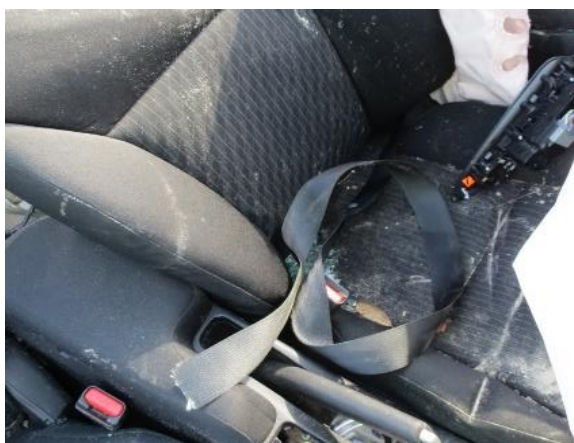
Figure 17. Driver's seat belt laying loose and cut by emergency personnel

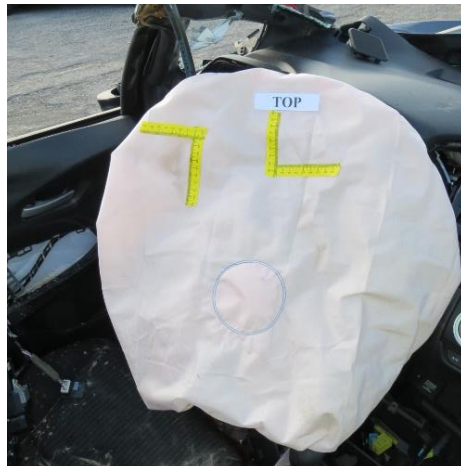
Figure 18. View of the driver's frontal air bag during the SCI vehicle inspection

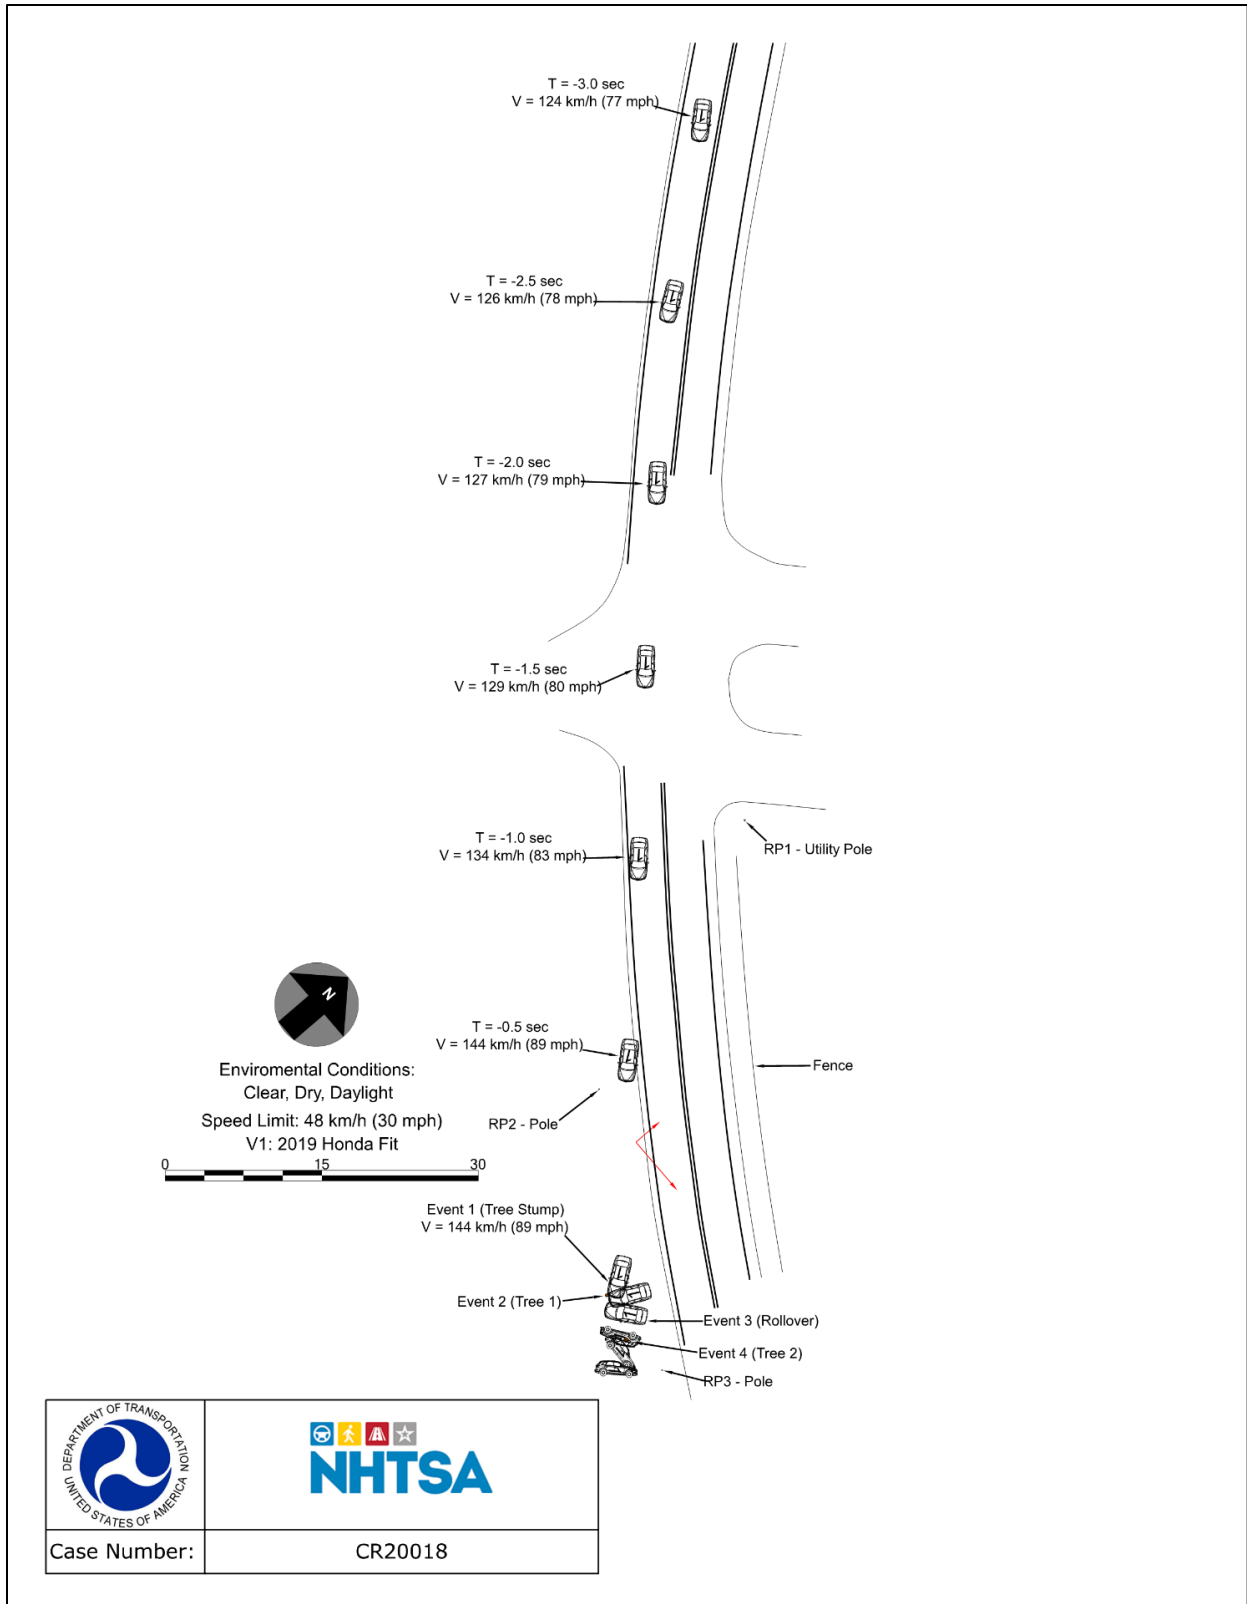
Crash Diagram: A Detailed View
