U.S. Department
of Transportation
**National Highway
Traffic Safety
Administration**

DOT HS 813 231

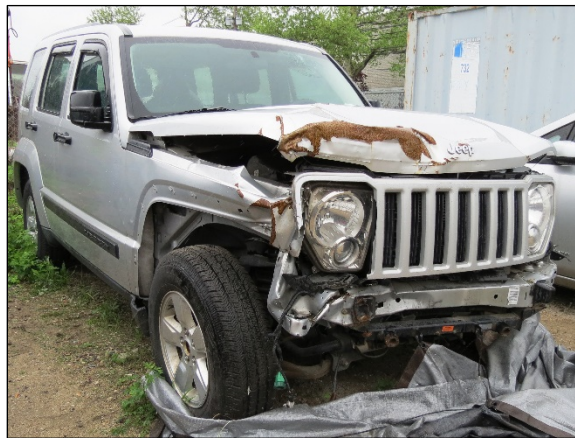
Figure 1. Right front oblique view of the involved 2011 Jeep Liberty

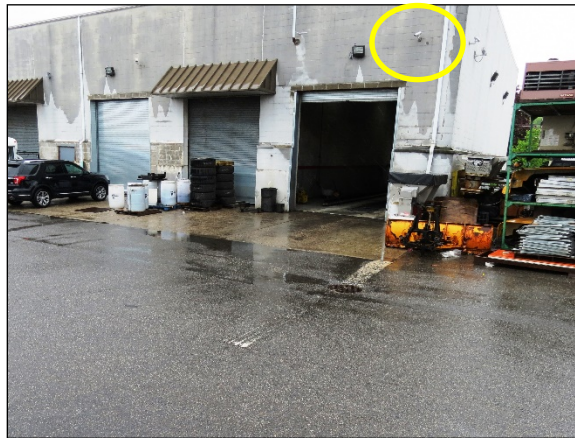
Figure 2. West-facing view of the building, overhead door, and security camera (highlighted by yellow circle)

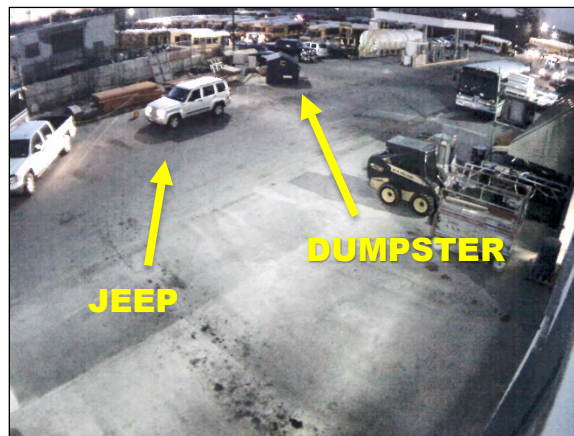
Figure 4. East-facing view of the private property parking lot and involved Jeep stopped near the dumpster (screen capture from video surveillance footage)

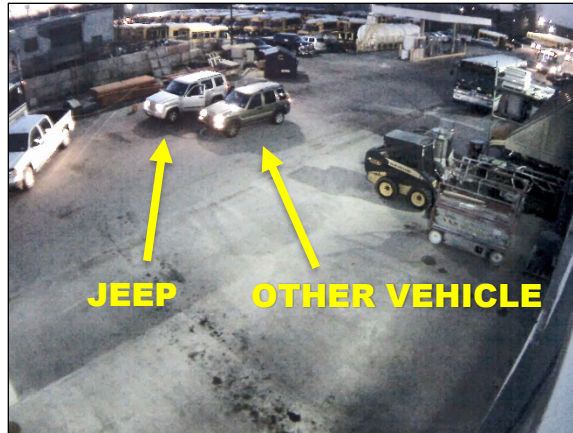
Figure 5. East-facing view of the Jeep and the other vehicle that stopped to have a conversation with the Jeep's driver (screen capture from video surveillance footage)

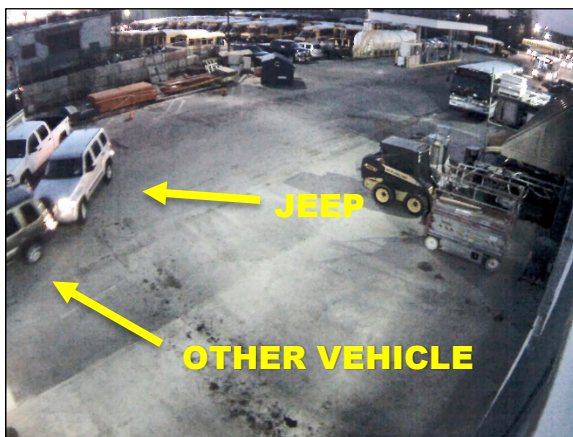
Figure 6. East-facing view of the Jeep during its impact/engagement with the other vehicle (screen capture from video surveillance footage)

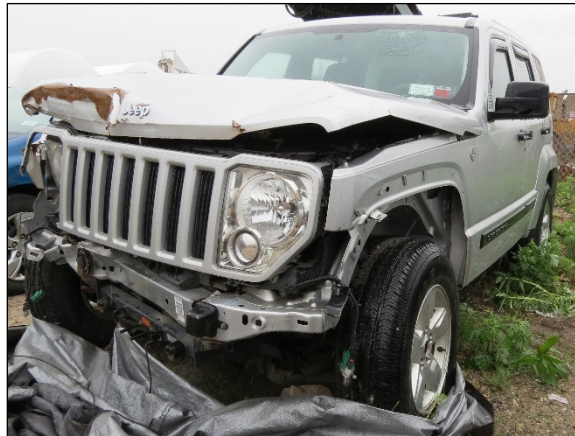
Figure 8. Front left oblique view of the 2011 Jeep Liberty at the time of the SCI vehicle inspection

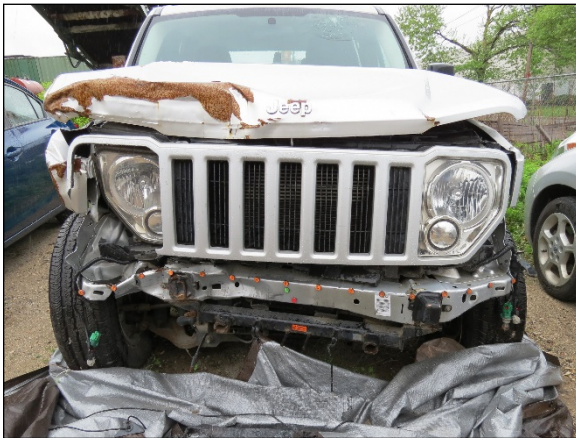
Figure 9. View of the front plane damage profile to the 2011 Jeep Liberty

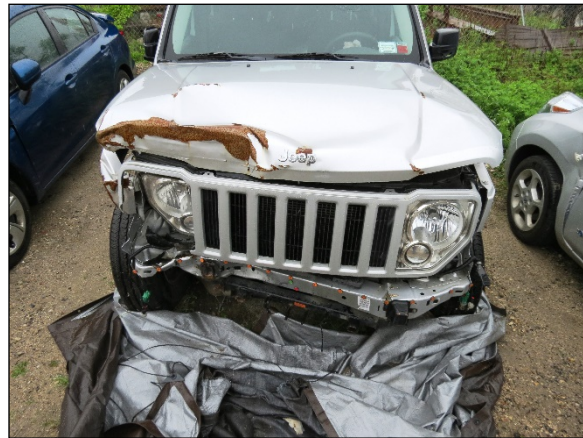
Figure 10. Damage pattern to the front plane of the Jeep from an overhead perspective

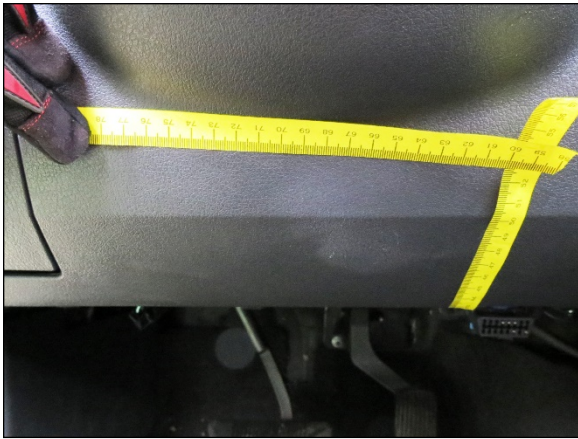
Figure 11. Driver right knee contact to the left lower instrument panel of the Jeep as documented during the SCI inspection

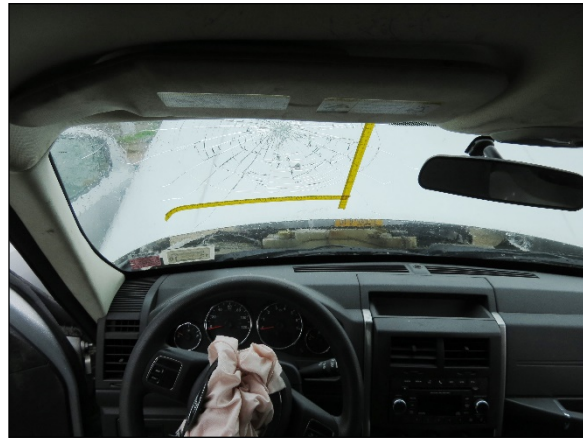
Figure 12. Fracture pattern to the windshield glazing of the Jeep resultant from contact by the driver's head during the crash

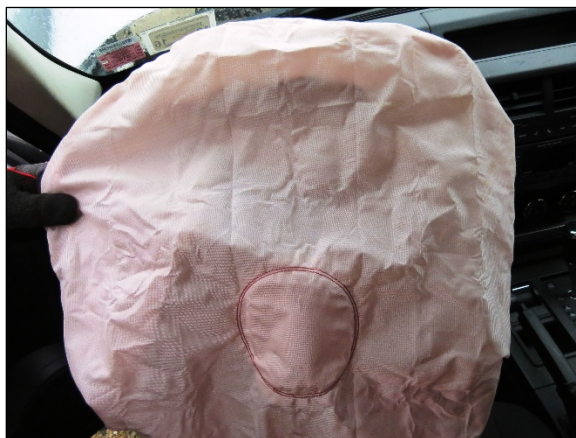
Figure 13. Deployed driver's frontal air bag in the Jeep

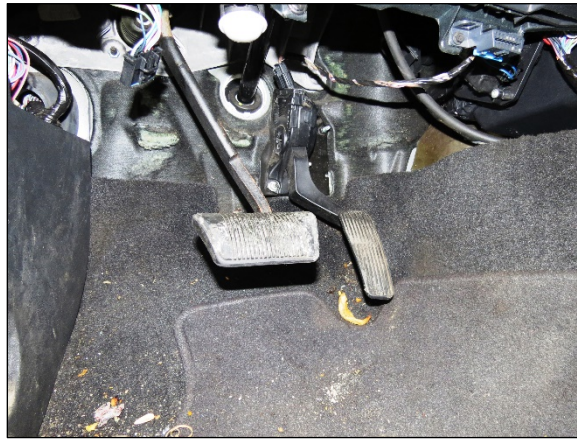
Figure 14. View of the driver foot controls in the Jeep, showing their lack of impedance/restriction

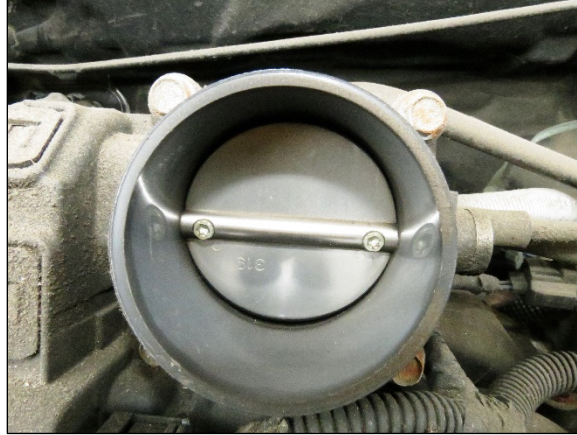
Figure 15. View of the Jeep's throttle body. A vehicle self-diagnostic test at ignition initiation confirmed functionality of the throttle during SCI inspection
