U.S. Department
of Transportation
**National Highway
Traffic Safety
Administration**

DOT HS 813 430

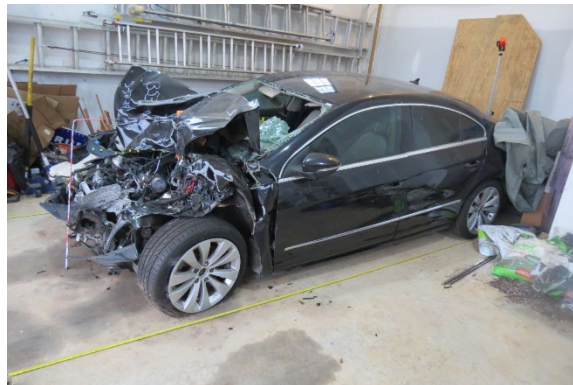
Figure 1. 2011 Volkswagen Passat CC

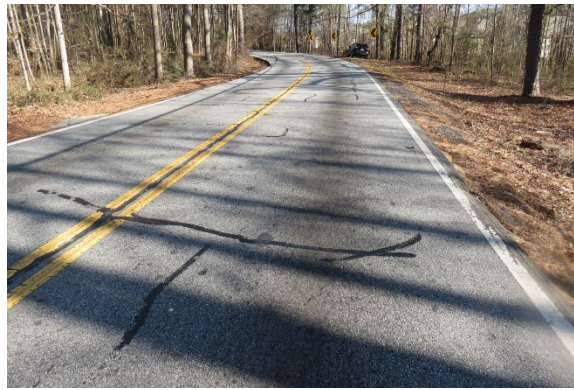
Figure 2. Northbound view of the crash site.

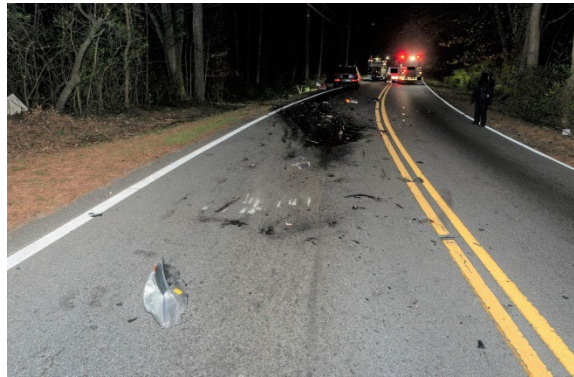
Figure 3. Southbound view of the location of the point of impact in the northbound lane. Image provided by the investigating police agency.

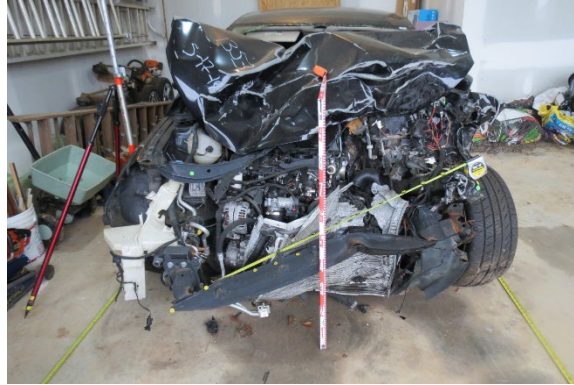
Figure 7. Front plane damage of Volkswagen

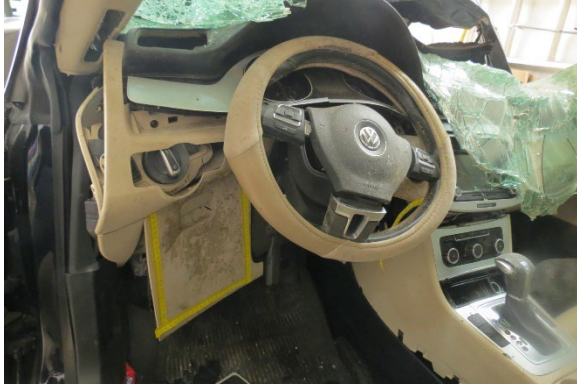
Figure 8. Contacts to steering wheel rim, column, and knee bolster

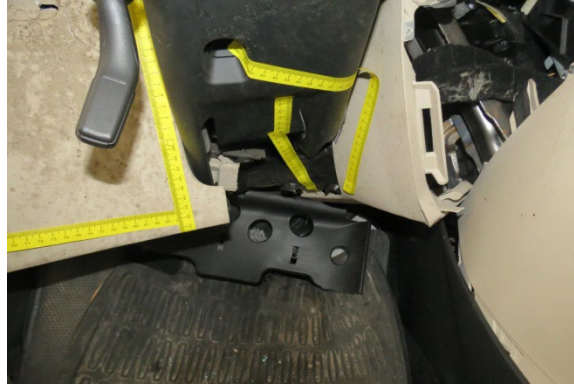
Figure 10. Driver's knee contacts to the lower steering column cover and lower instrument panel/bolster

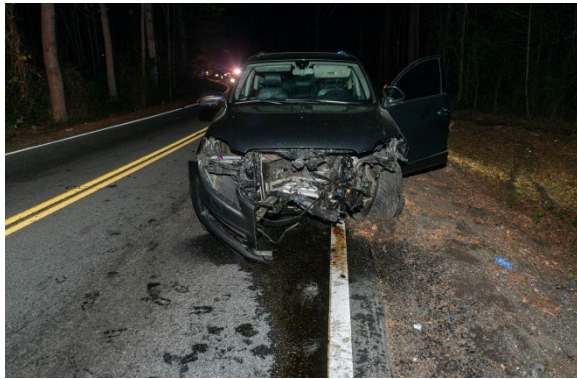
Figure 11. Final rest position of the Audi and the resultant frontal damage. Image obtained from the investigating police agency.

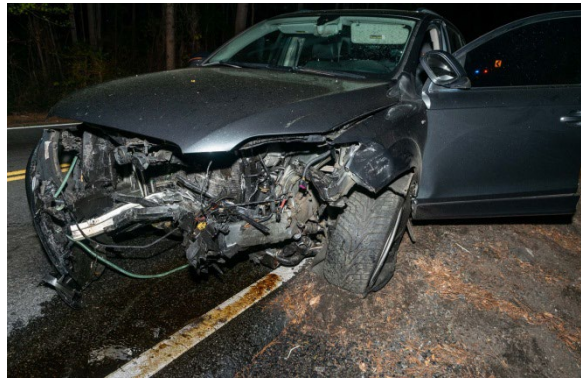
Figure 12. Frontal damage to the Audi. Image obtained from the investigating police agency.
