U.S. Department  
of Transportation

**National Highway  
Traffic Safety  
Administration**

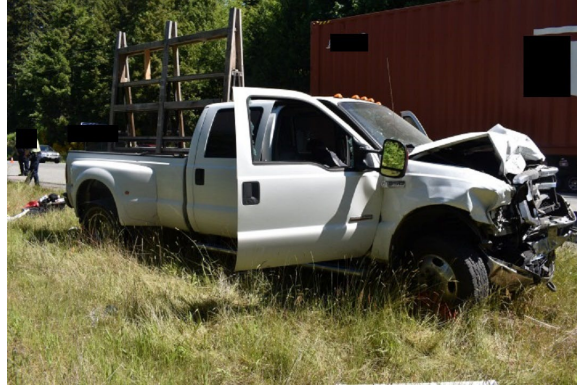
*Figure 2. Striking vehicle, 2005 Ford F-350, looking north (police photo)*

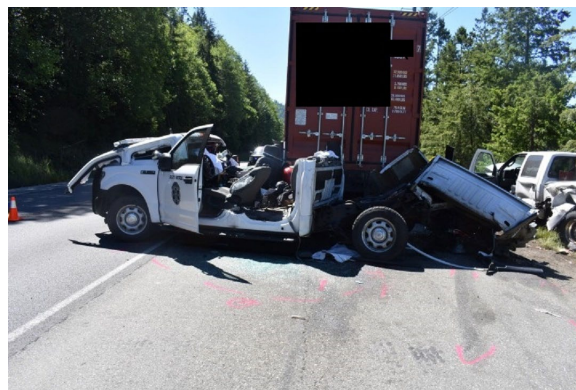
*Figure 3. Pratt trailer, 2015 Ford F-150 police vehicle, looking south*

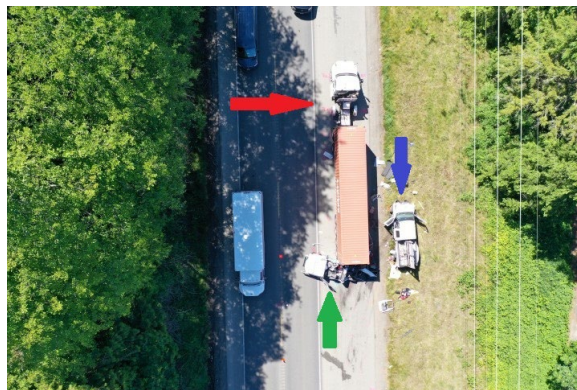
*Figure 5. Final rest positions (police image), Up = south, 2015 Ford F-150 (green), 2005 Ford F-350 (blue), 2015 Freightliner tractor/trailer (red)*

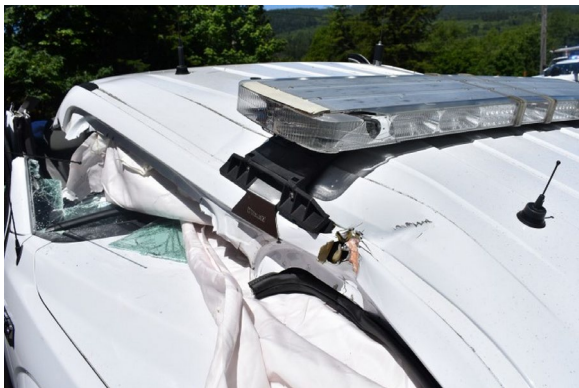
*Figure 6. 2015 Ford F-150, light bar (police photo)*

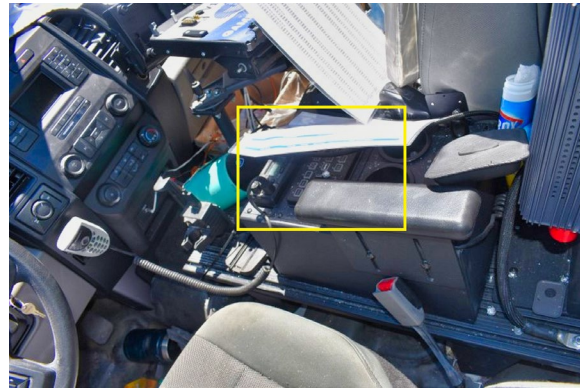
*Figure 7. 2015 Ford F-150, interior light switch (police photo)*

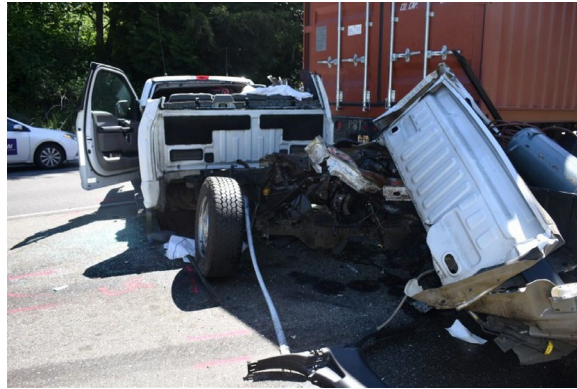
*Figure 8. 2015 Ford F-150, rear plane/bed damage (police photo)*

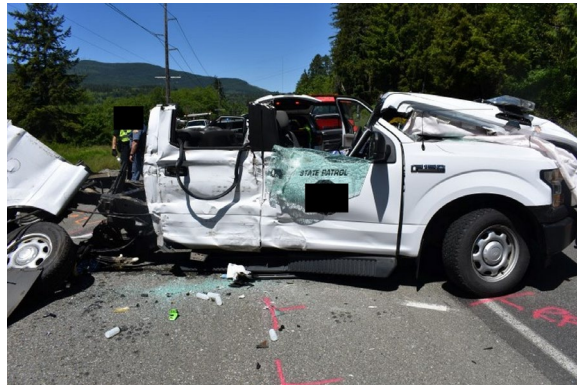
*Figure 9. 2015 Ford F-150, right plane damage (police photo)*

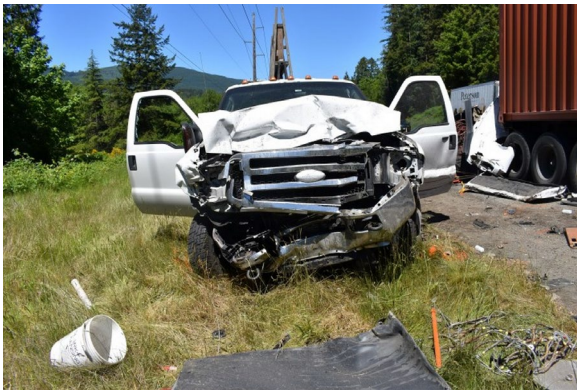
*Figure 10. Front plane damage, 2005 Ford F-350 (police photo)*

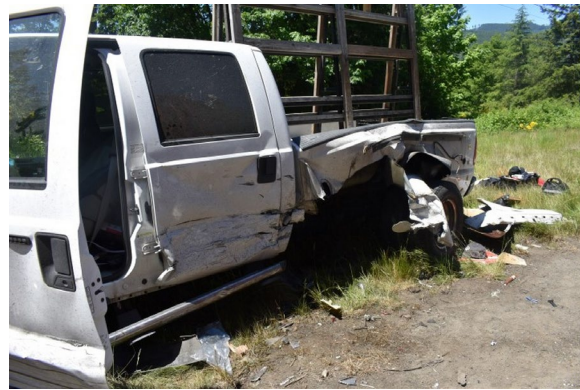
*Figure 11. Left plane damage, 2005 Ford F-350 (police photo)*

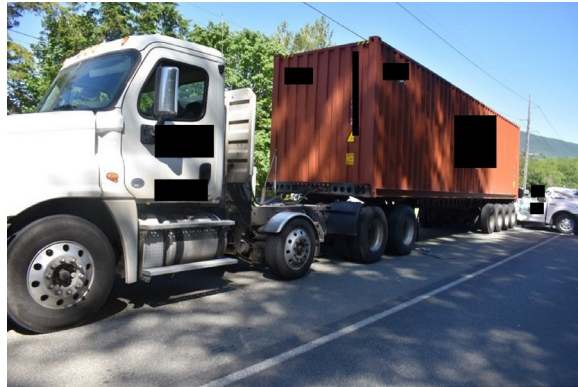
*Figure 12. 2015 Freightliner Cascadia tractor/2014 Pratt chassis trailer (police photo)*

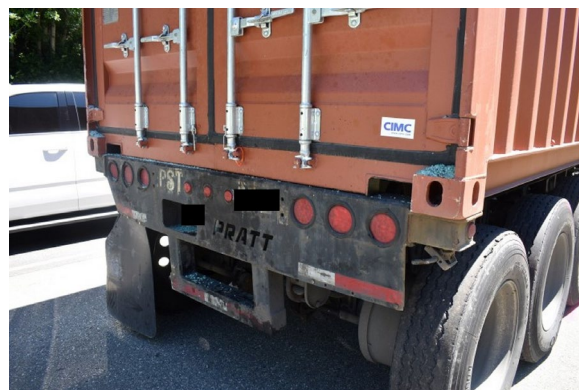
*Figure 13. Rear plane damage, 2014 Pratt chassis trailer and container (police photo)*
