U.S. Department
of Transportation

**National Highway
Traffic Safety
Administration**

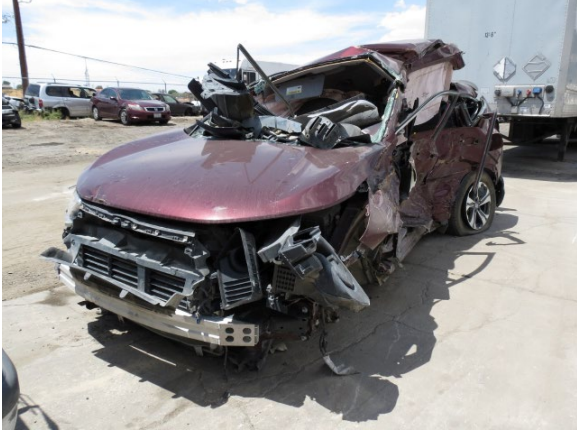
Figure 1. 2018 Honda CR-V

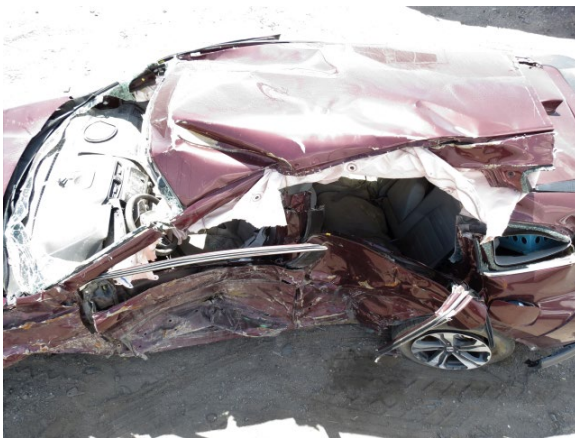
Figure 5. Left plane damage, 2018 Honda CR-V

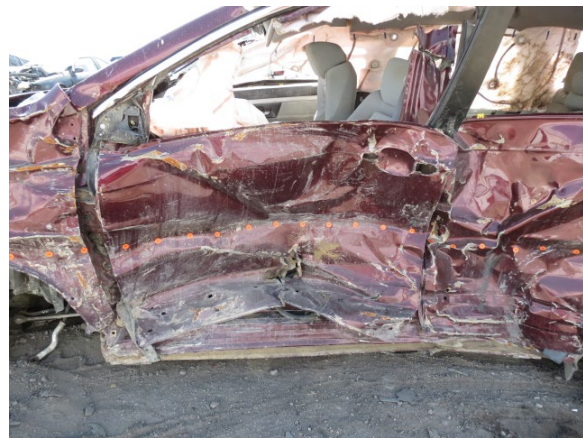
Figure 6. Left plane damage, 2018 Honda CR-V

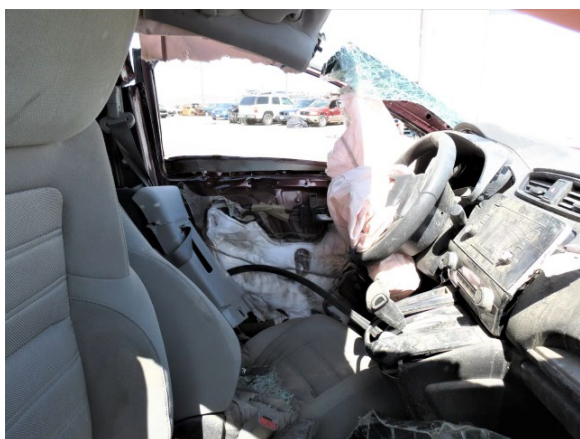
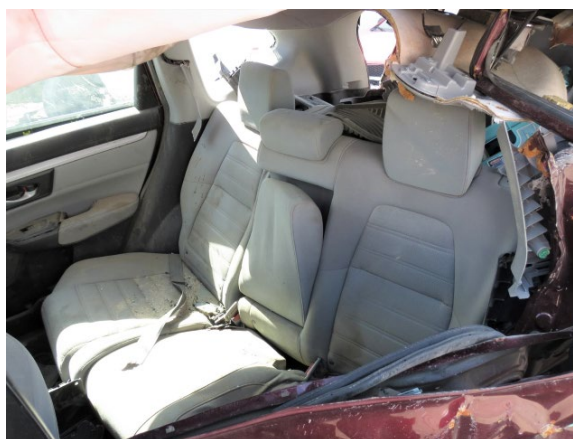
Figure 7. Interior damage, 2018 Honda CR-V *Figure 8. Interior damage, 2018 Honda CR-V*

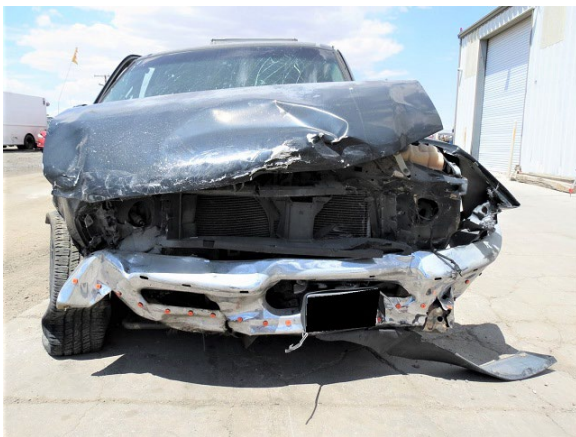
Figure 9. Exterior damage, 1998 Ford Expedition

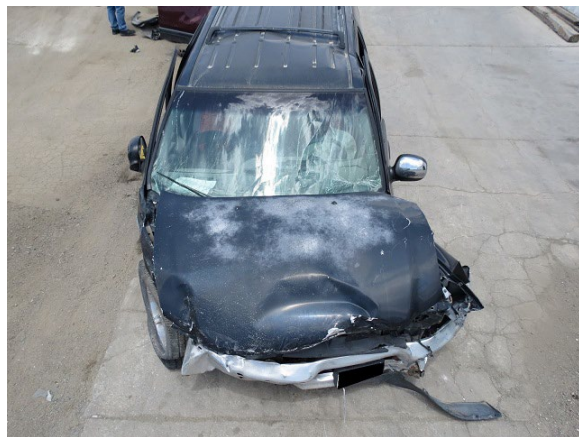
Figure 10. Exterior damage, 1998 Ford Expedition
