DOT HS 812 563

# **Special Crash Investigations On-Site Small Overlap/Oblique Impact Investigation Vehicle: 2012 Ford Focus Location: Missouri Crash Date: July 2016**

**INDIANA UNIVERSITY  
TRANSPORTATION RESEARCH CENTER  
ON-SITE SMALL OVERLAP/OBLIQUE  
IMPACT INVESTIGATION  
CASE NUMBER - IN16023  
LOCATION - MISSOURI  
VEHICLE - 2012 FORD FOCUS  
CRASH DATE - JULY 2016**

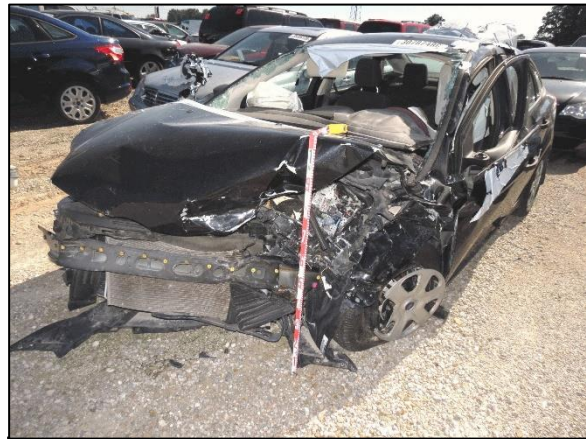
**Figure 1:** The damaged 2012 Ford Focus

This report documents the on-site investigation of a small overlap/oblique impact to a 2012 Ford Focus (**Figure 1**) and the injuries sustained by the driver. This crash investigation was initiated by the National Highway Traffic Safety Administration (NHTSA) in September 2016, after the crash was identified by the Special Crash Investigation team at the Indiana University Transportation Research Center through an online search of Missouri crash report abstracts. This investigation was assigned in September 2016, when permission for the vehicle inspection was obtained from the insurance company. The crash occurred in July 2016, at 1905 hours, in Missouri and was investigated by a local police agency. The crash involved the Ford and a 2005 Pontiac Sunfire. The Ford and crash scene were inspected in September 2016. The Pontiac was not inspected since it had been sold for salvage.

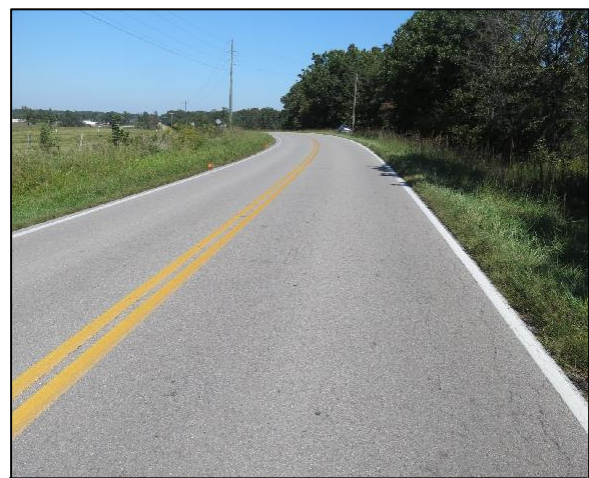
**Figure 3:** Northbound approach of the Pontiac

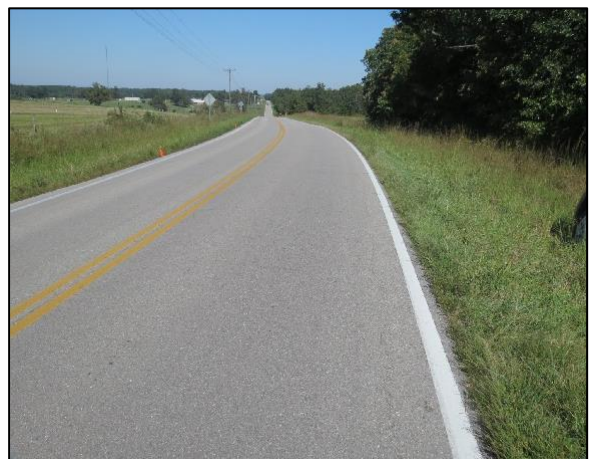
**Figure 4:** Area where Pontiac departed right side of roadway, view north

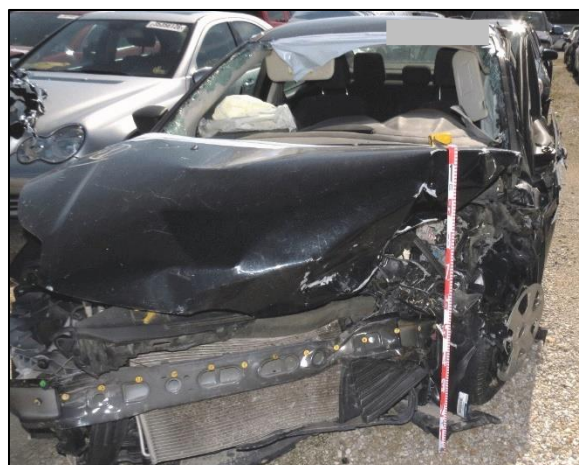
The right front corner of the Pontiac struck the front left corner of the Ford (**Figure 5**). The impact occurred 2.6 m (8.5 ft) into the Ford's travel lane (**Figure 6**). The force direction on the Ford was within the 11 o'clock sector and the impact resulted in actuation of the driver's and front row passenger's safety belt pretensioners, stage 2 deployment of both frontal air bags, and deployment of the left IC air bag. The Ford's EDR reported the maximum longitudinal and lateral velocity changes as -45.1 km/h (-28.0 mph) and 20.0 km/h (12.4 mph), respectively. The "Missing Vehicle" algorithm of the WinSMASH program calculated the Ford's total delta-V as 54 km/h (34 mph). The longitudinal and lateral velocity changes were -51 km/h (-32 mph) and 19 km/h (12 mph), respectively. WinSMASH calculated the total delta-V for the

**Figure 5:** Damage to the front plane of the Ford from the impact with the Pontiac

*Exterior Damage Event 1:* The entire front plane sustained direct and induced damage during the impact with the front plane of the Pontiac. The direct damage involved the Ford's bumper, hood, left headlamp/turn signal assembly, left fender, and left front wheel. The direct damage began at the left corner of the front bumper and extended 115 cm (45.3 in). The Field L was 126 cm (49.6 in) long and began at the same location. Crush measurements were taken on the bumper bar and the maximum residual crush was 64 cm (25.2 in) occurring at C<sub>1</sub>. The crush values were: C<sub>1</sub> = 64 cm (25.2 in), C<sub>2</sub> = 50 cm (19.7.3 in), C<sub>3</sub> = 40 cm (15.7 in), C<sub>4</sub> = 23 cm (9.1 in), C<sub>5</sub> = 5 cm (2.0 in), C<sub>6</sub> = 0 cm.

*Damage Classification Event 1:* The Collision Deformation Classification (CDC) was 11FDEW3 (340 degrees).

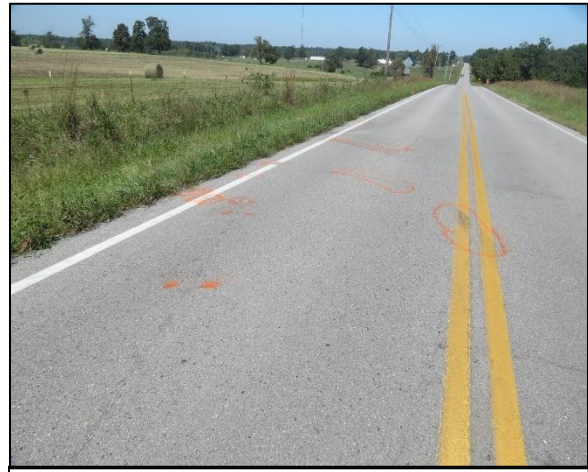
**Figure 6:** View northeast to area of impact in the southbound lane

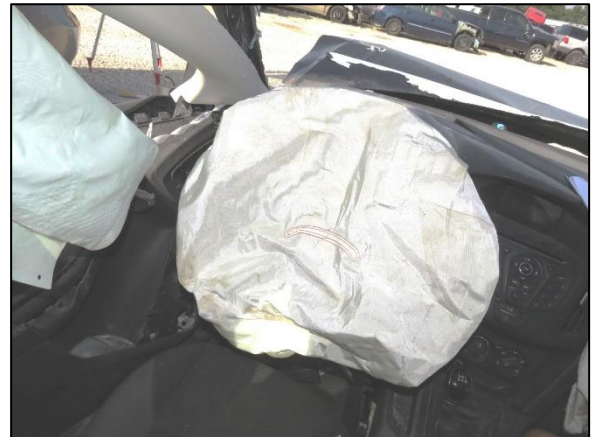
The driver's frontal air bag (**Figure 7**) was located within the steering wheel hub. The air bag module had two cover flaps constructed of pliable vinyl that were separated by a horizontal tear seam. The top flap was 5 cm (2.0 in) high and 13.5 cm (5.3 in) wide. The bottom flap was 13.5 cm (5.3 in) wide at the top, 7 cm (2.8 in) wide at the bottom, and 10 cm (3.9 in) high. The cover flaps opened at the designated tear seams and were undamaged. The deflated air bag was 54 cm (19.7 in) in diameter. Inspection of the air bag revealed no discernable evidence of occupant contact and no damage.

**Figure 7:** The Ford's driver's deployed frontal air bag, left IC, and left A-pillar

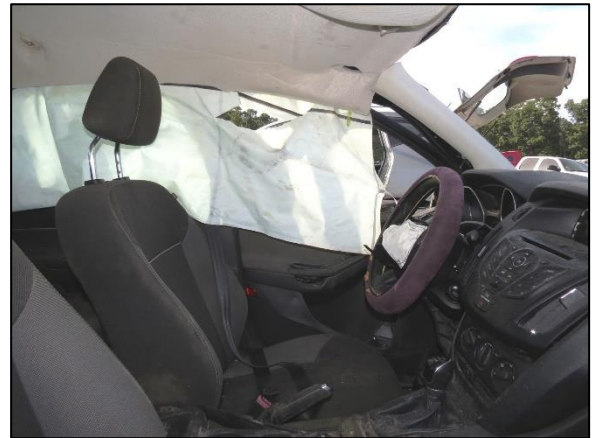
The IC air bags were located along the roof side rail inside the headliner and extended from the A-pillar to the C-pillar. The deflated left IC (**Figure 8**) was 154 cm (60.1 in) wide and 35 cm (20.1 in) high. The IC extended 15 cm (5.9 in) below the beltline in the second row. The distance the IC extended below the beltline in the front row could not be accurately measured since the IC had been cut in the front row, probably by emergency responders. There was a triangular-shaped gap between the front of the left IC and the A-pillar that was 21 cm (8.3 in) wide at the beltline. There was no discernable evidence of occupant contact to the left IC and no damage.

**Figure 8:** The Ford's deflated left IC air bag
