U.S. Department  
of Transportation

**National Highway  
Traffic Safety  
Administration**

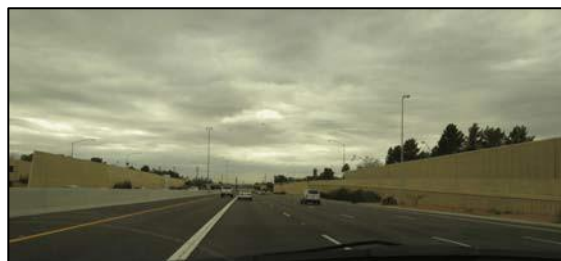
**Figure 2.** Southbound approach

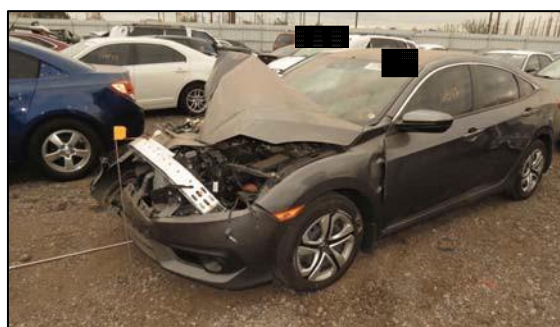
**Figure 3.** 2016 Honda Civic
