U.S. Department  
of Transportation  
**National Highway  
Traffic Safety  
Administration**

DOT HS 812 622

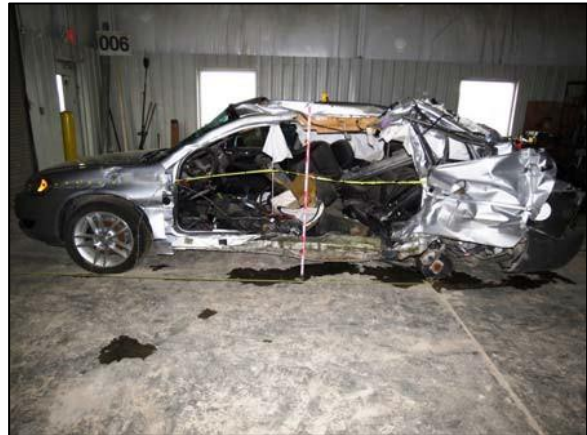
**Figure 1.** 2013 Chevrolet Impala

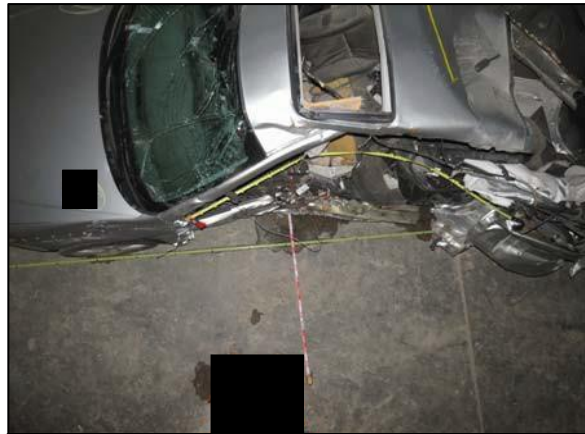
**Figure 5.** Overhead of damage from impact with Ford

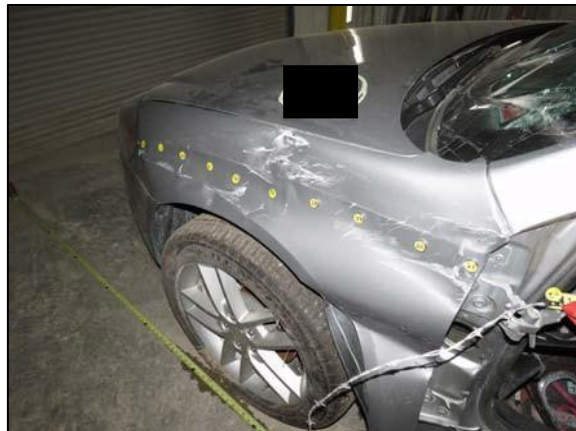
**Figure 7.** Chevrolet left fender damage

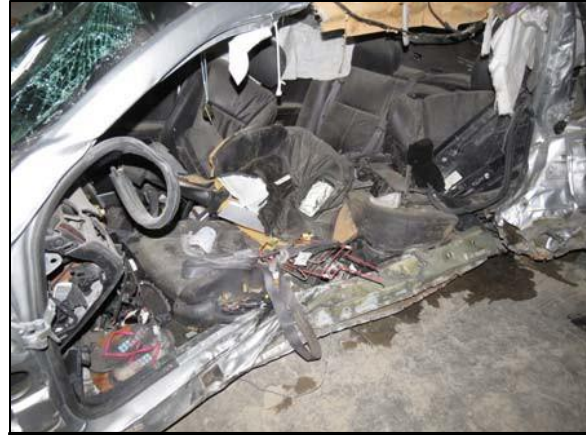
**Figure 8.** Chevrolet left plane intrusion damage

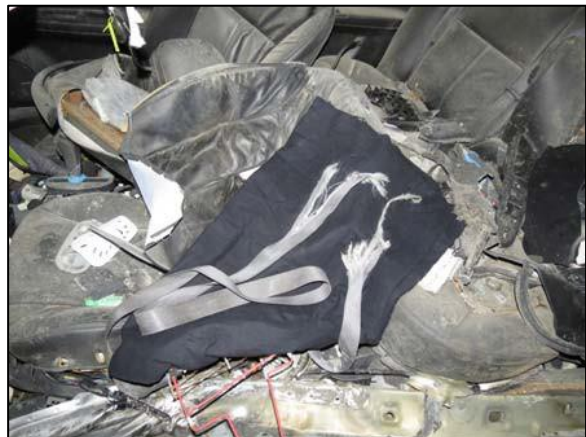
**Figure 9.** Chevrolet driver’s “horsetailed” seat belt

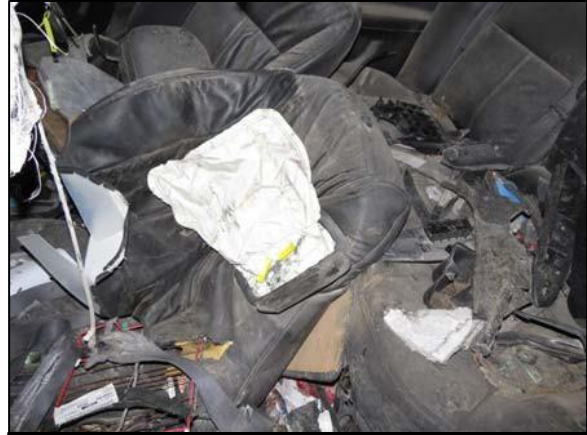
**Figure 10.** Cuts in driver's side impact air bag

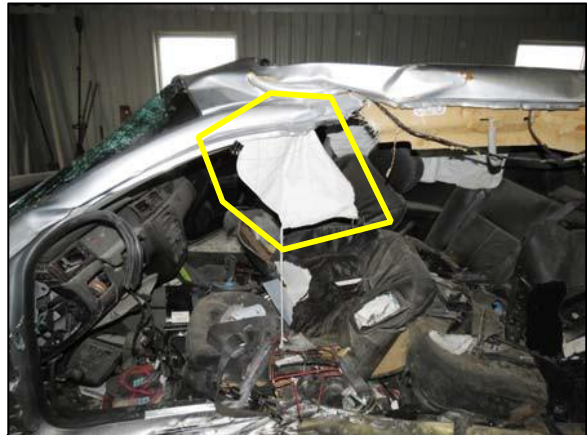
**Figure 11.** Remnant of left IC air bag
