U.S. Department
of Transportation

**National Highway
Traffic Safety
Administration**

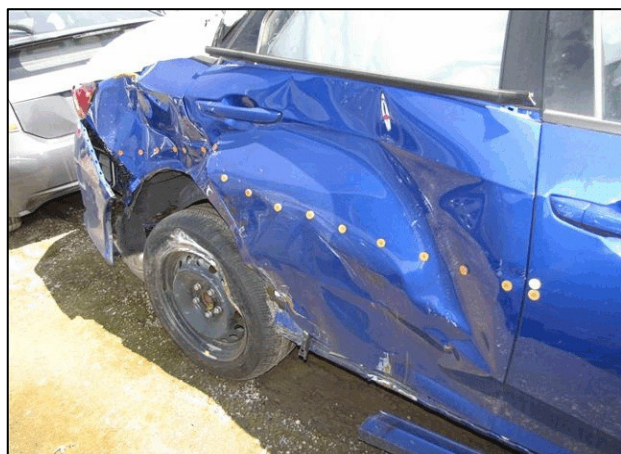
Figure 3. Right plane damage (Event 2), 2016 Honda Civic.

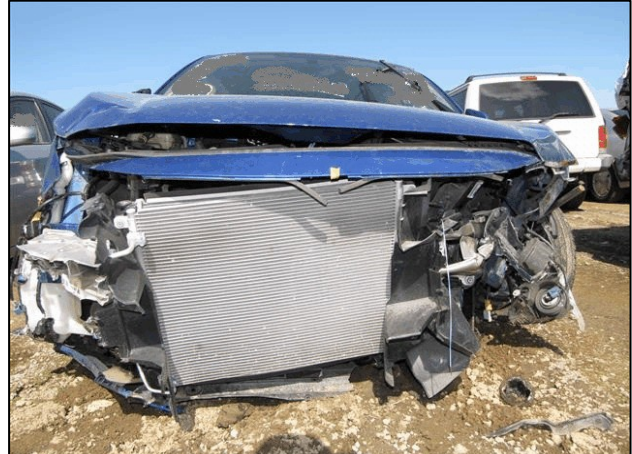
Figure 4. Front plane damage, 2016 Honda Civic.

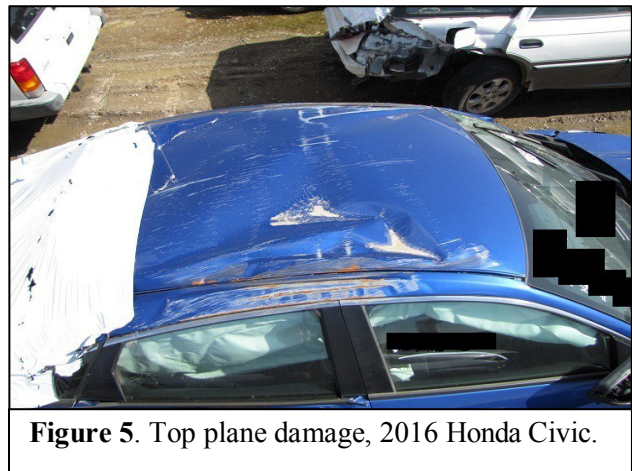
Figure 5. Top plane damage, 2016 Honda Civic.

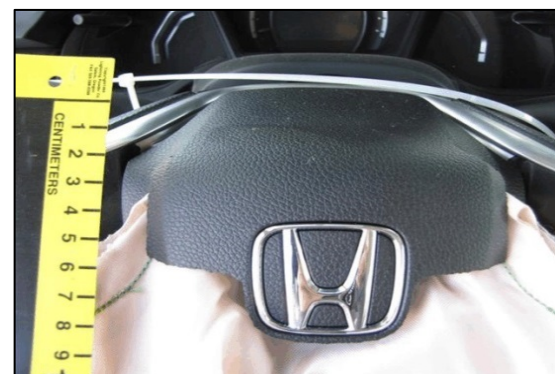
Figure 8. Top cover flap, deployed frontal air bag, 2016 Honda Civic.
