**Special Crash Investigations
On-Site Rollover Crash
Investigation;
Vehicle: 2015 Toyota Highlander;
Location: Texas;
Crash Date: March 2018**

16. Abstract This report documents the on-site investigation of the single-vehicle rollover crash of a 2015 Toyota Highlander, which was equipped with rollover/side impact inflatable curtain (IC) air bags that were certified to comply with Federal Motor Vehicle Safety Standard (FMVSS) No. 226, Ejection Mitigation. This crash occurred on the north roadside of a six-lane divided State highway that traversed in a northwest-southeast direction. The Toyota was equipped with multistage frontal air bags, front seat-mounted side impact air bags, and rollover/side impact IC air bags. A belted 67-year-old female drove the vehicle. The Toyota was traveling northwest in the left through lane when the driver lost control on the wet pavement and the vehicle departed the right side of the roadway. The left plane struck the end terminal of a blocked out, W-beam steel guardrail (Event 1). The vehicle rotated clockwise and rolled over (Event 2), left side leading, an estimated 12 quarter turns across a distance of approximately 37 m (121 ft) down an embankm

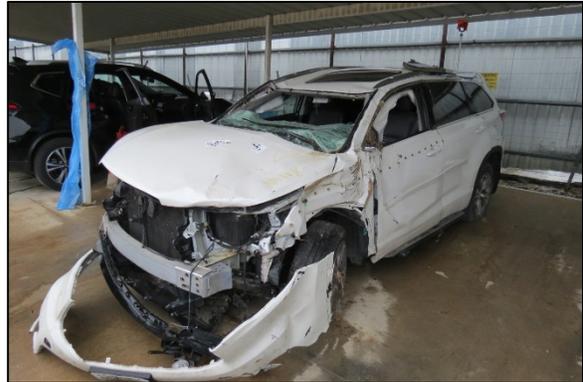
Figure 1. The damaged 2015 Toyota Highlander.

This report documents the on-site investigation of the single-vehicle rollover crash of a 2015 Toyota Highlander (**Figure 1**), which was equipped with rollover/side impact inflatable curtain (IC) air bags that were certified to comply with Federal Motor Vehicle Safety Standard (FMVSS) No. 226, Ejection Mitigation. This crash investigation was initiated by the National Highway Traffic Safety Administration in April 2018 through the sampling activities of the Crash Investigation Sampling System (CISS) and assigned to the Special Crash Investigation (SCI) team at the Indiana University Transportation Research Center. The crash occurred in Texas in March 2018 and was investigated by a local police agency. Cooperation with the driver's insurance company was initiated and finalized in April 2018. Vehicle and crash scene inspections were completed in May 2018. The driver could not be located for interview.

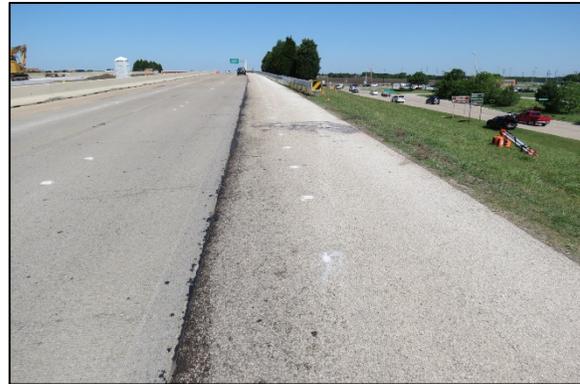
Figure 2. Northwest view, Toyota's approach to impact with end terminal.

16.1 km/h (10 mph), a temperature and dew point of 13.9 °C (57 °F), according to local weather reports. The Toyota's roadway had three concrete northwest-bound through lanes. The left, center, and right through lanes were 3.1 m (10.2 ft), 3.3 m (10.8 ft) and 3.5 m (11.5 ft) wide, respectively. The through lanes were bordered by shoulders that were each approximately 2 m (7 ft) wide. The median shoulder was concrete and the right shoulder was bituminous. The median was under construction and the roadway had temporary white dotted edge and lane lines (Botts dots) and there were no rumble strips. The median separated the northwest-bound through lanes from three southeast-bound through lanes. The roadway was wet and the positive grade in the area of the Toyota's approach was 3 percent. The speed limit was 113 km/h (70 mph). The crash diagram is included at the end of this report.

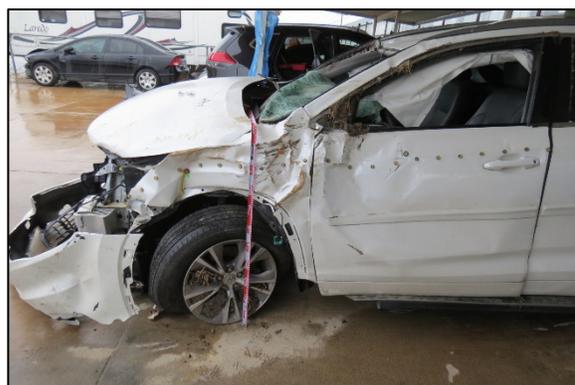
The left plane of the Toyota struck the end terminal (Event 1, **Figures 3 and 4**) on the north roadside. The force direction was in the 10 o'clock sector and according to EDR data, no air bags deployed as a result of this impact. The WinSMASH program could not be used to calculate delta V since an impact with a yielding object is out of scope for the program. However, the barrier algorithm of the program was used to calculate a barrier equivalent speed of 10 km/h (6 mph) based on the damage to the left fender. The result was considered to be reasonable. The vehicle continued in a northerly direction and traveled approximately 21 m (69 ft) down the negative 12 percent grade of an embankment and rolled over (Event 2, **Figure 5**), left side leading, an estimated 12 quarter turns across a distance of approximately 37 m (121 ft). The Toyota came to final rest on its wheels at the bottom of the embankment. The vehicle traveled approximately 69 m (226 ft) from road departure to final rest.

Figure 3. Damage from impact with end terminal.

The Toyota sustained damage to the left plane during the impact with the end terminal. There was direct damage to the left fender, front wheel, and hood. The direct damage began 287cm (113 in) forward of the left rear axle and extended 89 cm (35 in) rearward. The Field L was 132 cm (52.0 in) beginning 317 cm (124.8 in) forward of the left rear axle. Crush measurements were taken at the upper-door level and the maximum residual crush was 13 cm (5.1 in) occurring 287

The collision deformation classification (CDC) was 10LFEW2 (310 degrees). The severity of the damage was considered moderate based on damage to the fender.

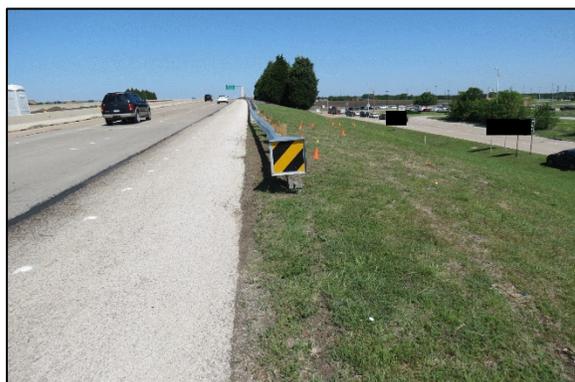
Figure 4. Northwest view, terminal head impact area.

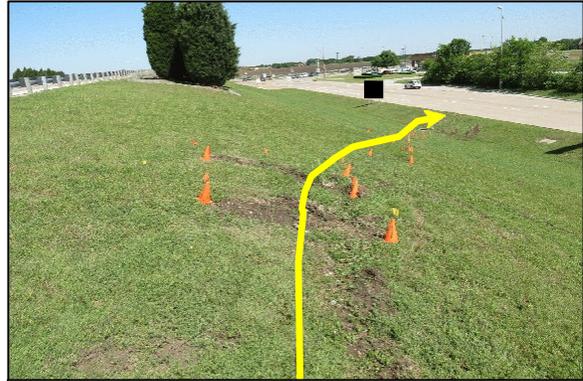
Figure 5. Rollover path and final rest area.

The rollover of the Toyota was initiated following the left plane impact with the end terminal as the vehicle traveled down the negative 12 percent grade of an embankment and rotated clockwise. The left side wheels furrowed into the ground as evidenced by grass and dirt deposits in both wheels and furrow marks in the ground. The vehicle then rolled over, left side leading, an estimated 12 quarter turns across a distance of approximately 37 m (121 ft). The rollover initiation type was classified as "Trip Over."

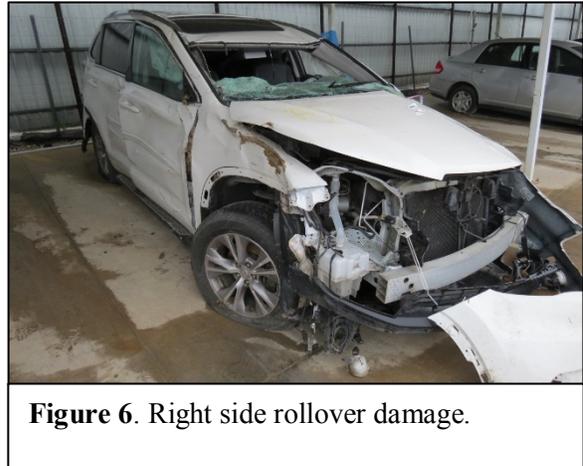
The Toyota's left, right, top, and back planes sustained damage during the rollover. The left plane sustained direct damage to the fender, front door, roof side rail and at the back of the quarter panel. The right plane sustained direct damage that extended from the fender to the quarter panel (**Figure 6**). The top plane sustained direct damage to the fender, windshield and front portion of the roof. The maximum vertical crush was 6 cm (2.4 in) occurring to the windshield header near the right A-pillar. The maximum lateral crush was 1 cm (0.4 in) occurring at the left A-pillar.

Figure 6. Right side rollover damage.

The CDC was 00TYDO2. The severity of the damage was minor based on the extent of crush to the top plane.

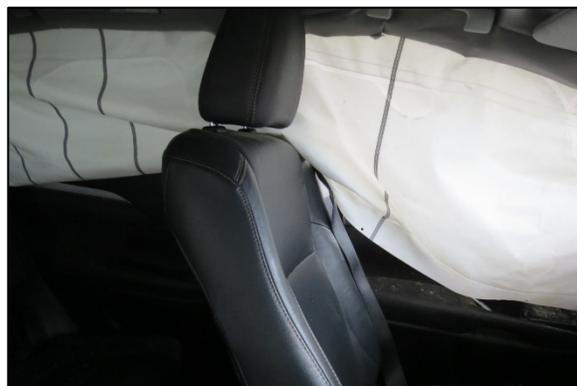
The left IC air bag was located along the left roof side rail inside the headline and extended from the D-pillar to the middle of the A-pillar. The IC Air bag measured 256 cm (100.8 in) in length, 50 cm (19.7 in) in height, and extended 20 cm (7.9 in) below the beltline at the driver's seating position. The width of the gap between the IC air bag and the base of the A-pillar was 11 cm (4.3 in) and the height of the IC air bag at the front attach point was 18 cm (7.1 in). The intrusion of the B-pillar, which was flush against the driver's seat back (**Figure 7**), did not allow the driver's IC air bag to extend fully down the side of the seat back.

Figure 7. Left IC air bag impeded by left seat back and intruded B-pillar.

The vehicle's rollover/side impact IC air bags were certified to comply with FMVSS No. 226 Ejection Mitigation. They provided coverage of the side window glazing in the front and second rows and the deflated IC extended 20 cm (7.9 in) below the beltline. The left front glazing was closed at the time of the crash and disintegrated during the rollover. The driver was restrained by the three-point lap and shoulder seat belt and remained in the vehicle throughout the crash.

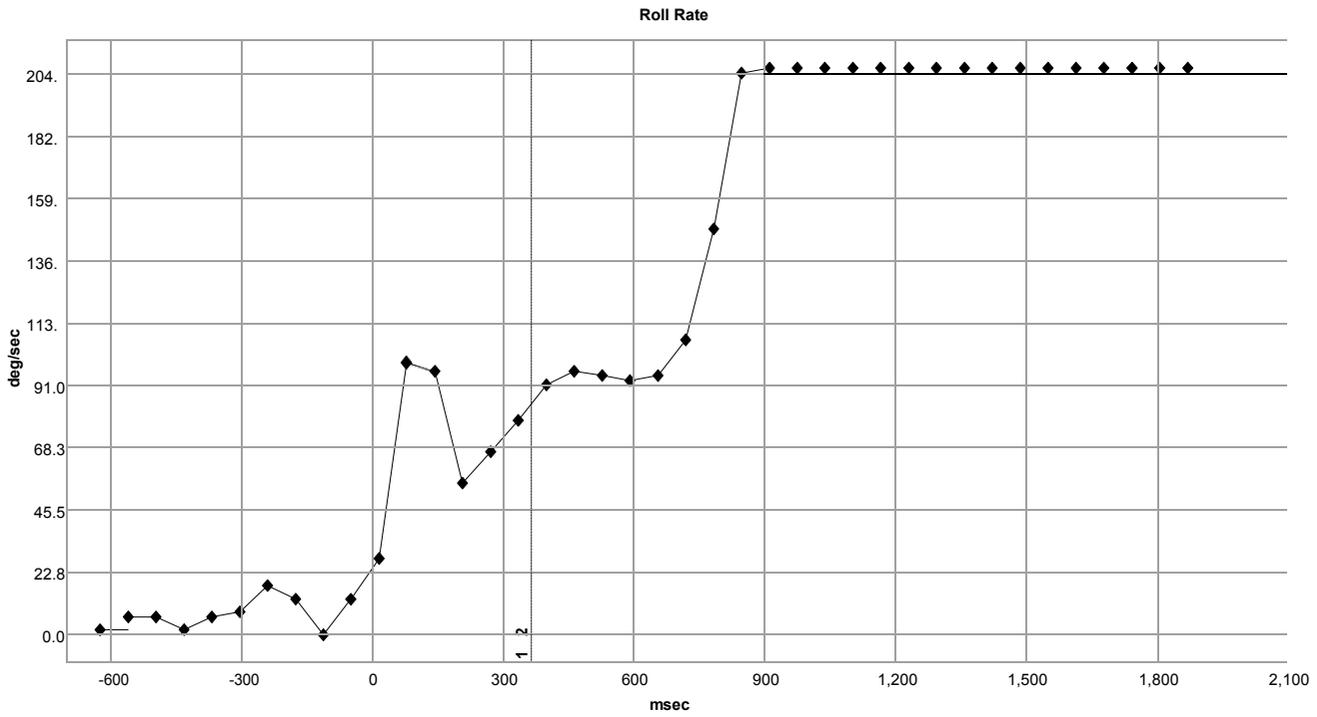
Rollover Crash Pulse (Most Recent Event, TRG 4 - table 1 of 2)

msec. Both IC air bags and the driver's pretensioner deployed at 366 msec after TRG. The maximum roll rate was 206.9 deg/sec and occurred 913 msec after TRG.

Recording Status, Time Series Data	Complete
Time from TRG to Next Sample (msec)	17
Roll Angle Peak (degrees)	454.6
Roll Angle at the Time of TRG (degrees)	4.8

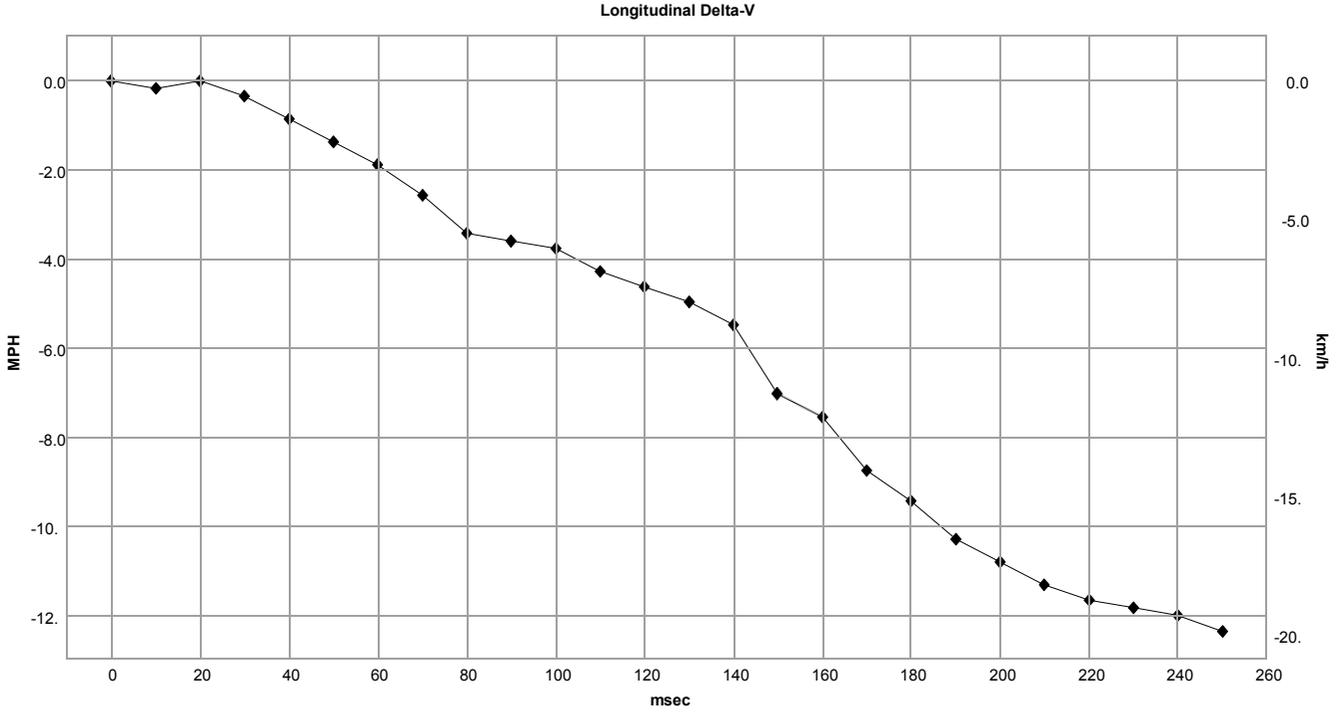
Longitudinal/Lateral Crash Pulse (1st Prior Event, TRG 3 - table 1 of 2)

System Status at Event, 3rd, 2nd, and 1st Prior Events (TRGs 1, 2, and 3): These three non-deployment events occurred during the impacts with the guardrail. No delta V values were reported for the 3rd and 2nd prior events. The 1st prior event reported the maximum longitudinal delta V as -20.1 km/h (-12.5 mph).

Recording Status, Time Series Data	Complete
Time from Time Zero to TRG (msec)	109.0
Length of Delta-V (msec)	250
Max. Longitudinal Delta-V (MPH [km/h])	-12.5 [-20.1]
Time, Maximum Delta-V, Longitudinal (msec)	254.5
Power Supply Status at Max. Delta-V	ON
Clipping Time of Longitudinal Delta-V (msec)	No
Clipping Time of Lateral Acceleration, Floor Sensor (msec)	No
