Special Crash Investigations Alleged Rollover Crash Investigation Vehicle: 2016 Chevrolet Equinox Location: South Dakota Crash Date: June 2018

16. Abstract This report documents the investigation of an alleged rollover crash involving a 2016 Chevrolet Equinox and a 1994 Mack CH600 dump truck and the fatal injuries sustained by all three occupants of both vehicles. The crash occurred in a four-leg intersection controlled by stop signs for eastbound and westbound traffic in a rural area of South Dakota in June 2018. The Chevrolet was being driven northbound by a belted 79-year-old male and was pulling a two-wheel utility trailer. A belted 71-year-old female occupied the front row right seat position. The Mack was being driven westbound by a belted 82-year-old male who entered the intersection without stopping. The front plane of the Chevrolet struck the left plane of the Mack. The Chevrolet was displaced to the left and departed the roadway on the left edge, and the trailer separated and departed the roadway on the right edge. The Mack departed the roadway on the right edge where it overturned onto its left plane. The investigation concluded no rollover event involving the Chevrolet

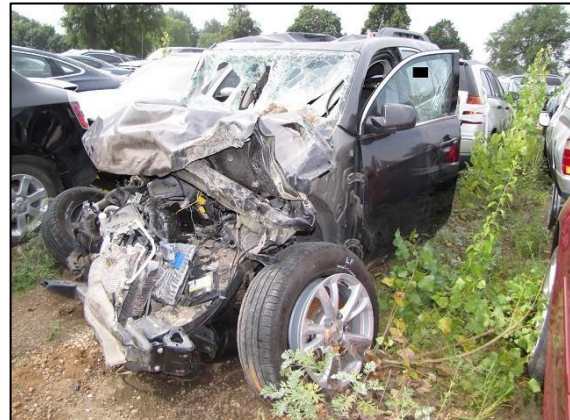
Figure 1. 2016 Chevrolet Equinox.

This report documents the investigation of an alleged rollover crash involving a 2016 Chevrolet Equinox (**Figure 1**) and a 1994 Mack CH600 and the fatal injuries sustained by all three occupants of the Chevrolet and the Mack truck. The crash was identified by the Special Crash Investigations (SCI) group of the National Highway Traffic Safety Administration. Dynamic Science, Inc., was directed to locate the Chevrolet and obtain images to assess its damage severity. The vehicle was located and images were obtained and forwarded to NHTSA, which assigned the case in August 2018. The police report and salvage listing indicated the vehicle sustained a rollover crash.

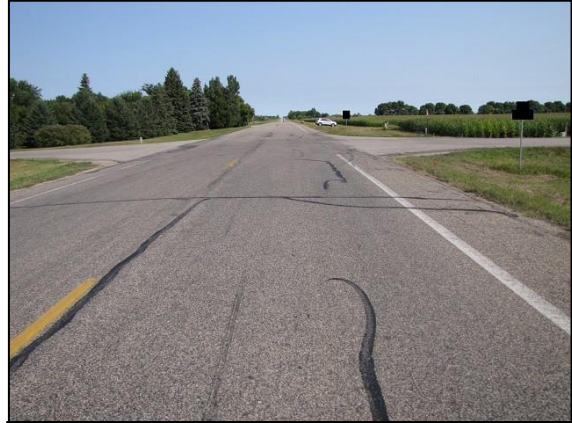
Figure 2. Crash site looking north.

The crash site was a four-leg intersection including a north/south roadway and an east/west roadway (**Figure 2**). The intersection was controlled by stop signs located at the northeast and

southwest corners for eastbound and westbound traffic. The north/south roadway was configured with one lane for each direction separated by a dashed yellow painted stripe and bordered by solid white painted fog lines and paved shoulders. The lanes measured 3.6 m (12.0 ft) each in width with the left shoulder measuring 1.2 m (3.9 ft) in width and the right shoulder measuring 1.6 m (5.2 ft) in width. In the pre-crash location, this roadway had a slope measuring positive 0.7 percent and a super-elevation measuring negative 0.7 percent. It was paved with asphalt in worn condition. The posted speed limit was 105 km/h (65 mph).

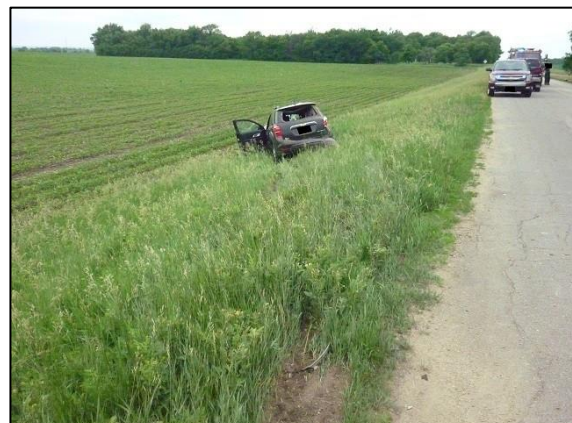
Figure 3. 2016 Chevrolet Equinox at final rest looking west from area of departure (police photo).

The crash included three events. Initially, the front plane of the Chevrolet struck the left plane of the Mack in an angled configuration (Event 1). The Chevrolet deposited several arcing gouge marks, the longest measuring 3.4 m (11.1 ft) long near the point of impact as it was displaced to the left initiating a counterclockwise rotation. The Chevrolet's right plane struck the left plane of the Mack in a secondary side slap configuration (Event 2). The Chevrolet traveled southwest on the east/west roadway leaving a trail of fluid and dirt before departing the roadway on the south edge. It traveled in a southwest trajectory through high grass for several meters before coming to rest in an upright orientation facing southwest on the roadside at a police-estimated distance of 45 m (150 ft) from the area of impact (**Figure 3**). Gouge marks, tire tracks, and fluid spillage on the roadway and roadside suggest the vehicle was

tracking from impact to final rest. At some time during the crash, the vehicle's trailer was displaced from the hitch departing the roadway on the northwest corner and coming to rest off the roadway.

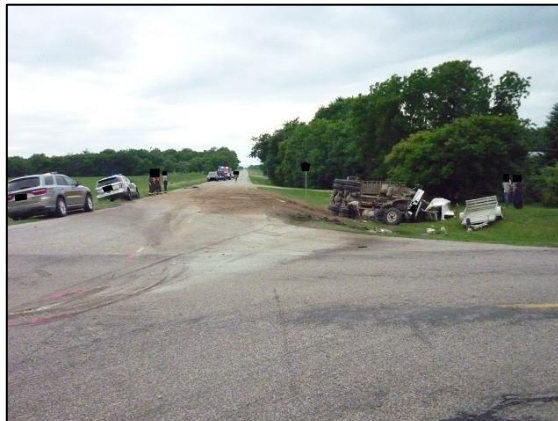
Figure 4. 1994 Mack CH600 at final rest looking west from area of impact (police photo).

The Mack traveled through the intersection in a northwest trajectory while rotating in a clockwise direction. It departed the roadway on the northwest corner depositing a group of linear scrape marks the longest measuring 1.7 m (5.6 m) long at the area of departure and overturned left side leading (Event 3) on the roadside before coming to rest on its left plane facing east an estimated distance of 30 m (100 ft) west of the area of impact (**Figure 4**).

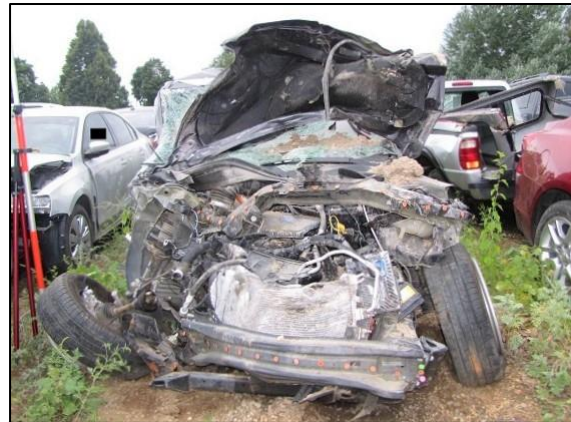
Figure 5. 2016 Chevrolet Equinox front plane damage.

The Chevrolet sustained severe damage to the front and right planes in the crash that included a front-to-side impact and a secondary, side-to-side impact with the Mack (**Figure 5**). A difference in the opposing vehicles' frame heights caused crush damage to the Chevrolet at bumper level and above bumper level on the front plane. The front bumper fascia was displaced from the vehicle and the backing bar was used to measure crush at bumper level. The upper radiator support was used to measure above bumper crush. Direct damage and the Field L were distributed from bumper corner to bumper corner and measured 113 cm (44.5 in). The Nikon Total Station and Faro Blitz programs computed crush measurements that were averaged in six increments as follows: $C_1 = 23$ cm (9.1 in), $C_2 = 30$ cm (11.8 in), $C_3 = 42$ cm (16.5 in), $C_4 = 41$ cm (16.1 in), $C_5 = 66$ cm (26.0 in), and $C_6 = 80$ cm (31.5 in). Maximum crush measured 80 cm (31.5 in) at the front right bumper corner and the Collision Deformation Classification (CDC) for the Chevrolet in Event 1 of 02FDEW5. A PDOF using EDR-reported velocity changes was calculated at 50 degrees.

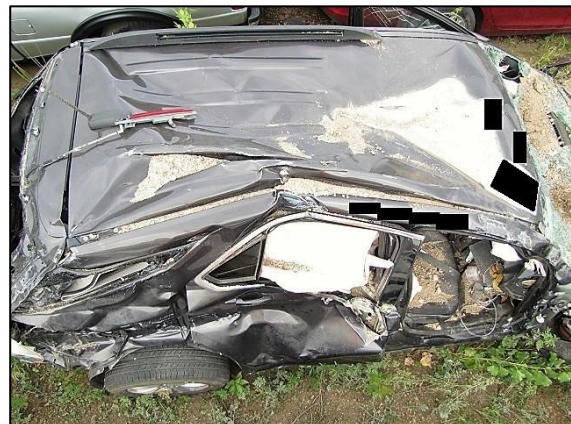
Figure 6. 2016 Chevrolet Equinox right plane damage.

The Chevrolet sustained direct damage to the right plane and induced damage to the top plane caused by the secondary impact with the Mack in Event 2 (**Figure 6**). Direct damage began at the right rear bumper corner and extended forward 327 cm (128.7 in) ending at the right front fender. The damage extended vertically to the right roof side rail. The Nikon Total Station and Faro Blitz programs computed crush measurements in six increments as follows: $C_1 = 12$ cm (4.7 in), $C_2 = 19$ cm (7.5 in), $C_3 = 23$ cm (9.1 in), $C_4 = 14$ cm (5.5 in), $C_5 = 26$ cm (10.2 in), and $C_6 = 24$ cm (9.4 in).

Maximum crush measured 26 cm (10.2 in) at the right A-pillar and the CDC for the Chevrolet in Event 2 was 04RDAW3. The observed PDOF was 110 degrees.

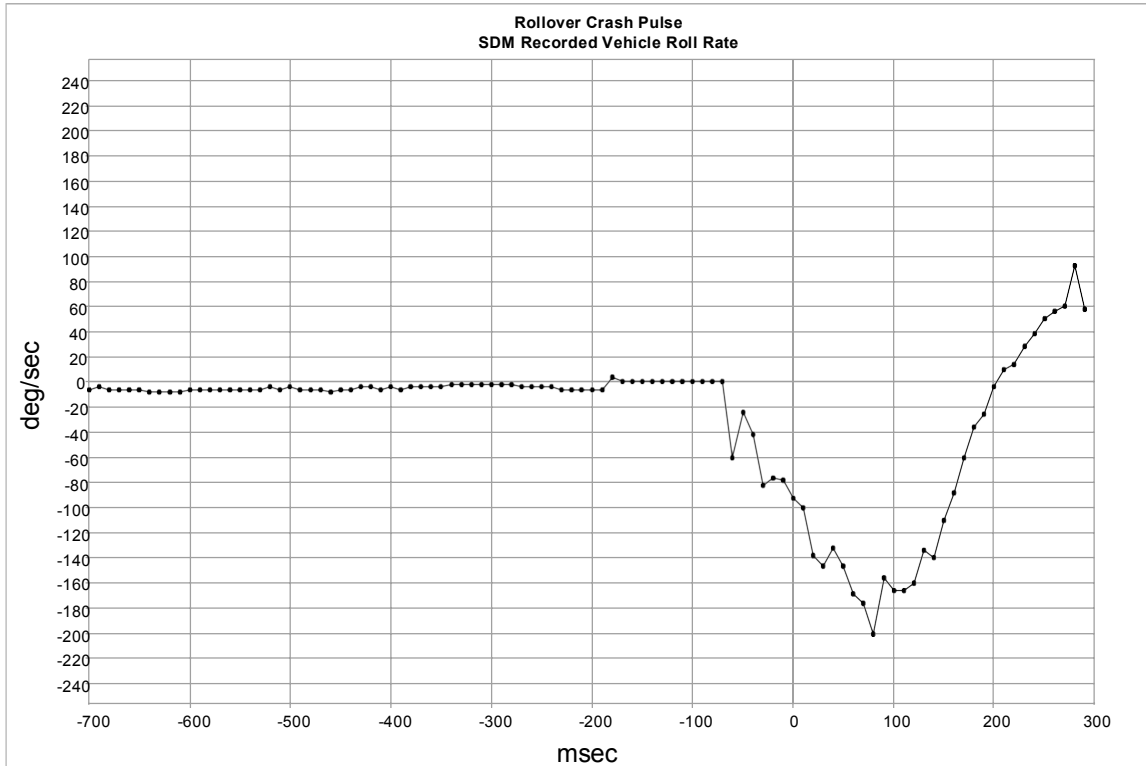
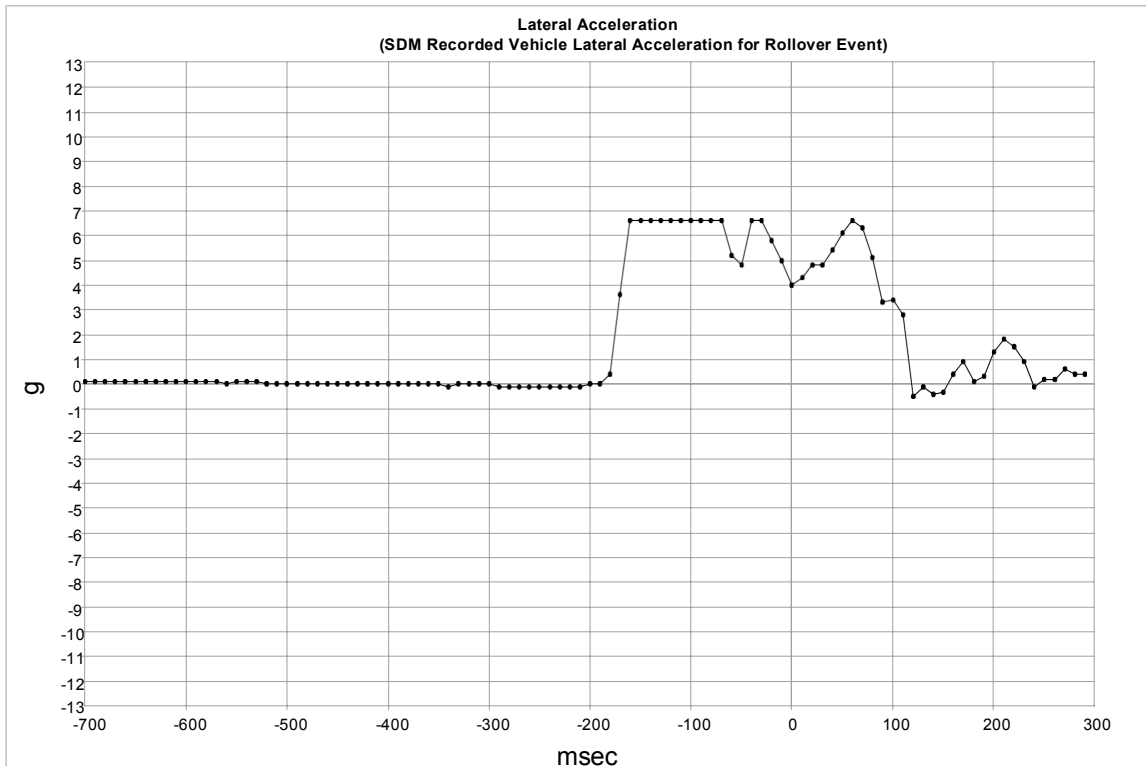
Rollover Crash Pulse (Event Record 2)

Time (msec)	SDM Recorded Vehicle Roll Rate (deg/sec)	Time (msec)	SDM Recorded Vehicle Roll Rate (deg/sec)
-700	-6	-200	-6
-690	-4	-190	-6
-680	-6	-180	4
-670	-6	-170	0
-660	-6	-160	0
-650	-6	-150	0
-640	-8	-140	0
-630	-8	-130	0
-620	-8	-120	0
-610	-8	-110	0
-600	-6	-100	0
-590	-6	-90	0
-580	-6	-80	0
-570	-6	-70	0
-560	-6	-60	-60
-550	-6	-50	-24
-540	-6	-40	-42
-530	-6	-30	-82
-520	-4	-20	-76
-510	-6	-10	-78
-500	-4	0	-92
-490	-6	10	-100
-480	-6	20	-138
-470	-6	30	-146
-460	-8	40	-132
-450	-6	50	-146
-440	-6	60	-168
-430	-4	70	-176
-420	-4	80	-200
-410	-6	90	-156
-400	-4	100	-166
-390	-6	110	-166
-380	-4	120	-160
-370	-4	130	-134
-360	-4	140	-140
-350	-4	150	-110
-340	-2	160	-88
-330	-2	170	-60
-320	-2	180	-36
-310	-2	190	-26
-300	-2	200	-4
-290	-2	210	10
-280	-2	220	14
-270	-4	230	28
-260	-4	240	38
-250	-4	250	50
-240	-4	260	56
-230	-6	270	60
-220	-6	280	92
-210	-6	290	58

Event 1 was a deployment event in which both frontal, both IC, and the front right seat-mounted side air bags deployed and both seat belt pretensioners actuated. Event 2 was a deployment level event during which no air bags deployed and an Event Severity Status: Rollover was captured. The rollover crash pulse indicated a counterclockwise rotation at a maximum roll rate of -200 degrees/second at 80 milliseconds (ms). The rollover data suggest the vehicle was tilted sharply to the left along its longitudinal axis during Event 2. Vehicle damage and scene evidence suggest the vehicle did not complete a quarter turn and eventually returned to its upright orientation before tracking to final rest.

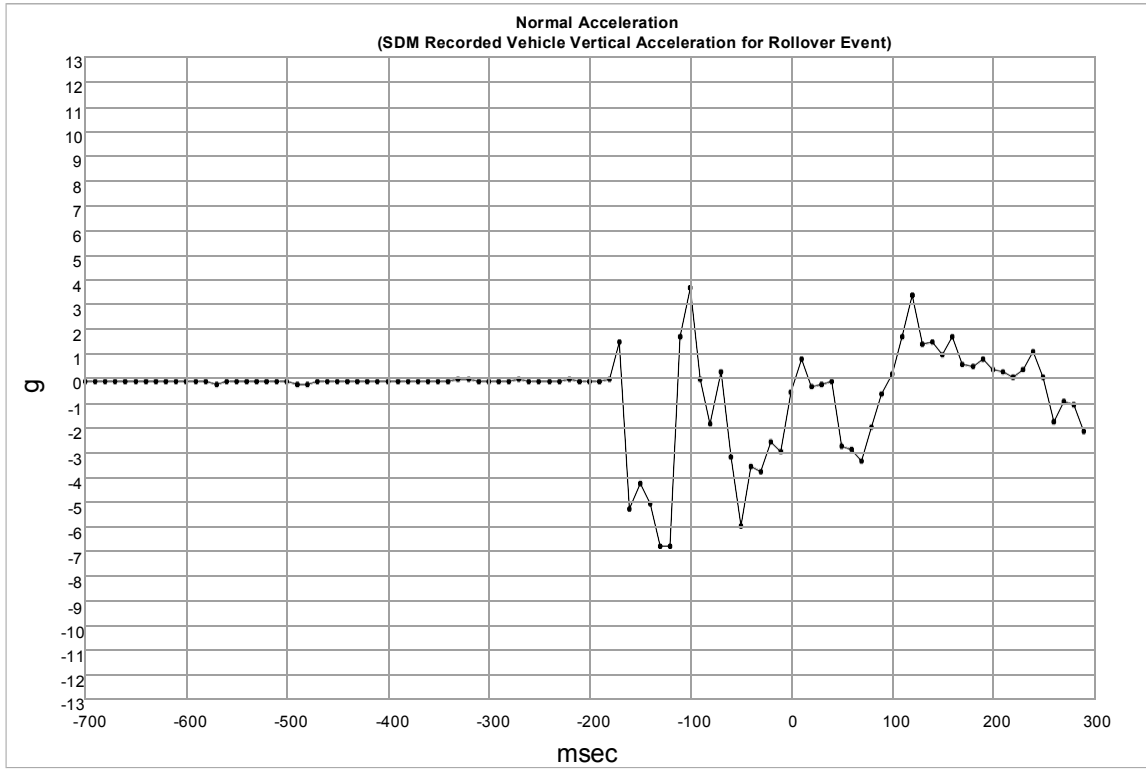
Vertical Crash Pulse (Event Record 2)

Time (msec)	Normal Acceleration (SDM Recorded Vehicle Vertical Acceleration for Rollover Event) (g)	Time (msec)	Normal Acceleration (SDM Recorded Vehicle Vertical Acceleration for Rollover Event) (g)
-700	0.0	-200	0.0
-690	0.0	-190	0.0
-680	0.0	-180	0.1
-670	0.0	-170	1.6
-660	0.0	-160	-5.1
-650	0.0	-150	-4.1
-640	0.0	-140	-4.9
-630	0.0	-130	-6.6
-620	0.0	-120	-6.6
-610	0.0	-110	1.8
-600	0.0	-100	3.8
-590	0.0	-90	0.1
-580	0.0	-80	-1.7
-570	-0.1	-70	0.4
-560	0.0	-60	-3.0
-550	0.0	-50	-5.8
-540	0.0	-40	-3.4
-530	0.0	-30	-3.6
-520	0.0	-20	-2.4
-510	0.0	-10	-2.8
-500	0.0	0	-0.4
-490	-0.1	10	0.9
-480	-0.1	20	-0.2
-470	0.0	30	-0.1
-460	0.0	40	0.0
-450	0.0	50	-2.6
-440	0.0	60	-2.7
-430	0.0	70	-3.2
-420	0.0	80	-1.8
-410	0.0	90	-0.5
-400	0.0	100	0.3
-390	0.0	110	1.8
-380	0.0	120	3.5
-370	0.0	130	1.5
-360	0.0	140	1.6
-350	0.0	150	1.1
-340	0.0	160	1.8
-330	0.1	170	0.7
-320	0.1	180	0.6
-310	0.0	190	0.9
-300	0.0	200	0.5
-290	0.0	210	0.4
-280	0.0	220	0.2
