# **Special Crash Investigations**

## **Child Restraint System Crash Investigation**

### **Vehicle: 2016 Chrysler Town & Country**

### **Crash Date: April 2018**

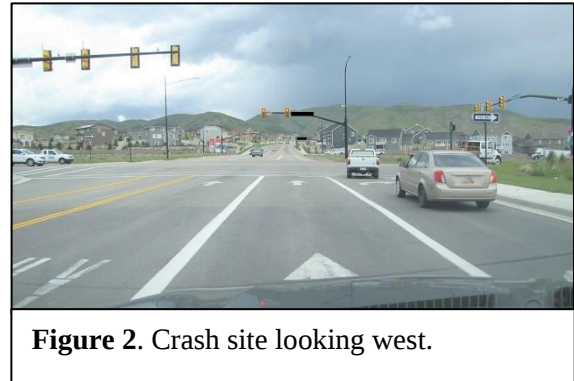
**Figure 2.** Crash site looking west.

The crash site was a four-leg intersection of a one-way northbound roadway and an east/west roadway (**Figure 2**). The intersection was configured with three-phase overhead traffic signals for all lanes. The northbound approach to the intersection was configured with a right turn lane, bike lane, two through lanes and a left turn lane. This roadway curved slightly right and was level. The eastbound approach was configured with one eastbound through lane, two left turn lanes and two westbound lanes. This was a straight roadway with a slope measuring negative 2.0 percent. The westbound approach was configured with one right turn lane, two westbound through lanes, a painted divider and two eastbound lanes. This was a straight roadway with a slope measuring negative 2.0 percent. The roadway in the intersection where the impacts occurred was level. The asphalt surface and painted stripes for all roadways were in good condition. The intersection was illuminated by overhead lamps. The posted speed limit was 89 km/h (55 mph) for the northbound roadway and 56 km/h (35 mph) for the east/west roadway. Conditions at the time of the crash were daylight, clear and dry. A crash diagram is included at the end of this report.

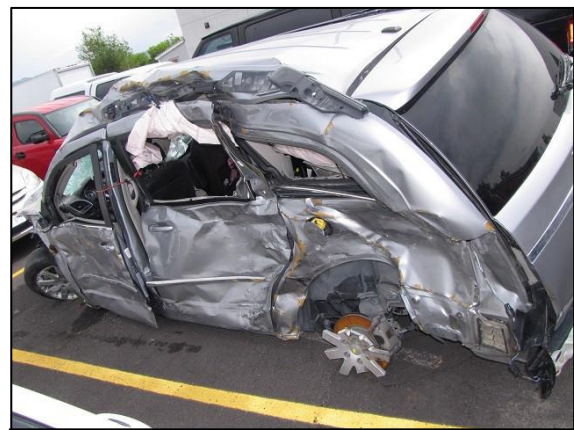
The Chrysler sustained severe damage to the left plane damage caused by the impact with the GMC (**Figure 3**). Direct damage was distributed longitudinally from bumper corner to bumper corner and vertically from sill to roof side rail. The left front tire was restricted rearward shortening the wheelbase, left rear tire was displaced and the wheel was fractured. Induced damage extended to the front plane where the grille and bumper fascia were displaced, and to the top plane where the roof was buckled and the roof rack was fractured. Forty-four measurements were taken at mid-door level by the Nikon Total Station and the Faro Blitz program computed crush measurements in six increments as follows:  $C_1 = 0$  cm,  $C_2 = 24$  cm (9.4 in),  $C_3 = 17$  cm (6.7 in),  $C_4 = 2$  cm (0.8 in),  $C_5 = 6$  cm (2.4 in), and  $C_6 = 24$  cm (9.4 in). Maximum crush located above the rear axle measured 24 cm (9.4 in). The Collision Deformation Classification (CDC) was 10LDAW3.

**Figure 3.** Left plane damage, the 2016 Chrysler Town & Country.

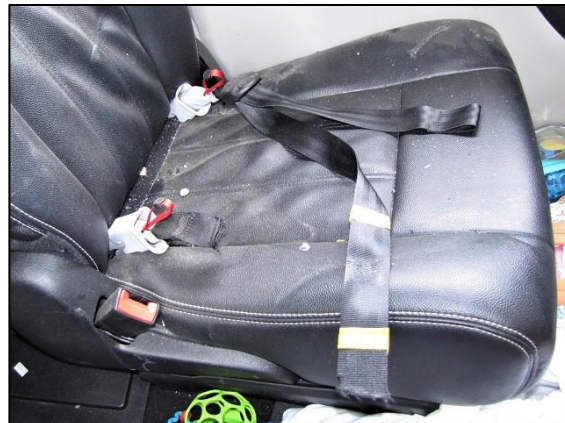
The 2-year-old female was seated in an unknown brand/model CRS anchored to the second row left seat using the LATCH system. The orientation of the CRS was unknown. The CRS lower anchor and tether straps were cut by responders during post-crash activities and the connectors were still attached to the anchors at the time of the SCI inspection. The left, adjustable lower

anchor strap revealed scuffs likely caused by occupant loading (**Figure 4**). The right anchor strap and tether strap were unremarkable. Efforts to identify the CRS were unsuccessful.

**Figure 4.** LATCH components second-row left seat, the 2016 Chrysler Town & Country.

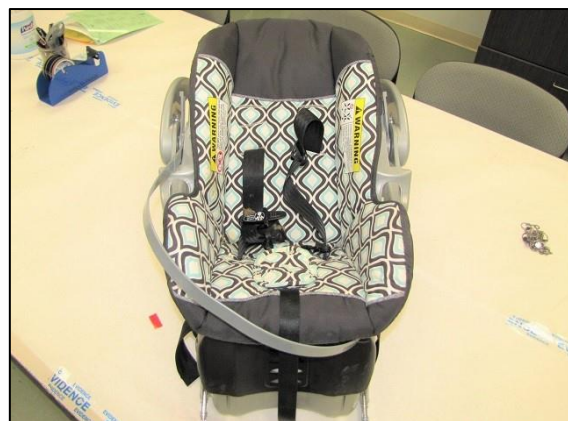
The 5-month-old female was seated in a Baby Trend Flex-Loc CRS (**Figure 5**) anchored to the second-row right seat. The CRS was identified by the model number TS41948 and the manufacture date of August 31, 2015. This rear-facing-only CRS was configured with an adjustable 5-point-harness system, removable seat pad, canopy, carry handle, fixed (non-adjustable) back, three sets of harness slots, seat angle indicator and LATCH (lower anchors only, no tether). The CRS was designed to be installed using either LATCH or the vehicle's seat belt with the removable stay-in-vehicle base, or using the vehicle's seat belt without the base. According to the investigating police officer, the CRS was installed using the base and LATCH. It was positioned on the second-row right seat cushion and installed rear-facing. The harness shoulder straps were positioned in the lowest set of slots. The LATCH connectors attached to the left and right LATCH anchors, spaced 24 cm (9.4 in) apart.

**Figure 5.** Baby Trend Flex-Loc CRS, the 2016 Chrysler Town & Country.

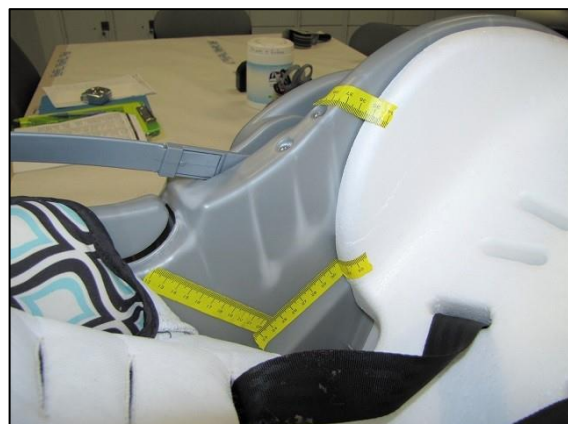
The CRS inspection documented evidence of occupant loading to the harness system and shell. A set of scuff marks were present on the right shoulder strap of the harness. The orientation and location of the scuff marks suggested they were caused when the occupant loaded the harness system at impact and the retainer clip pressed into the shoulder strap. With the pad removed, some

**Figure 6.** Baby Trend Flex-Loc damage to shell, the 2016 Chrysler Town & Country.

discoloration of the shell was documented. This discoloration was located primarily on the right aspect below the headrest (**Figure 6**). This area was likely loaded by the occupant at impact with the other vehicle. In a rear-facing orientation, the occupant was displaced toward the right aspect of the shell and the left side of the vehicle in response to the direction of force. Some scattered discoloration was present in the bottom aspect of the shell. It was likely the result lateral displacement of the occupant and CRS at impact. It is noteworthy that the vehicle bucket seat in which the CRS was installed also exhibited a visible tilt to the left side of the vehicle.

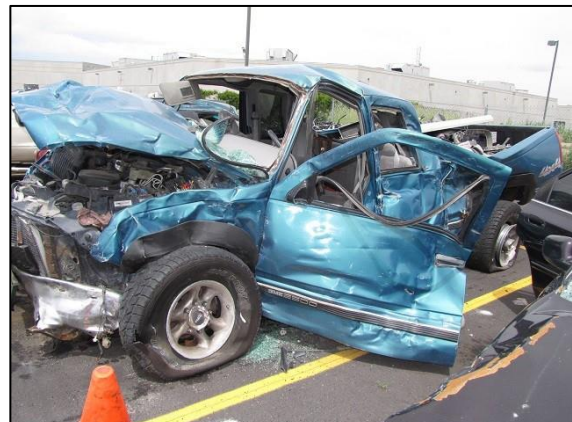
**Figure 7.** The 1997 GMC Sierra 2500.

The GMC sustained severe front plane damage caused at impact with the Dodge and moderate left plane damage caused at impact with the Chrysler. Direct damage to the front plane at bumper level was distributed laterally from corner to corner. The CDC for the GMC in Event 1 was 11FDEW2. Direct damage to the left plane began at the left front corner and extended to the left rear corner. The CDC for the GMC in Event 2 09LDEW3.

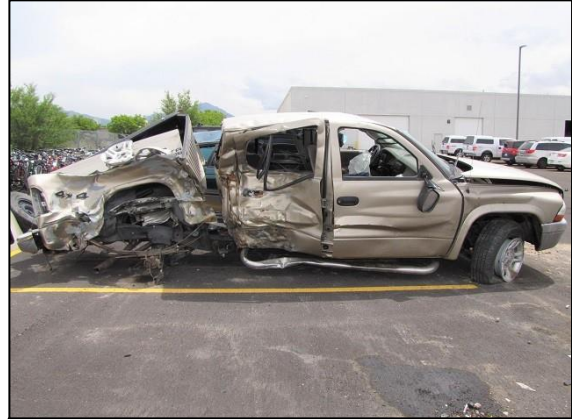
**Figure 8.** The 2003 Dodge Dakota.

The Dodge sustained severe right plane damage caused at impact with the GMC. Direct damage at mid-door level was distributed longitudinally from the right B-pillar to the right rear corner and vertically from sill to above the beltline. The CDC for the Dodge in Event 1 was 02RZAW3.
