**Special Crash Investigations:  
Remote Vehicle Fire/Child  
Restraint System Investigation;  
Vehicle: 2005 Dodge Ram 1500;  
Location: California;  
Crash Date: May 2017**

**Special Crash Investigations**  
**Remote Vehicle Fire/Child Restraint System Investigation**  
**Case Number: DS19015**  
**Vehicle: 2008 Dodge Ram 1500**  
**Location: California**  
**Crash Date: May 2017**

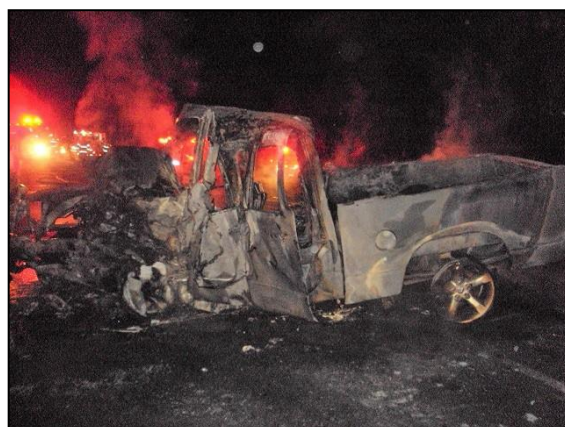
This report documents the remote vehicle fire/child restraint system (CRS) investigation of a post-crash fire in a 2008 Dodge Ram 1500 (**Figure 1**) involved in a head-on crash with a 1994 Ford Bronco and the two child occupants of the Dodge who were seated in CRSs. The investigation was intended to examine the events leading to the fire, how quickly the fire spread to the occupant compartment, the magnitude of the fire, the time sequence in which emergency medical services (EMS) and other responders arrived on-scene, occupant CRS usage, occupant restraint usage, and demographics and injury data. The crash was identified during a review of Fatality Analysis Reporting System (FARS) crash reports. The criteria for the crash type include a front- or side-plane impact, a fire that spreads to the occupant compartment, and at least one occupant seated in a CRS. The Special Crash Investigations (SCI) group of the National Highway Traffic Safety Administration assigned the case in July 2019. The police report, on-scene photos, and medical records were obtained.

**Figure 1.** The 2008 Dodge Ram 1500 (police photo).

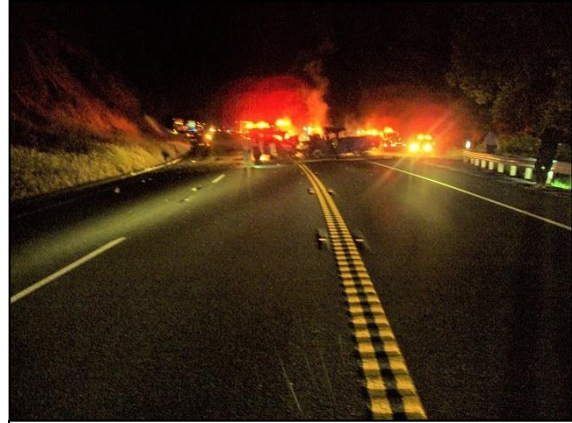
The crash occurred on a two-way, undivided, north/south, State highway in rural California. The roadway included two northbound lanes and one southbound lane each measuring 3.6 m (11.8 ft) wide (**Figure 2**). The northbound lanes were delineated by a dashed white painted stripe and were separated from the southbound lane by a double yellow painted stripe configured with a rumble strip. The roadway was bordered by paved asphalt shoulders measuring approximately 2.1 m (6.8 ft) wide. The roadway curved left in the southbound direction at a radius measuring approximately 317 m (1,040 ft) at the right fog line. According to the police report, the southbound lane had a downhill slope of approximately 5 percent. The speed limit was 89 km/h (55 mph). Conditions at the time of the crash were dark without illumination, cloudy, and wet. A crash diagram is included at the end of this report.

**Figure 2.** Crash site, looking south (police photo).

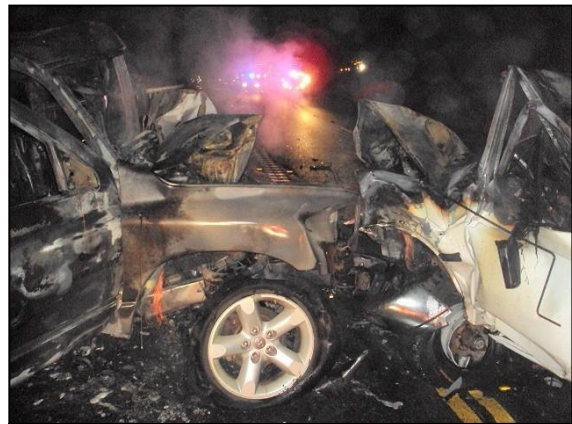
The crash occurred in the southbound lane where the front plane of the Dodge struck the front plane of the Ford head-on. The vehicles remained engaged as each initiated counterclockwise rotations of approximately 40 degrees. The Dodge came to rest in the southbound lane, facing east. The Ford came to rest in the second northbound lane from the right, facing west (**Figure 3**). Following the crash, both vehicles caught fire, which spread to their interiors.

**Figure 3.** At rest positions, the Dodge, left, and the Ford, right, (police photo).

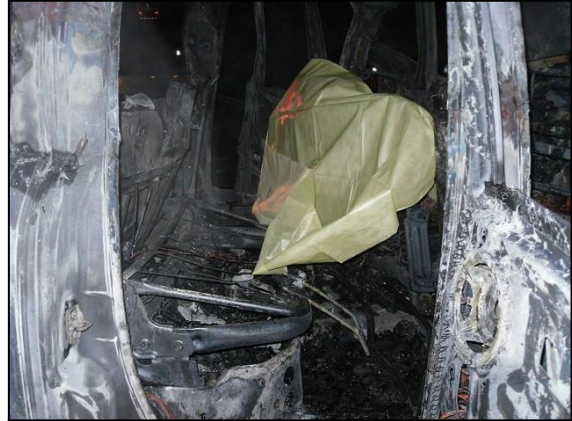
The Dodge’s interior sustained unknown damage caused by impact forces and major damage caused by fire (Figure 4). All glazing was disintegrated or displaced. According to the police report, the driver’s legs were trapped between his seat cushion and the steering column, suggesting longitudinal intrusion or seat deformation was likely present in the front row. One occupant’s medical records indicated that intrusion measuring 30-46 cm (12-18 in) was present in the vehicle.

**Figure 4.** Second-row damage, the 2008 Dodge Ram 1500 (police photo).

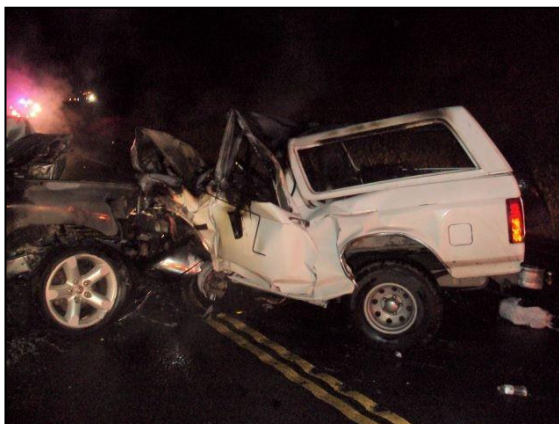
The Ford sustained disabling damage to the front plane (**Figure 5**) caused by the Event 1 impact with the Dodge and major damage to all planes caused by the fire. The estimated CDC for the Ford in Event 1 was 12FDEW4.

**Figure 5.** The 1994 Ford Bronco (police photo).
