U.S. Department  
of Transportation

**National Highway  
Traffic Safety  
Administration**

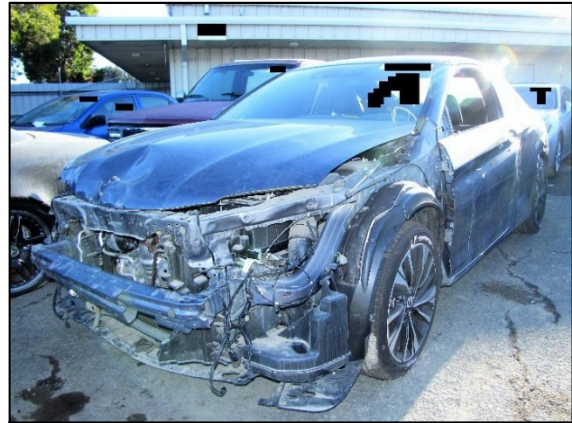
**Figure 1.** The 2017 Honda Accord.

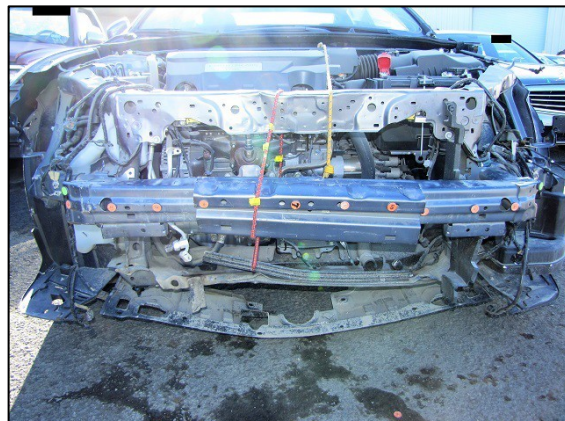
**Figure 4.** Front plane damage, the 2017 Honda Accord.
