**Special Crash Investigations:  
On-Site Asymmetrical Front Air Bag  
Deployment Crash Investigation;  
Vehicle: 2017 Ford F-150 SuperCrew;  
Location: Mississippi;  
Crash Date: July 2020**

**Special Crash Investigations  
On-Site Asymmetrical Front Air Bag Deployment Crash Investigation  
Office of Defects Investigation  
Case Number: CR20027  
Vehicle: 2017 Ford F-150 SuperCrew  
Location: Mississippi  
Crash Date: July 2020**

This report documents the investigation of the asymmetrical deployment of the frontal air bags in a 2017 Ford F-150 SuperCrew pickup truck (Figure 1). The Ford was driven by a belted 13-year-old female, with an unbelted 47-year-old male front right passenger, and a belted 13-year-old female second row right passenger. The Ford was involved in a single-vehicle roadside departure crash while traveling south on a two-lane undivided roadway in a rural area at night. The Ford departed the right road edge after exiting a right curve, traversed along the sloped roadside, and then struck the upslope of a ditch bank and two trees before coming to final rest in the roadside. The crash resulted in the deployment of the passenger's frontal air bag, but the driver's

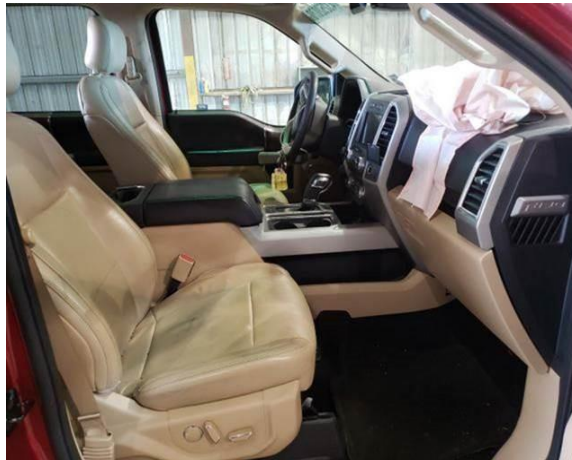
*Figure 1. View of the deployed passenger's frontal air bag in the 2017 Ford F-150 (image provided by the salvage facility)*

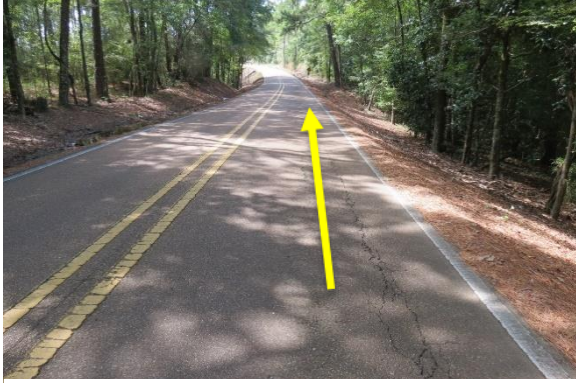
The Ford departed the right edge of the southbound lane in a tracking mode evidenced by rotating tire marks in the roadside as it entered the drainage ditch. The left tire mark measured 15.7 m (51.5 ft) long and the right was 25.6 m (84.0 ft) long. Both tire marks terminated at the edge of the eroded ditch.

Figure 2. South view, the Ford's travel path off west side of roadway

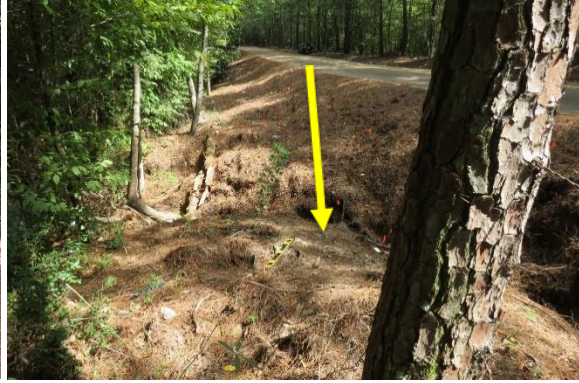
Figure 3. North view, lookback from tree impact, the arrow showing roadway departure/trajectory

The Ford vaulted the ditch, and its front plane and undercarriage struck the south ditch bank (Event 1, Figure 3), gouging the soft embankment. Dirt was embedded into the front bumper and the area between the bumper and the lower radiator support. The vehicle continued 4 m (13.1 ft) forward and struck the 30 cm (11.8 in) diameter tree with the front plane/center aspect (Event 2, Figure 4), resulting in a 12 o'clock direction of force impact. Due to the slope of the ditch bank and the slight pre-impact yaw, the Ford rotated approximately 15 degrees counterclockwise and rebounded from the tree impact (Figure 5). The lower aspect of the right cargo box, aft the rear axle, struck the small diameter tree (Event 3) as the Ford came to final rest engaged against the angled tree (see Figure 4).

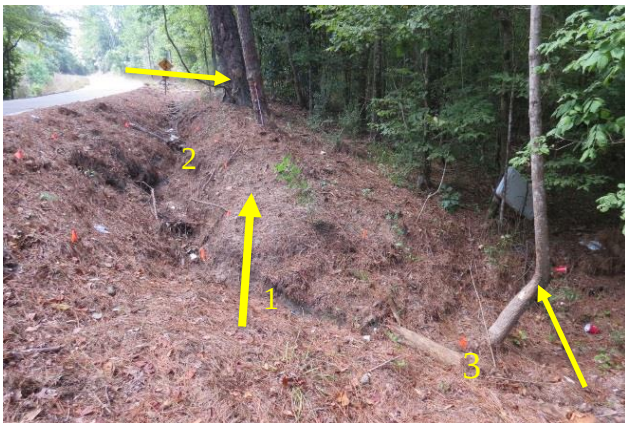
Figure 4. South view, ditch bank impact (1) and tree impacts (2,3)

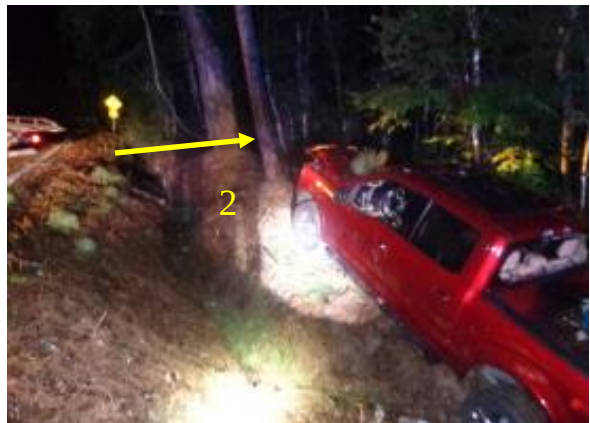
Figure 5. South view, police photo of the Ford at final rest, the arrow pointing to first tree impact

The Ford came to rest with the right quarter panel engaged against the small diameter tree facing in a southerly direction. At final rest, the back plane was in the ditch with the undercarriage resting on top of the most westerly ditch bank. The right front passenger stated in the SCI interview that the first arriving officer assisted the driver and second row right occupant from the

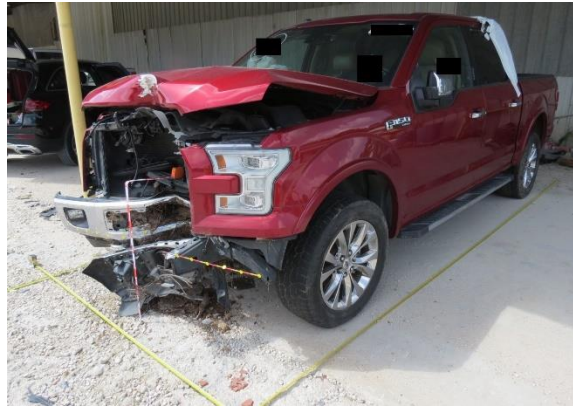
The Ford 4-door SuperCrew pickup truck had the Lariat trim level (Figure 6). The vehicle, manufactured in November 2016, was identified by the Vehicle Identification Number 1FTEW1EF8HKxxxxxx. At the time of the crash, the vehicle's odometer reading was 75,542 km (46,941 mi). Built on a 368 cm (144.9 in) wheelbase, the Ford was powered by a 5.0-liter, V-8, gasoline engine linked to a 6-speed automatic transmission with 4-wheel drive. The gross vehicle weight rating was 3,175 kg (7,000 lb) with gross axle weight ratings of 1,599 kg (3,525 lb) front and 1,724 (3,800 lb) rear. The Ford had vehicle manufacturer recommended size 275/55R20 tires mounted on OEM alloy wheels. The front tires were manufactured by Toyo, and the rear tires were Hankook brand. The vehicle manufacturer recommended tire pressure was 240 kPa (35 PSI) for both axles. Braking was achieved by power-assisted, 4-wheel disc brakes with ABS. Safety features included electronic stability control, a post-collision safety system, traction control, and a tire pressure monitoring system. Power steering was electric.

*Figure 6. Frontal damage from the Event 2 tree impact with dirt embedded from the Event 1 impact*

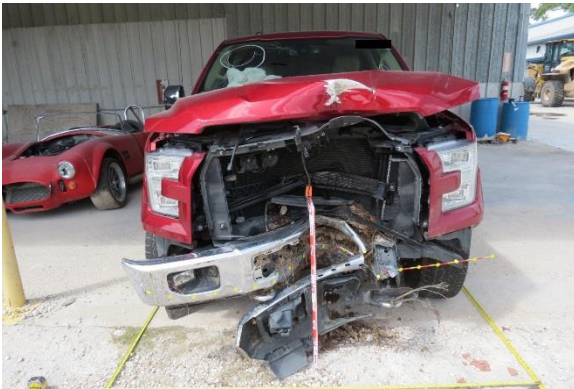
The Event 1 impact with the ditch bank resulted in minor damage to the front bumper that was masked by the subsequent Event 2 tree impact (Figure 7). Dirt was embedded in and between the bumper and the lower radiator support. The direction of force for this ditch bank impact was within the 12 o'clock sector. The Collision Deformation Classification (CDC) was 12FDLW99 (where 99 represents an unknown extent zone). The EDR did not record a delta V for this event.

*Figure 7. Frontal damage from the Event 2 tree impact with dirt embedded from the Event 1 impact*

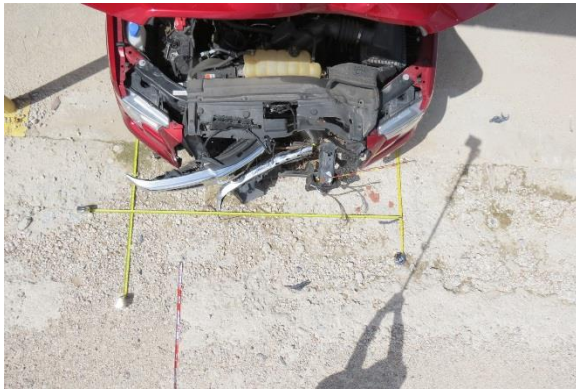
*Figure 8. Overhead view showing the extent of frontal crush*

The Ford continued forward, and the front plane struck the 30 cm (11.8 in) diameter tree (Event 2). The direct contact damage began 61 cm (24.0 in) right of the left bumper corner and extended 33 cm (13.0 in) to the right. The impact crushed the bumper to a maximum depth of 36 cm (14.2 in) located 92 cm (36.2 in) right of the right bumper corner. The Field L was 167 cm (65.7 in) and involved the full width of the end plane (Figure 8). Crush documents were documented on the front bumper beam, and the field L was 167 cm (65.7 in). The crush values were C1 = 0 cm, C2 = 0, C3 = 22 cm (8.7 in), C4 = 36 cm (14.2 in), C5 = 0 cm, and C6 = 0 cm (0 in). The CDC for this Event 2 impact was 12FCEN2. The damage algorithm of the WinSMASH program computed a longitudinal velocity change of -26 km/h (-16.2 mph) and a lateral component of 0 km/h. The collision fit the WinSMASH model, and the results appeared reasonable. The force of this impact most likely triggered the actuation/deployment of the Ford's safety systems, which were recorded by the EDR. The EDR did not record a delta V for this specific impact, as it occurred beyond the recording window of the module.

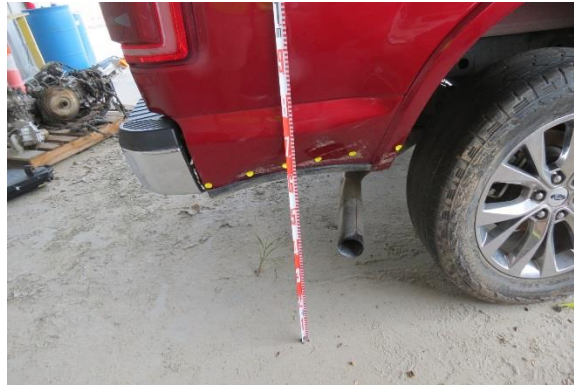
The lower right aspect of the cargo box struck the small diameter tree (Event 3, Figure 9) as the Ford rebounded from the Event 2 impact. The damage was located between the right rear wheel opening and the rear bumper and began 49 cm (19.3 in) aft of the axle location, extending 50 cm (19.7 in) rearward. A crush profile was documented and was as follows: C1 = 0 cm, C2 = 1 cm (0.4 in), C3 = 2 cm (0.8 in), C4 = 3 cm (1.2 in), C5 = 3 cm (1.2 in), and C6 = 2 cm (0.8 in). A maximum crush value of 3 cm (1.2 in) was located 69 cm (27.2 in) aft of the rear axle. The CDC for this Event 3 damage was 05RBLS1. This minor impact was not recorded by the EDR.

*Figure 9. Event 3 damage to the lower right aspect of the cargo box*

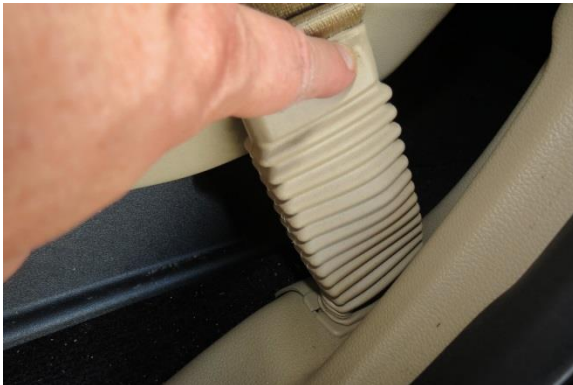
The driver's frontal air bag was concealed in the module mounted in the hub and in the four spokes of the steering wheel. Due to crash severity and driver seat belt use, it appears that the RCM logic was to actuate the pretensioners and not deploy the driver's frontal air bag.

*Figure 10. Actuated driver's lower anchor pretensioner*

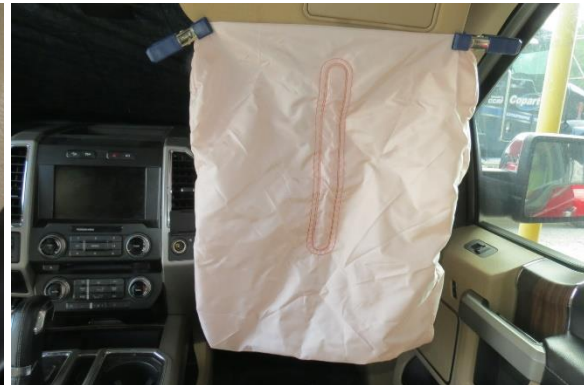
*Figure 11. Passenger's frontal air bag*

The passenger's frontal air bag (Figure 11) deployed through a single, forward-hinged module cover in the top right aspect of the instrument panel. The module cover was 13 cm (5.1 in) in depth and 30 cm (11.8 in) in width. The deployed front right air bag measured 50 cm (19.7 in) in width and 60 cm (23.6 in) in height in its deflated state. There was no contact evidence or damage to the deployed air bag. The front right occupant was unbelted; therefore, the RCM deployed a Stage-1 air bag to provide restraint to the unbelted occupant. Stage 2 deployed as a disposal.
