U.S. Department  
of Transportation  
**National Highway  
Traffic Safety  
Administration**

DOT HS 813 245

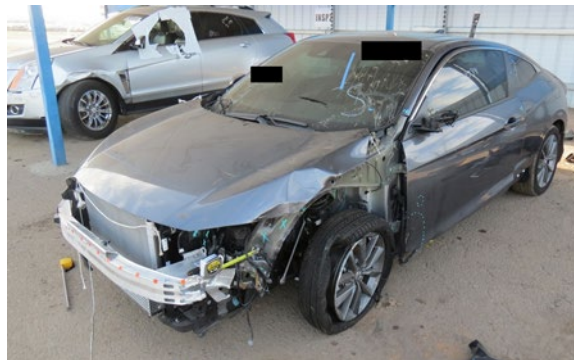
*Figure 1. The 2019 Honda Civic*

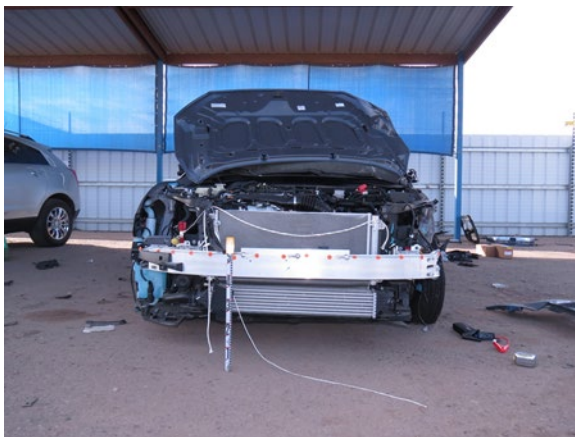
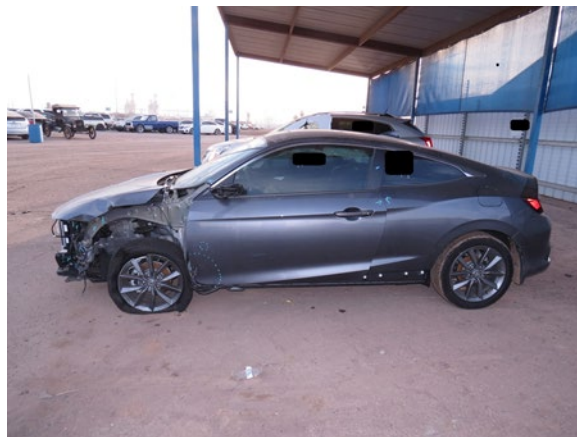
Figure 4. Front plane damage, the 2019 Honda Civic      Figure 5. Left plane damage, the 2019 Honda Civic

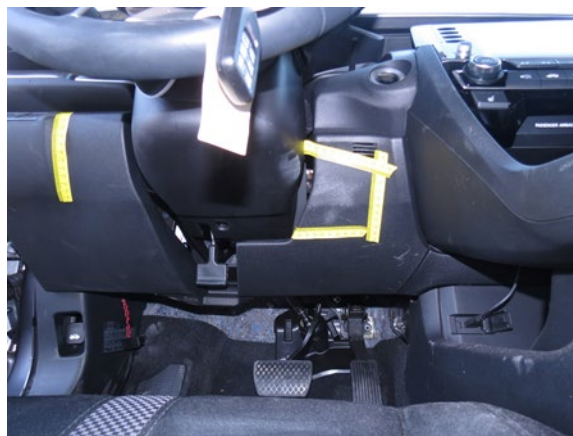
*Figure 7. Lower instrument panel contacts, the 2019 Honda Civic*

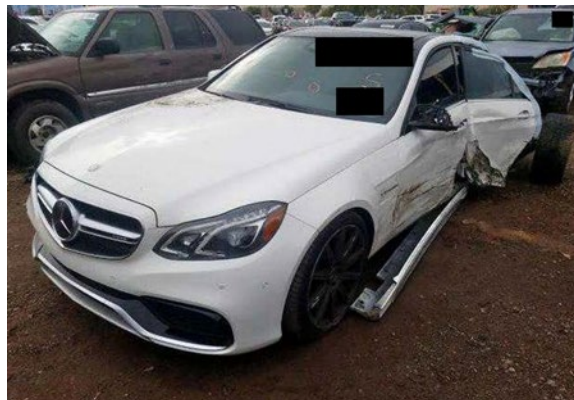
*Figure 8. The 2015 Mercedes-Benz E63 (insurance image)*
