DOT HS 813 365

# **Special Crash Investigations: On-Site Air Bag Non-Deployment Crash Investigation; Vehicle: 2018 Chevrolet Traverse; Location: New York; Crash Date: April 2018**

**Special Crash Investigations  
On-Site Air Bag Non-Deployment Crash Investigation  
Office of Defects Investigation  
SCI Case Number: CR18026  
Vehicle: 2018 Chevrolet Traverse  
Location: New York  
Crash Date: April 2018**

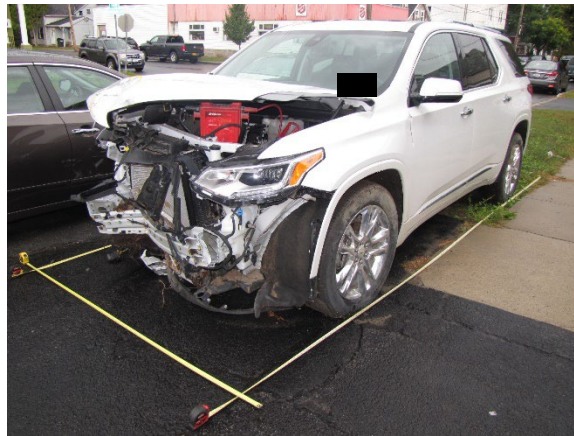
*Figure 1. Right front oblique view of the Chevrolet.  
Image supplied by the police investigator.*

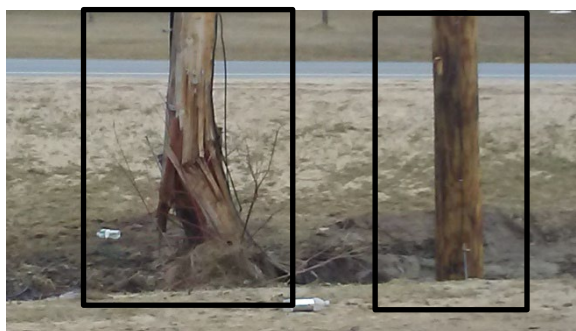
The front of the Chevrolet struck a delineator post (Event 1) located at the apex and its front plane and forward undercarriage struck the ground (Event 2), as the vehicle entered the ditch and grass depression. The undercarriage impact most likely enabled the sensing algorithms (AE) of the vehicle's air bag systems. The Chevrolet traveled along the ditch and struck the utility pole with the right aspect of its front plane (Event 3). The utility pole (Figure 3) partially fractured and was displaced in the ground by the force of the impact. The barrier equivalent speed of the crash calculated by the WinSMASH program was 29 km/h (18 mph). This calculation was considered to be borderline due to the yielding properties of the impact. The maximum EDR-recorded delta-V was -68 km/h (-42 mph) at 420 milliseconds.

*Figure 3. North-facing view at the crash site of the struck and fractured utility pole (left) and the replaced utility pole (right). Image supplied by the owner of the Chevrolet.*

- The impact to the utility pole caused it to partially fracture and become displaced in the ground. This effectively resulted in a yielding impact.
- The yielding properties of these two crash events were considered a singular crash event by the EDR.

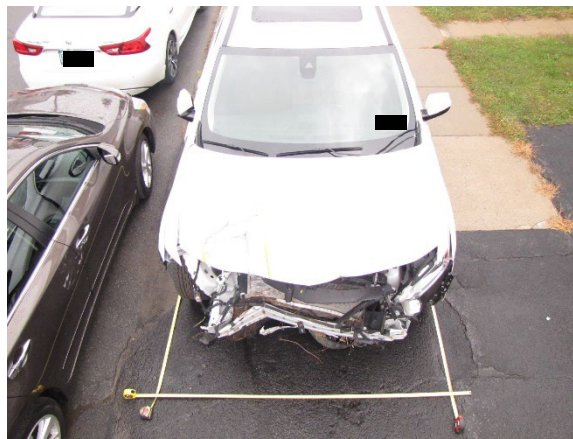
*Figure 4. Overhead view of the Chevrolet depicting the frontal deformation*

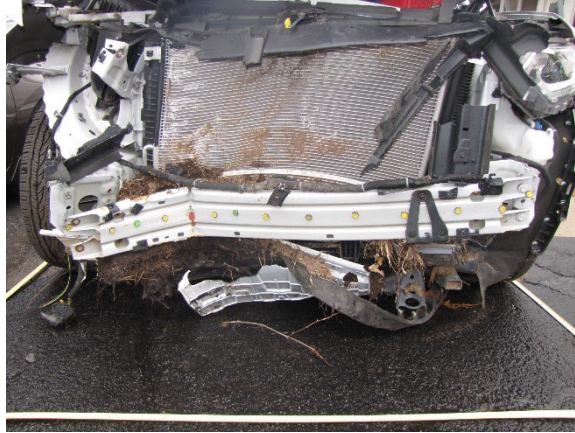
The front plane of the Chevrolet was involved in three closely spaced impact events. The first event involved a steel delineator post that was positioned at the apex of the Y-junction. Based on its location, the center aspect of the front plane struck and deflected the delineator post as the vehicle overrode it. The bumper fascia separated from the Chevrolet and was discarded prior to the SCI inspection. The exact location of the delineator post impact could not be determined. The estimated collision deformation classification (CDC) for this event was 12FCEN1.

The second event involved the lower aspect of the bumper fascia and forward undercarriage as the vehicle entered the ditch area of the depression. The full width of the lower frontal plane struck and gouged the earthen ditch bank as the Chevrolet continued forward. Contact damage consisted of dirt and grass embedded into the air conditioning condenser with dirt and grass on top of the bumper beam and embedded into the lower radiator support and undercarriage. The CDC for this event was 12UFDW1.

The third event involved damage to the right aspect of the bumper fascia, the right headlamp assembly, hood face and bumper beam from the impact with the utility pole. The direct contact damage projected to the bumper beam began 28 cm (11.0 in) right of the vehicle's centerline and extended an additional 33 cm (13.0 in) to the right. Maximum crush was 28 cm (11.0 in) located 44 cm (17.3 in) right of center. The hood face and upper radiator support were crushed rearward. The residual crush profile measured across the deformed bumper reinforcement beam (Figure 5) was as follows: C1 = 0, C2 = 6 cm (2.4 in), C3 = 15 cm (5.9 in), C4 = 26 cm (10.2 in), C5 = 28 cm (11.0 in), C6 = 12 cm (4.7 in). The right wheelbase was reduced 3 cm (1.2 in). The left wheelbase was unchanged. All the doors remained closed during the crash and were operational at inspection. The body gap at the interface of the right front door and B-pillar was reduced with frictional interference indicative of residual body deformation. The CDC for this Event #3 impact was 12FREN2. For comparative purposes, the barrier equivalent speed of the yielding object crash as calculated by the WinSMASH program was 29 km/h (18 mph).

*Figure 5. Close-up view of the Chevrolet's frontal deformation*
