DOT HS 813 382

**Special Crash Investigations:  
Remote Hyperthermia Fatality  
Investigation;  
Vehicle: 2017 Ford Fiesta;  
Location: Arizona;  
Incident Date: August 2020**

**Special Crash Investigations  
Remote Hyperthermia Fatality Investigation  
Case Number: DS20014  
Vehicle: 2017 Ford Fiesta  
Location: Arizona  
Incident Date: August 2020**

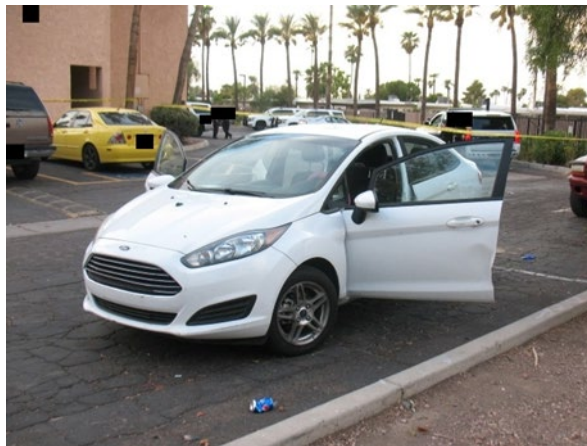
*Figure 1. 2017 Ford Fiesta, looking southwest  
(police photo)*

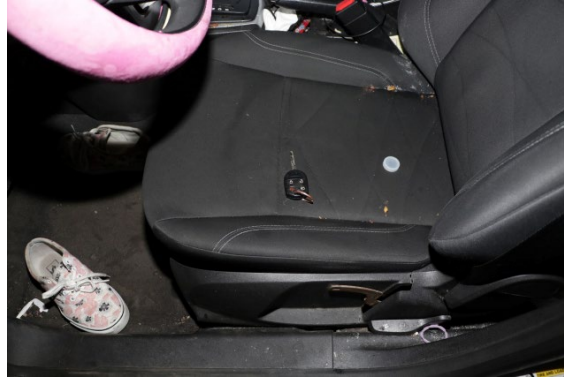
*Figure 2. Vehicle key (police photo)*

The status of the door locks prior to the incident was unknown. When police arrived, the front and second row doors were unlocked. When they discovered the child in the vehicle, they found the key fob for the vehicle next to her on the driver's seat cushion (Figure 2). The security system consisted of an engine immobilizer and anti-theft alarm. The vehicle had exterior pull-out style handles, a wireless remote key, and a cylinder style lock for the driver's door. The Fiesta had electric power interior door locks. Each door in the vehicle could be unlocked by pulling the interior handle. The front door handles needed to be pulled once to unlock and unlatch the front doors. The second-row handles required two pulls, one to unlock the door and a second to unlatch the door. The second-row doors had child safety locks that actuated using the vehicle's manual key. Police photos revealed the left and right child safety locks were in the locked setting. The vehicle had electric power window regulators and the windows were closed during the incident.

was in the parking lot north of the unit and that the child could recognize it upon sight and could distinguish it from other vehicles in the area. Police went to the vehicle, looked inside and observed the child in the driver's seat at 1658 hours. The car key was visible on the seat cushion next to the child. Her total time in the vehicle was approximately 5 hours.
