DOT HS 813 444

**Special Crash Investigations:  
On-Site Driver's Frontal Air Bag  
Non-Deployment Crash  
Investigation;  
Vehicle: 2019 Ford Fusion;  
Location: Texas;  
Date: June 2020**

**Special Crash Investigations**  
**On-Site Driver's Frontal Air Bag Non-Deployment Crash Investigation**  
**Office of Defect Investigation**  
**Case Number: CR20019**  
**Vehicle: 2019 Ford Fusion**  
**Location: Texas**  
**Crash Date: June 2020**

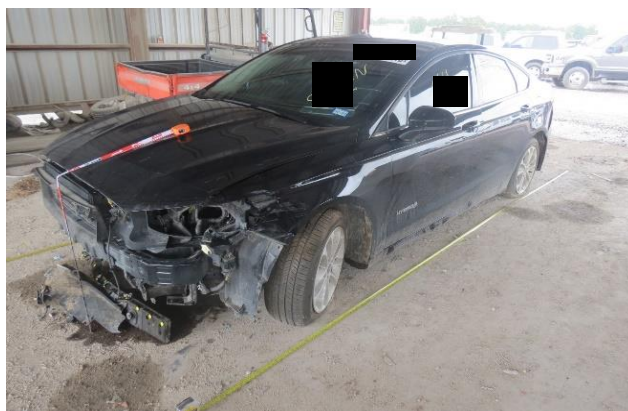
*Figure 1. The 2019 Ford Fusion*

This report documents the onsite investigation of the non-deployment of the driver frontal air bag during the roadside departure and frontal crash of a 2019 Ford Fusion (Figure 1) into a culvert drainage pipe. The 32-year-old unbelted female driver sustained minor injuries during the crash. The Ford had certified advanced 208-compliant frontal air bags, a driver knee air bag, front-seat-mounted side impact air bags, inflatable curtain (IC) air bags, front row seat belt retractor pretensioners, and crash avoidance features. Only the driver knee air bag deployed in the crash, which occurred in June 2020 and was investigated by a local police agency. The driver notified the National Highway Traffic Safety Administration of the crash and an investigation was assigned to the Special Crash Investigations team at Crash Research and Analysis, Inc., in July 2020. The team contacted the driver, tow yard, and driver's insurance company to establish cooperation to inspect the vehicle. The vehicle scene inspections and driver interview were completed in July 2020.

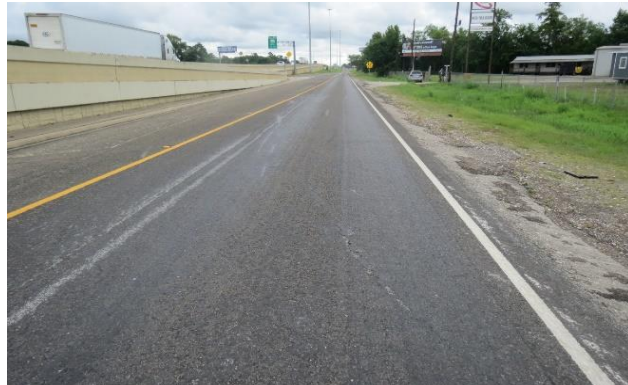
*Figure 2. Northeast view of the Ford's travel path prior to roadway departure*

The police crash report stated the Ford was traveling northeast on the service road (Figure 2) and the driver was intending to proceed straight ahead. The driver stated during the SCI interview that the vehicle was traveling 56 km/h (35 mph) and that she fell asleep prior to the incident. The Ford's EDR reported the vehicle was traveling at a speed of 136 km/h (84.6 mph) 5 seconds prior to algorithm enable (AE). The Ford departed the roadway and entered the ditch and continued northeast, traveling parallel to the roadway (Figure 3).

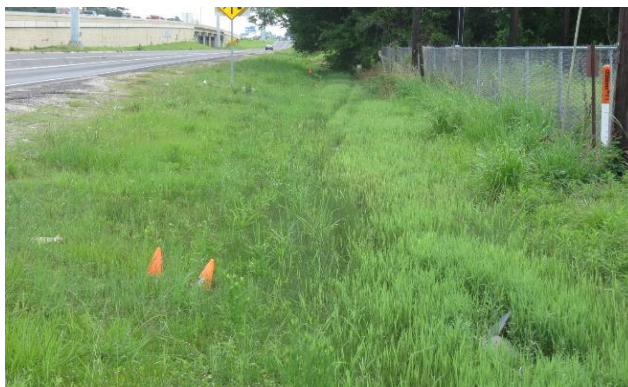
*Figure 3. Northeast view, travel path in watery ditch*

The Ford traveled in the ditch for approximately 88 m (289 ft) and during this time, the right plane sideswiped an unknown object (Event 1), causing minor damage to both right doors. The imaged EDR data indicated that the brakes were never applied. The speed of the vehicle gradually reduced through rolling resistance in the ditch to 61 km/h (38 mph) at the time of AE.

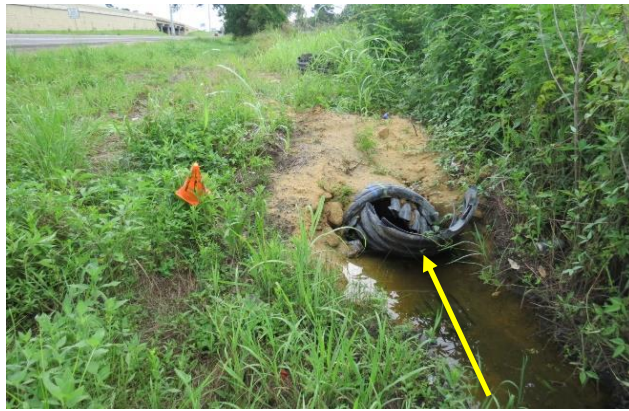
*Figure 4. Northeast view, plastic culvert pipe contacted by the front lower plane of the Ford*

The lower cross-member of the front plane struck and fractured the end of a 61 cm (24.0 in) diameter, corrugated plastic pipe (Event 2) buried in the sand under a crossing driveway at the end of the ditch (Figure 4). As a result, the driver knee air bag deployed. No other air bags deployed. The vehicle vaulted over the 10 m (32.8 ft) wide sandy driveway. The vault distance was approximately 20 m (66 ft) and the Ford continued northeastward on the other side of the driveway for approximately 20 m (66 ft) before coming to final rest in the ditch facing northeast.

The Ford's impact to the plastic drainage pipe at the end of the ditch involved the lower engine compartment and undercarriage components. As a result, the longitudinal crash pulse was elongated, with maximum delta V occurring at 245 msec after AE. It is probable that this "soft" impact was assessed by the restraints control module to not require deployment of the driver frontal air bag.

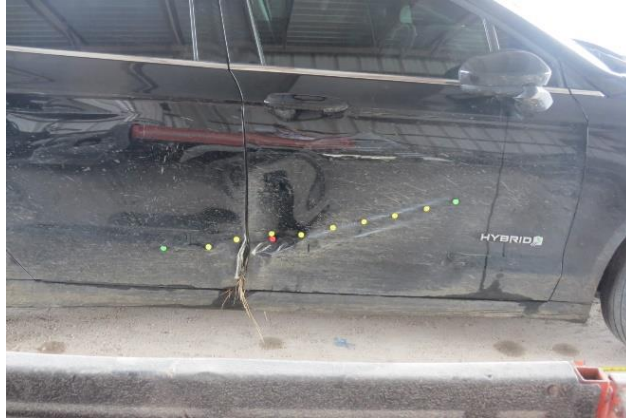
The Ford sustained minor-severity direct damage to the right doors from an unknown object while it was traveling through the watery ditch. The direct damage (Figure 5) began 193 cm (76.0 in) forward of the right rear axle and extended rearward 93 cm (36.6 in). Lateral deformation was 1 cm (0.4 in) or less. The sideswiping damage properties were out-of-scope for an analysis with the WinSMASH program. The collision deformation classification (CDC) assigned to this damage pattern was 12RPMS1.

*Figure 5. Sideswipe damage to the Ford's right doors*

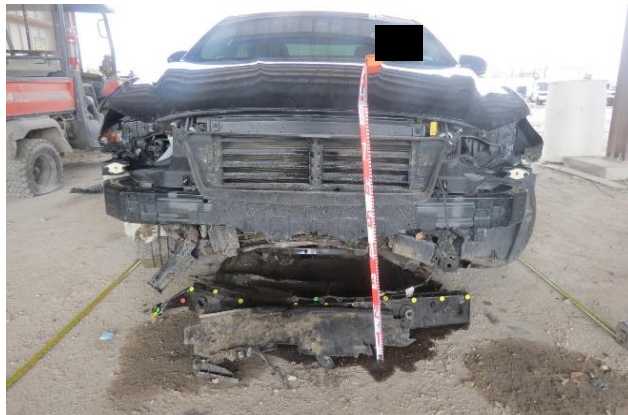
The lower cross-member beneath the front bumper of the Ford (Figure 6) was damaged during the Event 2 impact with the plastic drainage pipe and driveway. The front bumper fascia, radiator, and lower support beam were directly damaged. The direct damage began 1 cm (0.4 in) right of the center point and extended 60 cm (23.6 in) to the right. The residual crush profile measured as follows: C1 = 13 cm (5.1 in), C2 = 2 cm (0.8 in), C3 = 0, C4 = 3 cm (1.2 in), C5 = 11 cm (4.3 in), C6 = 14 cm (5.5 in). The WinSMASH program could not be used to determine velocity change because impacts to yielding objects are out of scope for the program. The barrier equivalent speed was 18 km/h (11.2 mph). The CDC for this damage pattern was 12FZLW1 (0 degrees).

*Figure 6. Front end damage to the Ford. Note bottom stabilizer bar.*

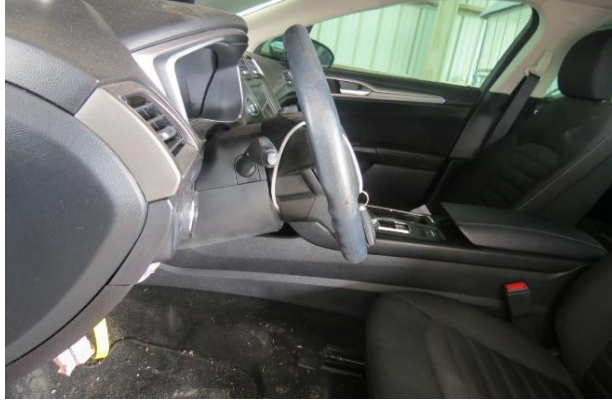
The interior of the Ford did not sustain any crash force damage or intrusion during the crash sequence. No side glazing was contacted or damaged and all doors remained closed and operational. The steering wheel assembly was in the full-up tilt and full forward telescoping positions. It was contacted by the driver and the top half of the rim was displaced forward (Figure 7) approximately 1 cm (0.4 in). The driver also contacted and cracked the windshield above the steering wheel, near the header (Figure 8), and scuffs were noted on the left knee bolster (Figure 9).

*Figure 7. Steering wheel rim of the Ford bent slightly forward*

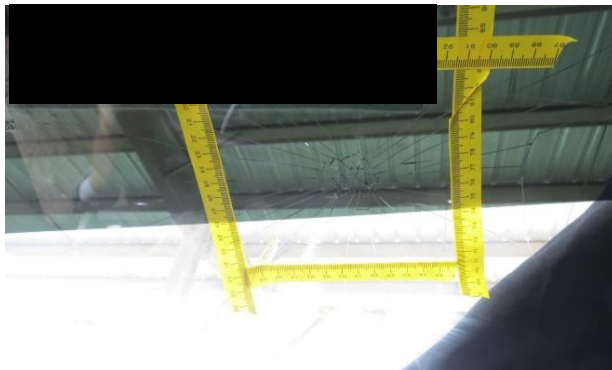
*Figure 8. The Ford's upper windshield cracked from occupant contact*

The vehicle traveled off the roadway at a high rate of speed into a shallow, water-filled ditch. The driver stated during the SCI interview that she had fallen asleep. The EDR did not record a brake application, but the vehicle's speed decelerated from 136 km/h (84.6 mph) at 5 seconds prior to AE to 61 km/h (38.0 mph) at AE. The frontal/undercarriage impact resulted in deployment of the driver knee air bag. The driver sustained bruising on both shins from knee to ankle from loading through the air bag and contacting the knee bolster. She continued forward and sustained an approximate 10 cm (4 in) contusion located from the base of her neck to the top of her right breast due to contact with the steering wheel rim. The driver's face contacted the windshield evidenced by injuries to her nose and mouth. The windshield was fractured approximately 10 cm (4 in) below the header.

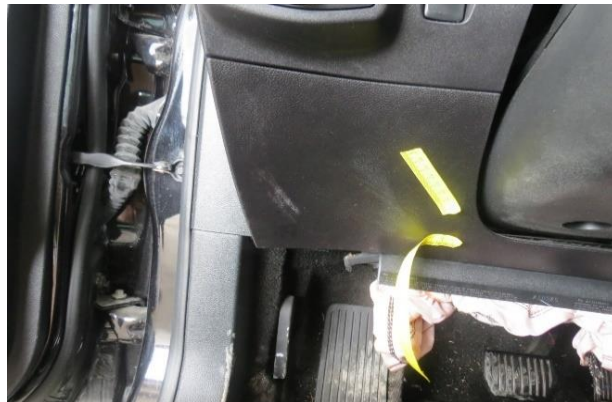
*Figure 9. Left knee bolster contact*

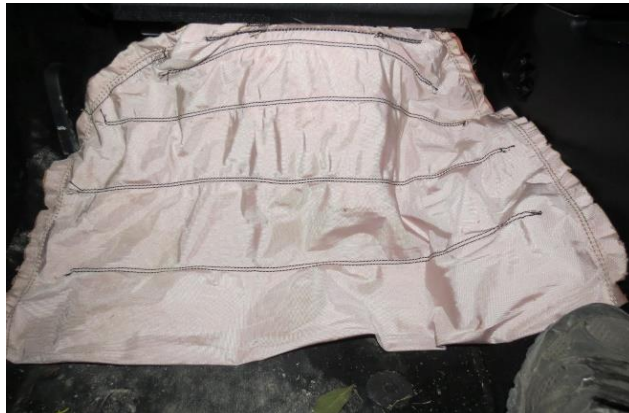
The knee air bag (Figure 10) was located at the bottom of the knee bolster, behind the vinyl panel. The deflated air bag measured 65 cm (25.6 in) wide and 35 cm (13.8 in) tall. There was no discernable contact or damage to the air bag. The module cover was a two-flap configuration made of semi-rigid vinyl, with a horizontal tear seam across the center. The flaps were 35 cm (13.8 in) wide and 3 cm (1.2 in) in height. The cover flaps opened at the designated tear seam and were undamaged.

*Figure 10. Deployed knee air bag*

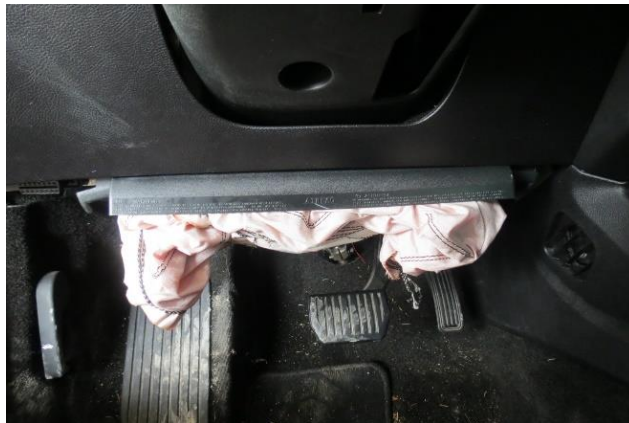
*Figure 11. Packed knee air bag with upper flap opened*

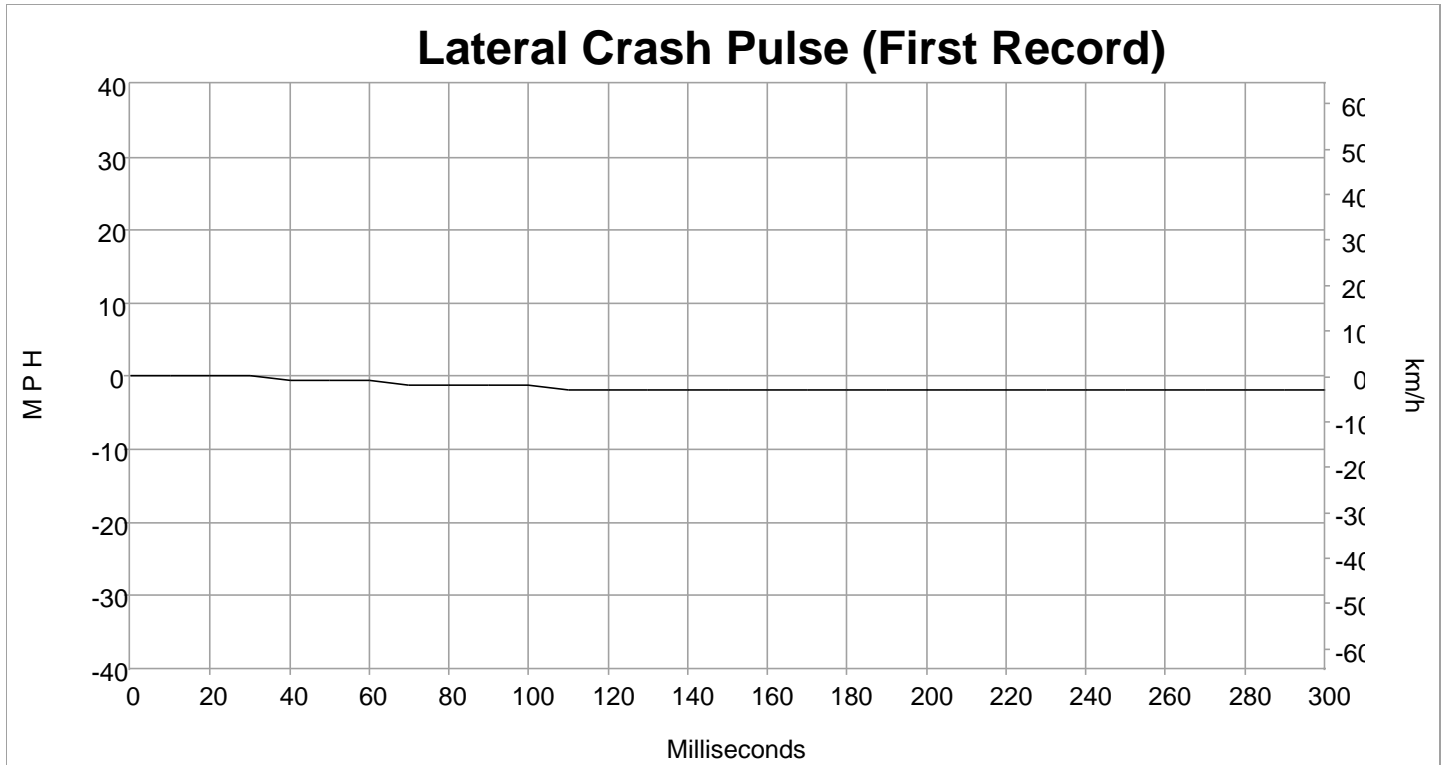
**Lateral Crash Pulse (First Record)**

<b>Time (msec)</b>	<b>Delta-V, Lateral (MPH)</b>	<b>Delta-V, Lateral (km/h)</b>
0	0.00	0.00
10	0.00	0.00
20	0.00	0.00
30	0.00	0.00
40	-0.62	-1.00
50	-0.62	-1.00
60	-0.62	-1.00
70	-1.24	-2.00
80	-1.24	-2.00
90	-1.24	-2.00
100	-1.24	-2.00
110	-1.86	-3.00
120	-1.86	-3.00
130	-1.86	-3.00
140	-1.86	-3.00
150	-1.86	-3.00
160	-1.86	-3.00
170	-1.86	-3.00
180	-1.86	-3.00
190	-1.86	-3.00
200	-1.86	-3.00
210	-1.86	-3.00
220	-1.86	-3.00
230	-1.86	-3.00
240	-1.86	-3.00
250	-1.86	-3.00
260	-1.86	-3.00
270	-1.86	-3.00
280	-1.86	-3.00
290	-1.86	-3.00
300	-1.86	-3.00

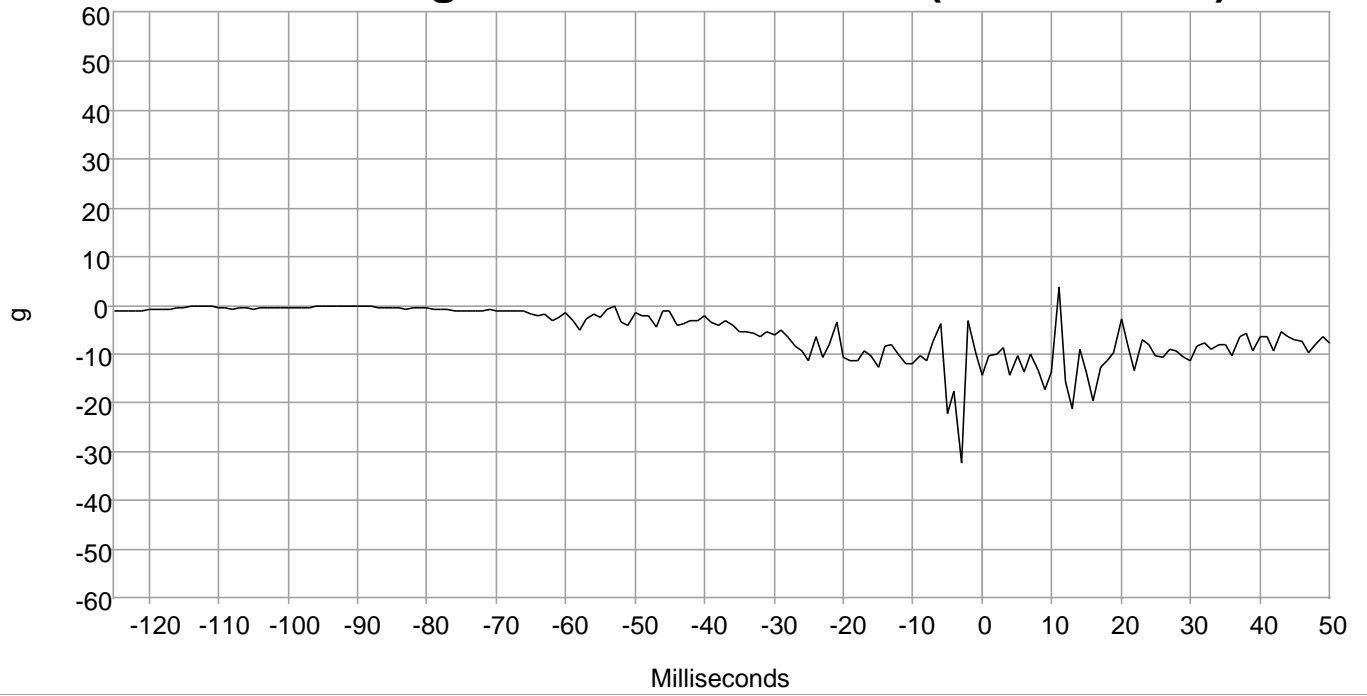
### Longitudinal Acceleration (First Record)

<b>Time (msec)</b>	<b>Longitudinal Acceleration (g)</b>
-125	-1.00
-124	-1.00
-123	-1.00
-122	-1.00
-121	-1.00
-120	-0.75
-119	-0.75
-118	-0.75
-117	-0.75
-116	-0.50
-115	-0.50
-114	-0.25
-113	-0.25
-112	-0.25
-111	-0.25
-110	-0.50
-109	-0.50
-108	-0.75
-107	-0.50
-106	-0.50
-105	-0.75
-104	-0.50
-103	-0.50
-102	-0.50
-101	-0.50
-100	-0.50
-99	-0.50
-98	-0.50
-97	-0.50
-96	-0.25
-95	-0.25
-94	-0.25
-93	-0.25
-92	-0.25
-91	-0.25
-90	-0.25
-89	-0.25
-88	-0.25
-87	-0.50
-86	-0.50
-85	-0.50
-84	-0.50
-83	-0.75
-82	-0.50
-81	-0.50
-80	-0.50
-79	-0.75
-78	-0.75
-77	-0.75
-76	-1.00
-75	-1.00
-74	-1.00
-73	-1.25
-72	-1.00
-71	-0.75
-70	-1.25
-69	-1.00
-68	-1.00

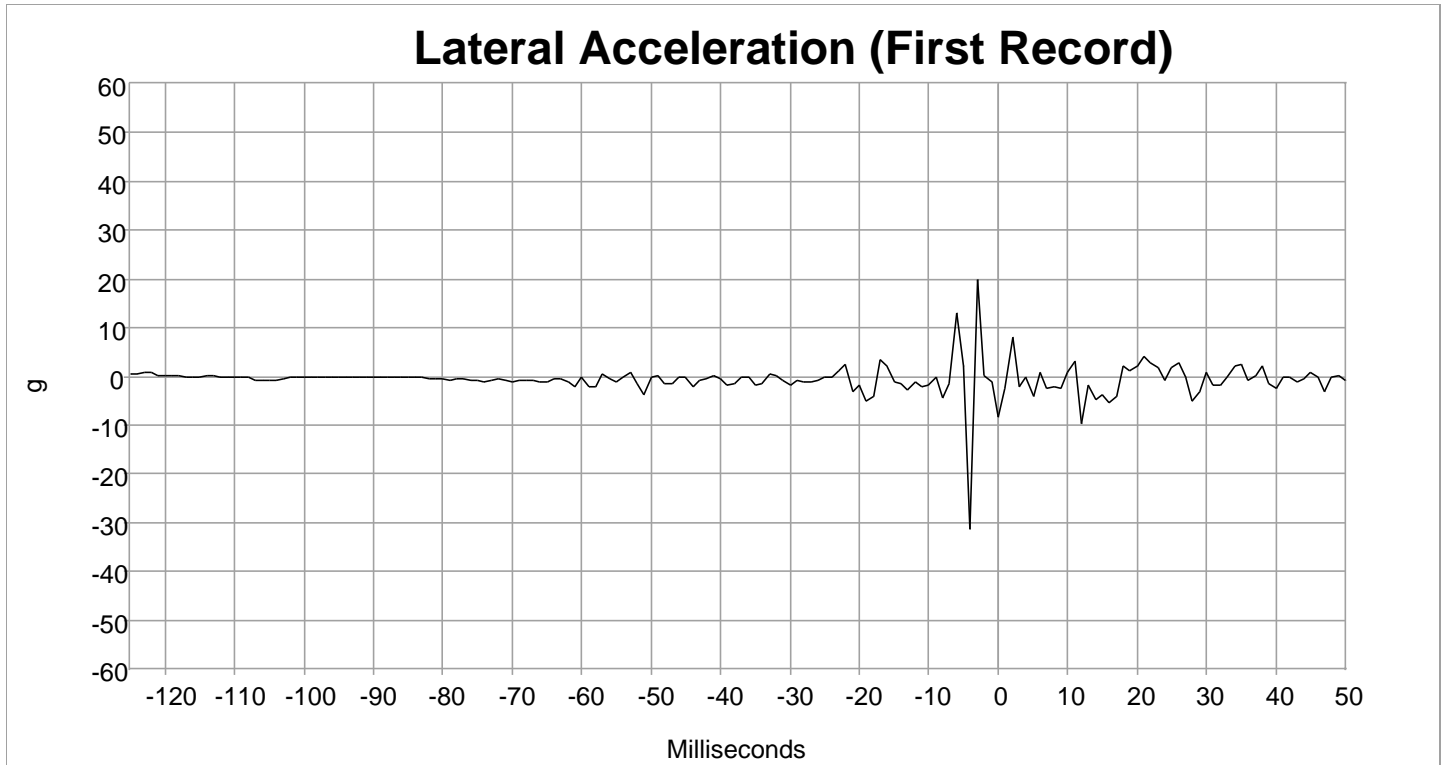
**Lateral Acceleration (First Record)**

<b>Time (msec)</b>	<b>Lateral Acceleration (g)</b>
-125	0.50
-124	0.50
-123	0.75
-122	0.75
-121	0.25
-120	0.25
-119	0.25
-118	0.25
-117	0.00
-116	0.00
-115	0.00
-114	0.25
-113	0.25
-112	0.00
-111	0.00
-110	0.00
-109	-0.25
-108	-0.25
-107	-0.75
-106	-0.75
-105	-0.75
-104	-0.75
-103	-0.50
-102	-0.25
-101	0.00
-100	0.00
-99	0.00
-98	0.00
-97	0.00
-96	0.00
-95	0.00
-94	0.00
-93	0.00
-92	0.00
-91	0.00
-90	0.00
-89	0.00
-88	0.00
-87	0.00
-86	-0.25
-85	-0.25
-84	-0.25
-83	-0.25
-82	-0.50
-81	-0.50
-80	-0.50
-79	-0.75
-78	-0.50
-77	-0.50
-76	-0.75
-75	-0.75
-74	-1.00
-73	-0.75
-72	-0.50
-71	-0.75
-70	-1.00
-69	-0.75
-68	-0.75
