DOT HS 813 562

# **Special Crash Investigations: On-Site Rollover Crash Investigation; Vehicle: 2021 Subaru Crosstrek; Location: Pennsylvania; Crash Date: June 2021**

**Special Crash Investigations  
On-Site Rollover Crash Investigation  
Case Number: CR21021  
Vehicle: 2021 Subaru Crosstrek  
Location: Pennsylvania  
Crash Date: June 2021**

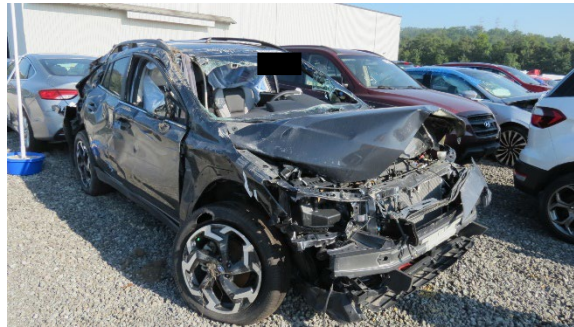
*Figure 1. Right-front oblique view of the Subaru*

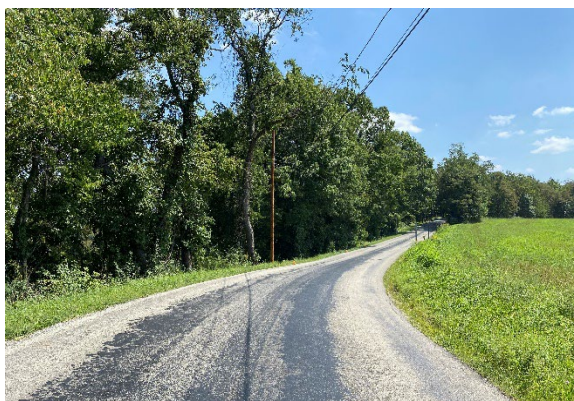
The Subaru was traveling southeast (Figure 2) in the right lane at an EDR-reported speed of 74 km/h (46 mph) 5 seconds prior to algorithm enabled (AE). The driver, for unknown reasons, allowed the vehicle to track straight through the curve. She did steer to the right beginning at 2.5 seconds prior to AE but it was insufficient to maintain the roadway. The vehicle departed the left (east) side of the roadway.

*Figure 2. Southeast view of the Subaru's pre-crash approach to the crash site*

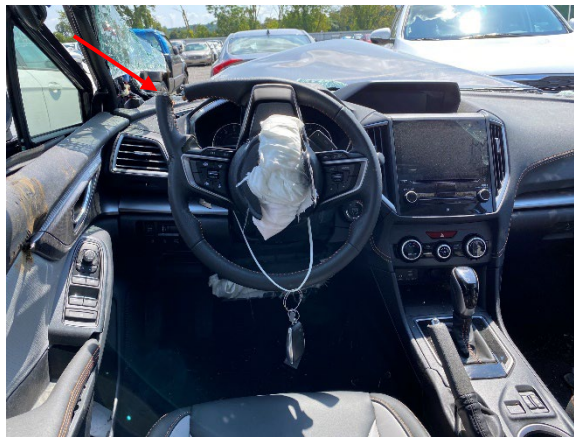
fractured at the 5-o'clock sector (Figure 4) likely by recovery efforts. The vehicle's roof (Figure 5) was scuffed and soiled likely by recovery personnel during the extraction process.

*Figure 4. View of the Subaru's fractured steering wheel*

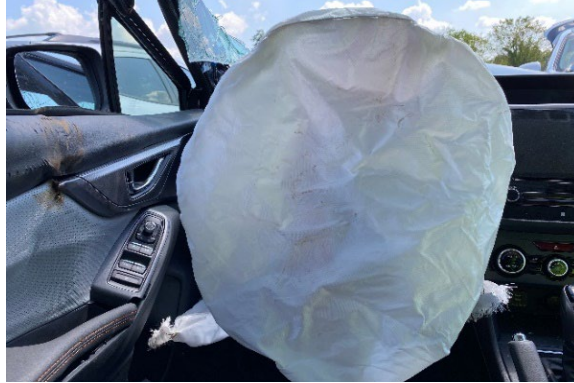
The Subaru had several supplemental restraints for its occupants. These included dual-stage driver's and passenger's frontal, driver knee, front outboard seat-mounted side impact, and IC air bags. IC air bags would deploy for rollover and/or side-impact collisions. The driver's frontal (Figure 6), driver knee (Figure 7), and both IC air bags deployed during the crash sequence.

*Figure 6. View of the driver's frontal air bag in the Subaru*

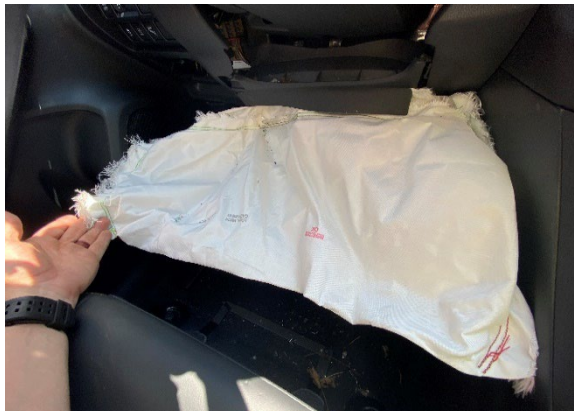
*Figure 7. View of the driver's knee air bag in the Subaru*

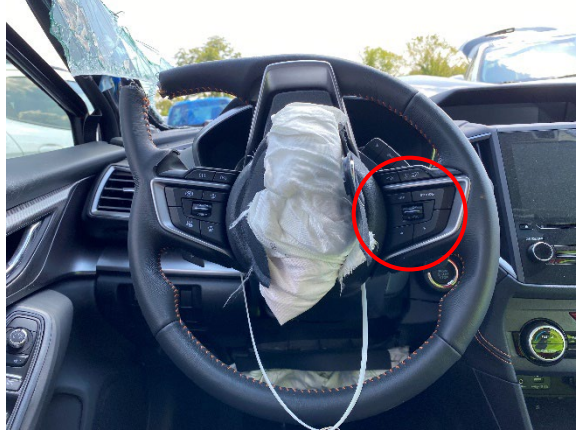
The 2021 Subaru Crosstrek had several CA systems, known collectively by the manufacturer as EyeSight, that were designed to aid and support the driver in avoiding a potential crash and/or reducing the severity of a crash event should a collision be imminent. The driver could turn these CA systems on or off by pressing buttons located on the steering wheel (Figure 8), left side of the steering column (Figure 9), and overhead console. It is unknown if the driver had manually activated these systems. These systems included forward collision warning, crash imminent braking, roadway departure mitigation, lane departure warning, lane keeping assist, blind spot detection, and adaptive cruise control. Per the EyeSight manual,<sup>2</sup> the lane departure warning, lane keep assist, and roadway departure mitigation systems would not have engaged in this crash since there are no roadway markings and the EyeSight software doesn't capture road edges. Additionally, the forward collision warning and crash imminent braking systems would not engage due to the EyeSight software not being able to capture telephone poles.

*Figure 8. Image of CA system buttons on the steering wheel*

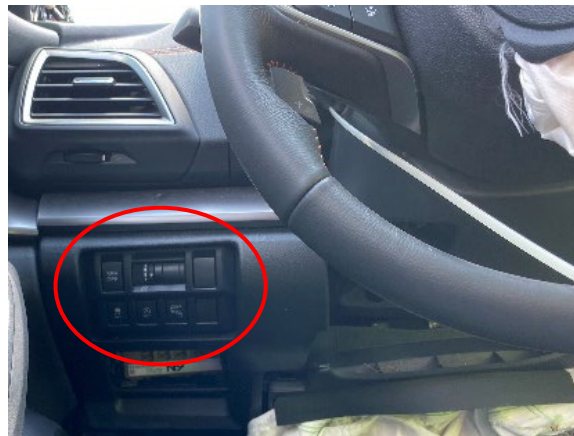
*Figure 9. Image of CA system buttons left of the steering wheel column*
