**Special Crash Investigations:  
Remote Non-Traffic Surveillance  
Power Window Entrapment  
Investigation;  
Vehicle: 2019 Toyota 4Runner;  
Location: Arizona;  
Incident Date: October 2021**

**Special Crash Investigations**  
**Remote Non-Traffic Surveillance Power Window Entrapment Investigation**  
**Case No. DS21009**  
**Vehicle: 2019 Toyota 4Runner**  
**Location: Arizona**  
**Incident Date: October 2021**

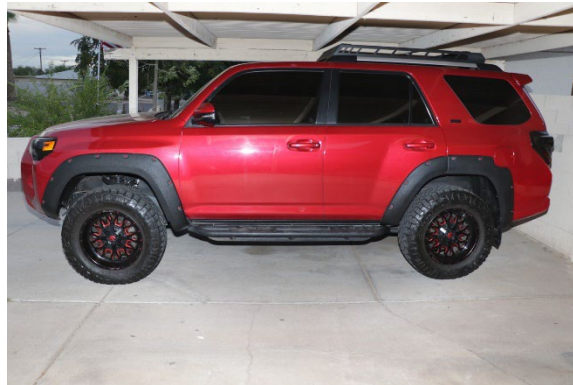
*Figure 1. 2019 Toyota 4Runner (police image)*

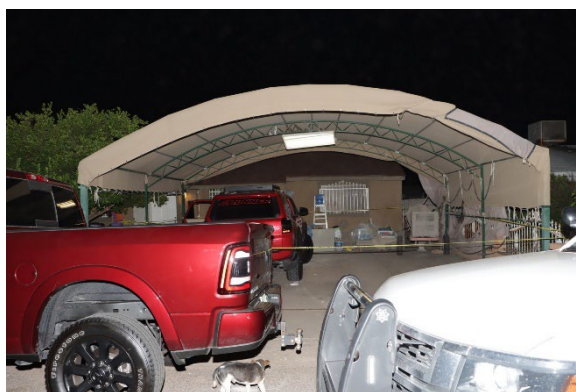
The incident site was the driveway (Figure 2) of a private single-floor residence that was set back approximately 9 m (29.3 ft) from the roadway. The house and roadway were separated by a sidewalk and low metal and brick fence. The house faced north with an undivided city street in front. The front yard was gravel covered and had several small trees, several chairs, and a fire ring. A string of lights illuminated this area. The driveway was to the left of the house (west) and had parking for three vehicles. The driveway was covered by a tan-colored carport canopy with a large light fixture hanging from the frame. The 4Runner was parked under the canopy facing south. It was dark at the time of the incident with the nearest streetlight approximately 30 m (98 ft) east of the driveway. The nearest weather station reported conditions as 26 °C (79 °F), light winds, 29 percent humidity, and partly cloudy. An incident diagram and satellite view are included at the end of this report.

*Figure 2. 2019 Toyota 4Runner, parked under canopy, facing south (police image)*

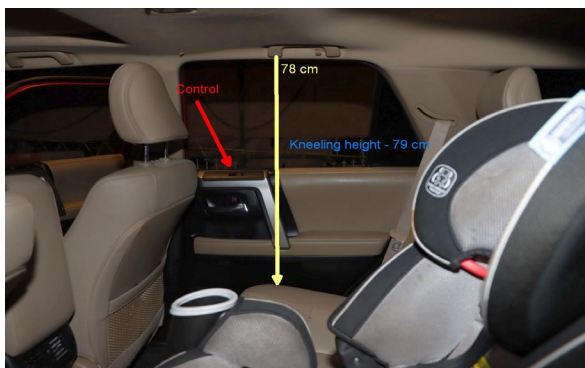
Based on available information, the 2-year-old child strayed away from the adults at the party and entered the Toyota on her own through an open front door. She was left unattended for an unknown period but several minutes at least. The vehicle was powered on with the key present. Based on the interior height of the vehicle and the child's height it appears likely she was facing the second-row right window on her knees (Figure 6). The child was operating the window switch in an unknown fashion, possibly running it up and down several times with her left hand. Her head was outside of the window. There was evidence in the form of fingerprints that the child's right hand was grasping the upper part of the window (Figure 7). The police photos showed a linear transfer that ran from the top of the window to the bottom. It appears that this streak was created post-incident when the window was raised from the closed position and smeared existing transfers. The incident likely occurred when the child closed the window with her head outside. She may have continued operating the control to extricate herself for a short time before going unconscious.

*Figure 6. Second-row right of the 2019 Toyota 4Runner (police image)*

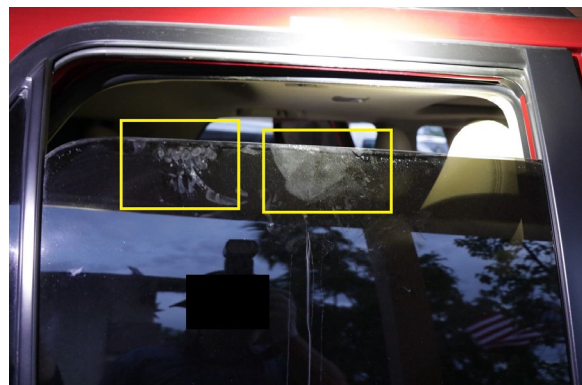
*Figure 7. Second-row right window of the 2019 Toyota 4Runner with hand and neck print transfers, (police image)*
