# **Special Crash Investigations: On-Site Frontover Investigation; Vehicle: 2022 Chevrolet Tahoe; Location: California; Incident Date: May 2022**

**Special Crash Investigations**  
**On-site Frontover Investigation**  
**Case Number DS22025**  
**Vehicle: 2022 Chevrolet Tahoe**  
**Location: California**  
**Incident Date: May 2022**

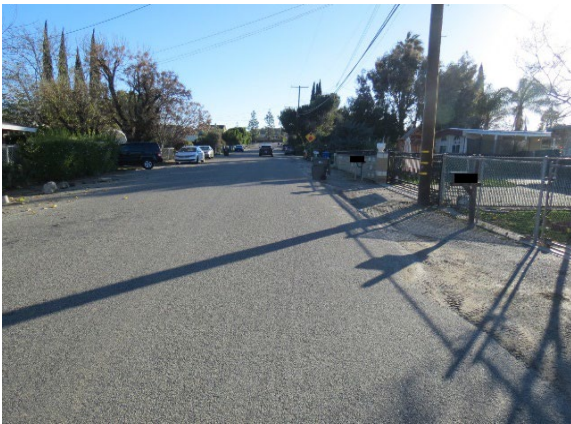
*Figure 1. Driveway approach,*

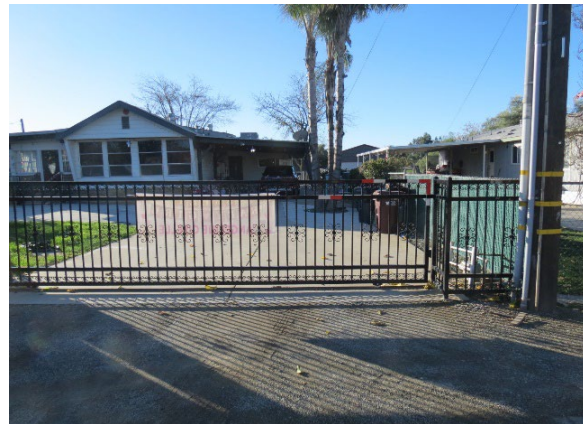
*Figure 2. Eastbound approach, driveway on right*

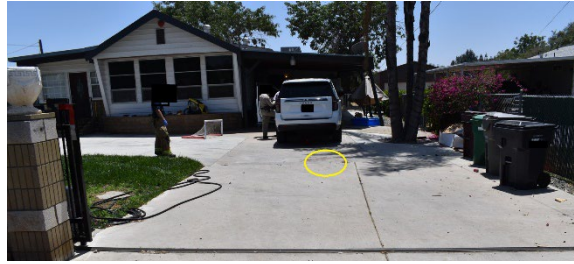
The Chevrolet entered the driveway and traveled approximately 9 m (29 ft). The Chevrolet ran over the child and continued forward (Figure 3). The driver felt a bump and continued forward before stopping the vehicle. The driver's wife came out of the residence and asked if he knew where the child was. He told her that he didn't know. She went to the back of the Chevrolet and saw the child on the ground bleeding. It appeared that the child had either crawled or walked into the driveway from the west near the trash cans and was struck by the right-side tires.

*Figure 3. Area of impact, looking south (police photo)*

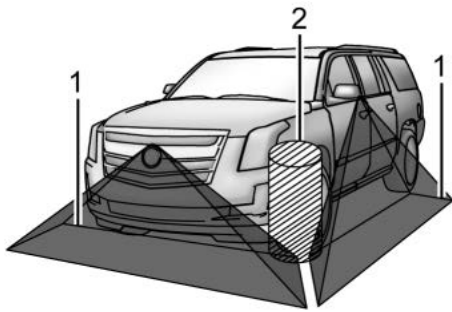
According to the Chevrolet's window sticker, it had assistance systems for parking and backing. One assistance component is called the Surround Vision system. According to the owner's manual the system can display various views (Figures 4 and 5) surrounding the vehicle in the infotainment display. There are several warnings in the manual associated with the feature, including "the surround vision cameras have blind spots and will not display all objects near the corners of the vehicle...the cameras do not display children, pedestrians, bicyclists, crossing traffic, animals, or any other object outside the cameras' field of view, below the bumper, or under the vehicle."

*Figure 4. Camera views, (1) views displayed, (2) area not shown (excerpted from owner's manual)*

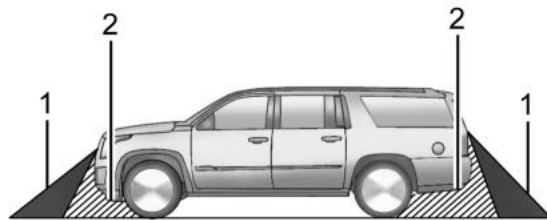
*Figure 5. Camera views, (1) views displayed, (2) area*

Views can be accessed in the infotainment display, including front/rear top-down view, front/rear side view, surround view, and several trailer related views. Surround view displays an image of the area surrounding the vehicle and is displayed alongside whatever view has been selected when the vehicle speed is below 12 km/h (8 mph). There were no indications from the police or in the driver's statements that any of the view options were being used during this incident.

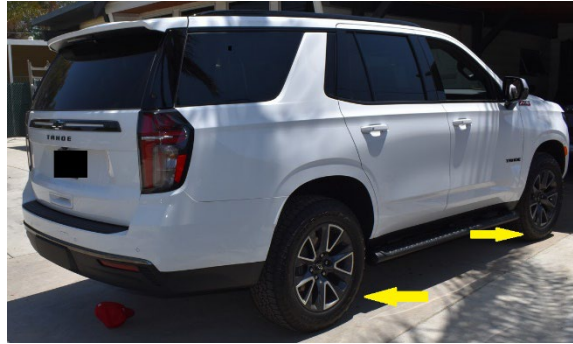
The Chevrolet did not sustain any residual damage. There were blood transfers on the tread of the right front and right rear tires (Figure 6). The collision deformation classifications (CDCs) for these no residual damage contacts were 12FRWN3 and 12FRWN9, respectively.

*Figure 6. Blood contacts to tires, 2022 Chevrolet Tahoe (police image)*

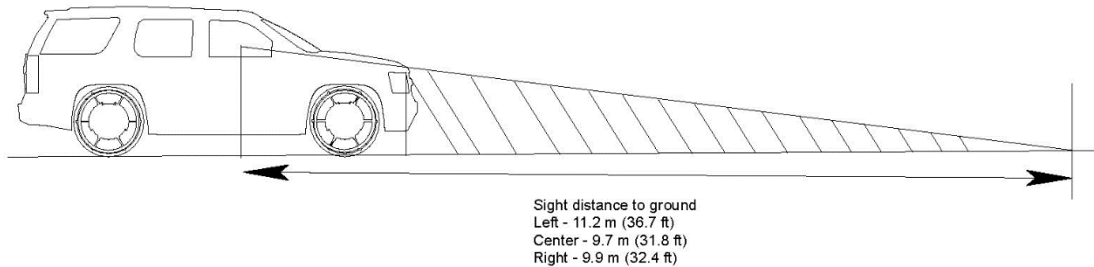
Based on available data, the sight distance to the ground for the driver looking forward over the left hood, over the center of the hood, and over the right hood was 11.2 m (36.7 ft), 9.7 m (31.8 ft), and 9.9 m (32.4 ft), respectively (Figure 7).

*Figure 7. Sight visibility diagram*

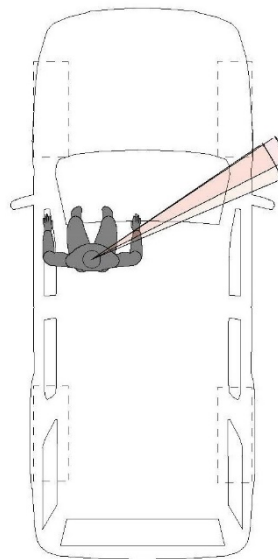
The right A-pillar was a potential blind spot area as the 14-month-old child came from the right to the left. The lateral width of the A-pillar directly correlates to the projected width of a blind spot. For the Chevrolet, the width dimensions for the A-pillar were 14 cm (5.5 in), 13 cm (5.1 in), 13 cm (5.1 in) for the bottom, middle and top, respectively. One study focused on A-pillar driver obscuration/location and A-pillar passenger obscuration that determines the interaction between the driver and vehicle's pillar, which affects the driver's ability to see external objects, including pedestrians.<sup>2</sup> In the study, vehicle pillars were measured in the all-around view from the driver's monocular eye point 63.5 cm above the seating reference point considering all obstructive elements. For the study, measurements and data were collected from approximately 75 vehicles. The minimum A-pillar obscuration was determined to be 7° and the maximum was reported as 11.5° (Figure 8). The authors noted that there are other interior dimensions that affect obscuration/location, including seating reference point to ground front, seat height, and torso angle.

There was also a blind spot created by the right rear-view mirror. The mirror was 28 cm (11.0 in) wide with an 8 cm (3.1 in) gap between the mirror and the lower A-pillar. The base of the side window was 132 cm (51.9 in) above the ground. It does not appear that the mirror or A-pillar played a role in this incident.

Figure 8. Passenger A-pillar obscuration. Minimum A-pillar obscuration (7°); minimum A-pillar obscuration (11.5°)

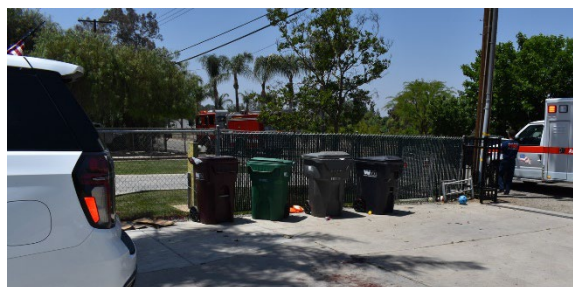
The 14-month-old child appeared to have been on the west side of the driveway (Figure 9), near the fence and trash cans. He likely crawled or walked into the driveway from the right when he saw his father open the gate and enter the driveway. His actions after getting into the driveway are unknown. He was run over by both right-side tires.

Figure 9. Likely child's location, looking
