DOT HS 813 672

# **Special Crash Investigations: On-Site Rollover Crash Investigation; Vehicle: 2021 Toyota RAV4; Location: Arizona; Crash Date: March 2022**

**Special Crash Investigations  
On-Site Rollover Crash Investigation  
Case No. DS22011  
Vehicle: 2021 Toyota RAV4  
Location: Arizona  
Crash Date: March 2022**

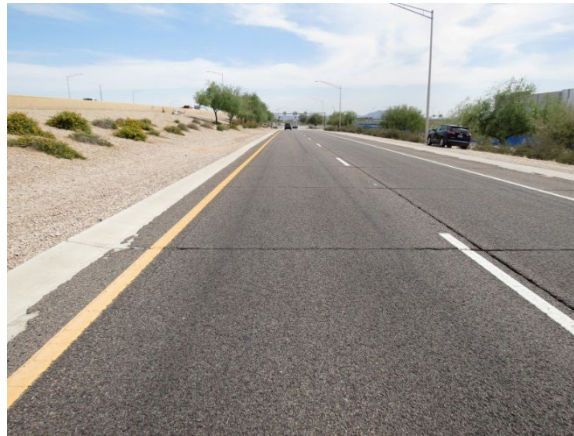
The crash site was the southbound exit ramp of a two-lane divided State highway in Arizona (Figure 3). The ramp was straight and level. It had two lanes each measuring 3.7 m (12.0 ft) wide separated by a dashed white painted lane line and bordered by a solid white painted fog line on the right and a solid yellow painted fog line on the left. The pavement and painted lines were in good condition. The roadway had a paved left shoulder and concrete gutter that were 1.0 m (3.3 ft) wide and a paved right shoulder and concrete gutter that were 3.1 m (10.2 ft) wide. The adjacent left roadside was an ascending gravel-covered embankment planted with low shrubs. The embankment had a maximum positive slope measuring 27 percent. At the top of the embankment, a concrete retaining wall measuring 78 cm (30.7 in) high separated the embankment from the highway. A breakaway metal light pole measuring 25.4 cm (10.0 in) in diameter at its base and 13.7 m (45.0 ft) tall stood between the exit ramp and wall. The posted speed limit for the highway was 105 km/h (65 mph). Conditions at the time of the crash were afternoon, daylight, clear and dry. A crash diagram is included at the end of this report.

*Figure 3. Pre-crash approach, looking south*

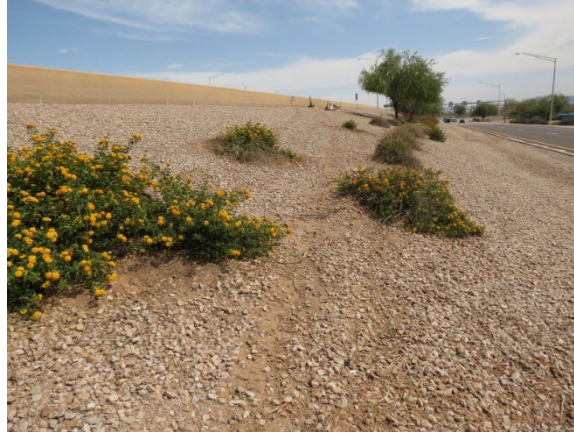
*Figure 4. Crash site looking south to POI*

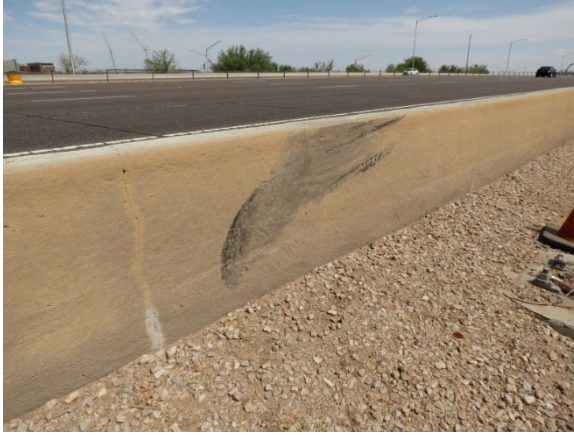
The Toyota's front plane struck the concrete wall at an approximate heading angle of 170° (Event 1). Contact damage to the vehicle was on the front left corner outboard of the frame and bumper backing bar. The Toyota's left front tire struck and rode up the wall, depositing black marks measuring 134 cm (52.8 in) long and 68 cm (26.8 in) high ending at the top of the wall (Figure 5). The contact between the left front wheel and the wall caused the rim to bend and the tire to de-bead. The Toyota reached a state of instability with its left front tire off the ground. It rebounded off the wall and initiated a bounce-over type right side leading rollover. A breakaway metal light pole was located 95 cm (37.4 in) west of the wall. During the rollover, the vehicle's front plane struck the pole (Event 2) causing it to fracture at its base and fall to the ground (Figure 6). Direct damage to the Toyota was located on the right aspect of the front plane and hood. Following the pole impact, the Toyota continued to overturn until it completed one quarter-turn (Event 3) and its right plane contacted the ground. It came to rest on its right side, facing east on the roadside.

*Figure 5. POI Event 1, retaining wall looking south*

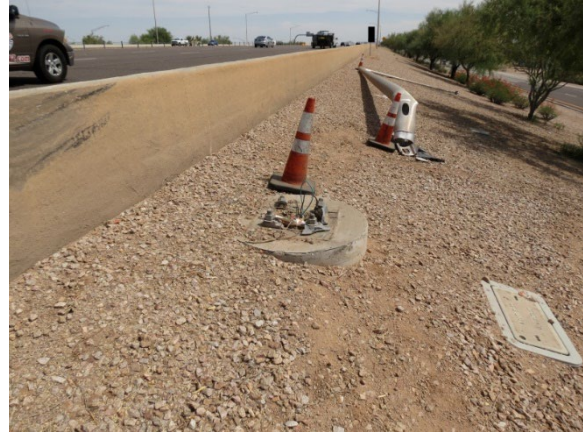
Front plane deformation for the wall and pole impacts was overlapping. The pole impact was higher in severity. The vehicle's EDR report did not capture an EDR event for the wall impact. The pole impact precluded using the WinSMASH reconstruction program because the vehicle had begun to overturn, and the pole yielded when it was sheared from its base. For the pole impact (4th Prior Event, TGR 2 of EDR report), the EDR captured a deployment-level frontal crash. The EDR-reported maximum delta V was -33.4 km/h (-20.8 mph) at 116.0 msec. The driver's frontal (1st stage) and knee air bags deployed, and his seat belt pretensioner actuated, at 21.5 msec. The inflatable curtain (IC) air bag deployed at 30.0 msec, and the driver's frontal air bag deployed (2nd stage), at 51.5 msec.

*Figure 6. POI Event 2, light pole looking south*

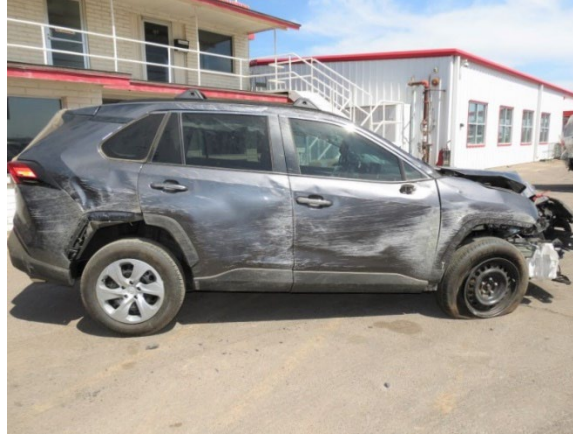
For the Event 3 rollover, direct damage extended from back to front on the right plane and measured 422 cm (166.1 in) (Figure 8). Direct damage extended vertically from sill to roof side rail. Maximum lateral crush to the greenhouse measured 2 cm (0.8 in) and was located on the right roof side rail at 92 cm (36.2 in) forward of the rear axle. The CDC for the rollover was 00RDAO3. The top plane did not contact the ground and no vertical crush was present.

*Figure 8. Right plane damage, 2021 Toyota RAV4*

Police did not report the vehicle’s exact final rest location, but scene evidence including glass from the backlight suggested an estimated rollover distance of 6 m (20 ft). Rollover damage to the vehicle’s greenhouse included sheet metal surface scratches and minor crush. Two factors that possibly mitigated the roll distance were the pole impact and the loose gravel surface of the embankment.
