DOT HS 813 699

**Special Crash Investigations:  
On-Site Ambulance Crash  
Investigation;  
Vehicle: 2018 Ford Transit Type II  
Ambulance;  
Location: Texas;  
Crash Date: January 2022**

**Special Crash Investigations  
On-Site Ambulance Crash Investigation  
SCI Case No: CR22002  
Vehicle: 2018 Ford Transit Type II Ambulance  
Location: Texas  
Crash Date: January 2022**

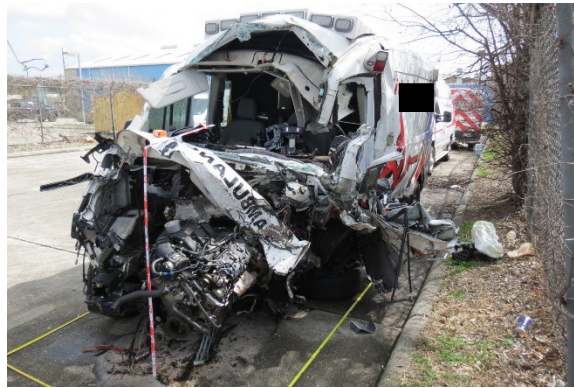
*Figure 1. 2018 Ford Transit Type II ambulance*

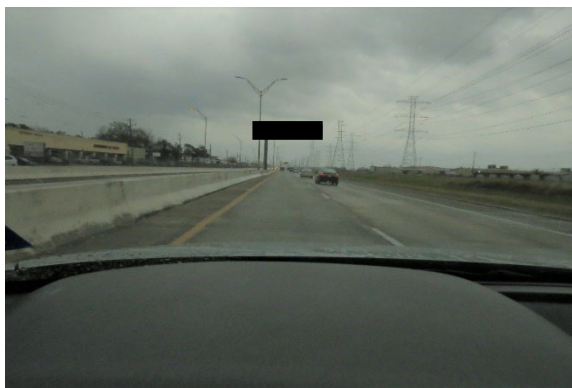
Based on an analysis of post-impact dynamics, it was determined that the ambulance was traveling east in the left eastbound lane, intending to continue straight (Figure 2). The Chevrolet was traveling west, against traffic, in the eastbound lanes, at an EDR-reported speed of 142 km/h (88 mph) in the same lane as the ambulance.

*Figure 2. East view, ambulance's approach to impact*

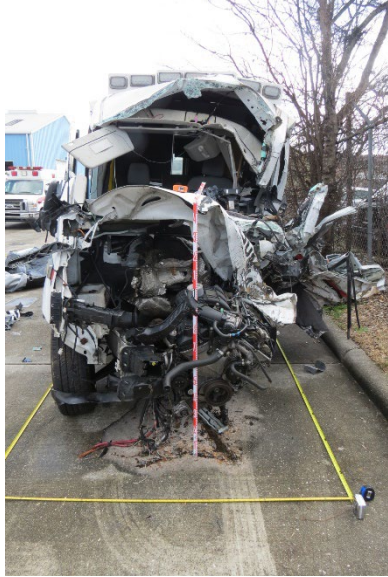
The ambulance's front-left and front-center aspects (Figure 3) sustained severe damage during the impact with the Chevrolet's front. The direct damage began 8 cm (3.1 in) left of the centerline and extended 80 cm (31.5 in) to the left. The direct damage continued along the left sill to the rear wheel (Figure 4) as the ambulance continued over the top of the Chevrolet. The ambulance's bumper beam detached from its connections and crush measurements were taken at the ends of both frame rails. The Field L was 86 cm (33.9 in) and the maximum residual crush was 149 cm (58.7 in), occurring at the left frame rail, 73 cm (28.7 in) left of the centerline. The crush measurements were: C1 = 156 cm (61.4 in), C2 = 127 cm (50.0 in), C3 = 99 cm (39.0 in), C4 = 70 cm (27.6 in), C5 = 41 cm (16.1 in), C6 = 12 cm (4.7 in). The collision deformation classification (CDC) for this damage pattern was 12FYAW6.

*Figure 3. Front end damage*

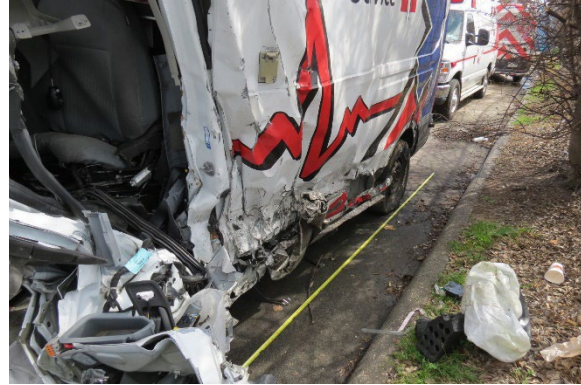
*Figure 4. Left sill damage*

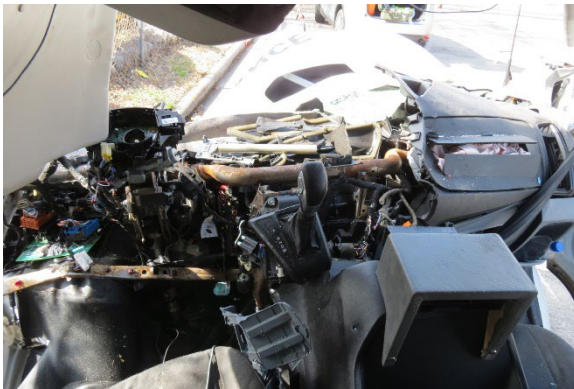
The ambulance had significant interior damage and intrusion to the occupant compartment (Figure 5) from the impact with the Chevrolet. The left A-pillar, instrument panel, and B-pillar intruded longitudinally 42 cm (16.5 in), 35 cm (13.8 in), and 35 cm (13.8 in), respectively. Possible blood or body fluid was noted on the driver's frontal air bag, but due to the severe damage, no other discernable occupant contacts were noted in the vehicle. Rescue personnel had removed the steering column to ease occupant extrication. Damage to the patient compartment was minimal.

*Figure 5. Severe intrusion damage of ambulance's instrument panel (image taken from center of cab)*

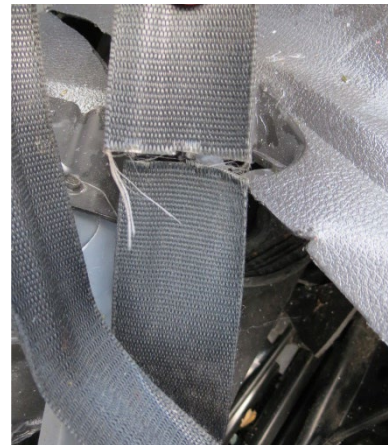
The driver was restrained by the lap and shoulder seat belt. At the time of SCI inspection, the latch plate was found in the buckle. The lap belt was cut by rescue personnel, approximately 28 cm (11 in) from the floor anchor (Figure 6) and near the D-ring (Figure 7).

*Figure 6. Driver's lap belt cut by rescue personnel*

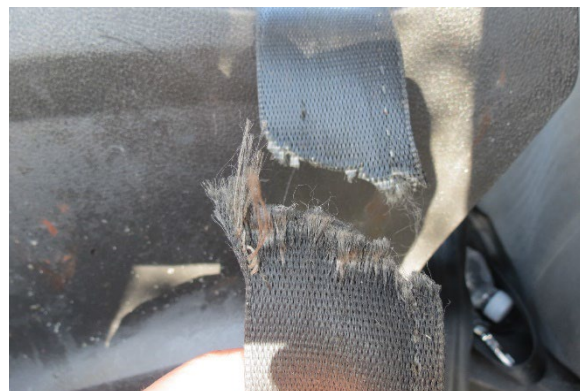
*Figure 8. Driver's seat belt webbing cut near D-ring*

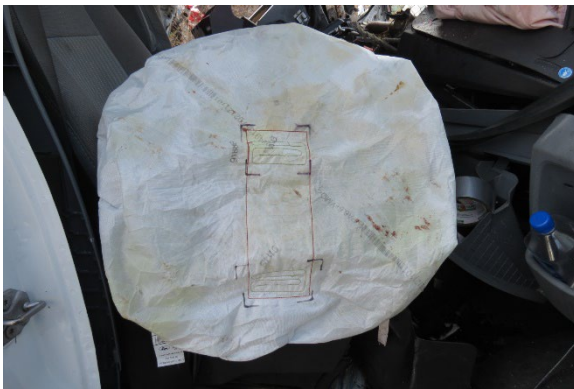
also discolored, possibly from body fluid, but there was no damage and no other discernable evidence of occupant contact (Figure 9). The module cover was a two-flap configuration constructed of pliable vinyl with a horizontal tear seam. The top flap was 10 cm (3.9 in) wide and 4 cm (1.6 in) high, while the bottom flap measured 17 cm (6.7 in) across the top of the flap and 8 cm (3.1 in) across the bottom. The bottom flap was 9 cm (3.5 in) high. There was no damage or discernable contact evidence on the flaps.

*Figure 9. Discolored face of driver's frontal air bag*

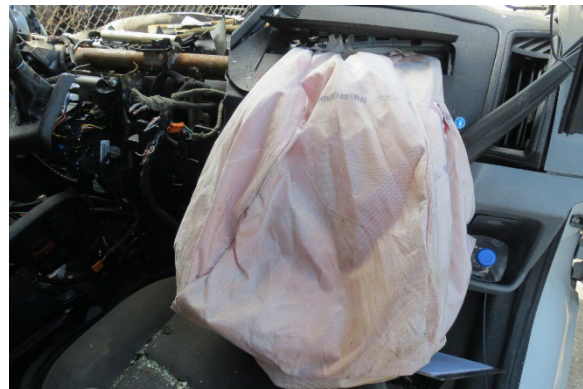
The passenger's frontal air bag was in the top of the instrument panel. The deployed air bag measured 56 cm (22.0 in) in height and 40 cm (15.7 in) wide. There was a yellowish discoloration on the air bag face but there was no discernable contact evidence otherwise (Figure 10). The module cover was a two-flap configuration constructed of stiff vinyl with a horizontal tear seam. The top and bottom flaps were 32 cm (12.6 in) wide and 6 cm (2.4 in) high. There was no damage or discernable contact evidence to the flap.

*Figure 10. Deployed passenger's frontal air bag*

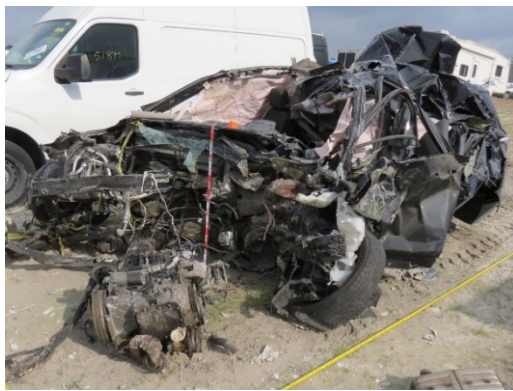
The Chevrolet's front end (Figures 11 and 12) was directly damaged during the impact with the ambulance. Direct damage began at the centerline and extended approximately 80 cm (31.5 in) to the left. The Field L was 183 cm (72.0 in) and crush measurements were taken on the two frame rails since the bumper beam had been detached from the left rail. The crush values were C1 = 172 cm (67.7 in), C2 = 144 cm (56.7 in), C3 = 117 cm (46.1 in), C4 = 89 cm (35.0 in), C5 = 61 cm (24.0 in), and C6 = 34 cm (13.4 in) with the maximum residual crush measured as 172 cm (67.7 in), occurring on the left frame rail, which was 116 cm (45.7 in) left of the centerline. The windshield was 80 cm (31.5 in) in longitudinal width and the maximum crush did not exceed this zone.

*Figure 11. Front-left oblique view of Chevrolet*

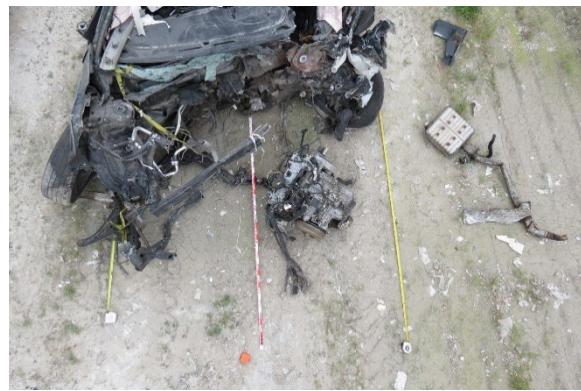
*Figure 12. Overhead view of Chevrolet frontal damage*
