**National Highway
Traffic Safety
Administration**

**Special Crash Investigations:
Guardrail End Terminal
Crash Investigation;
Vehicle: 2017 Ford F-250;
Location: California;
Crash Date: July 2017**

Special Crash Investigations
Guardrail End Terminal Crash Investigation
Case Number: DS17011
Vehicle: 2017 Ford F-250
Location: California
Crash Date: July 2017

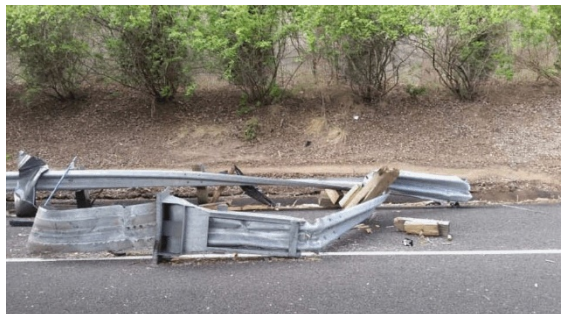
Figure 2. ET-Plus and extruded W-beam (Caltrans photo)

This report documents the guardrail end terminal crash investigation of a 2017 Ford F-250 (Figure 1) that struck an ET-Plus guardrail end terminal (Figure 2) and a concrete pier, resulting in serious injuries to the driver. The investigation is intended to determine what role the guardrail may have played in causing the injuries to the driver. This case was initiated by the California Department of Transportation (Caltrans) that notified the Federal Highway Administration (FHWA) of the crash. The investigation was conducted at the request of the Federal Highway Administration. After reviewing the case and determining that the ET-Plus guardrail end terminal qualified and that the case was of interest, the FHWA forwarded the notification, along with on-scene images to the Special Crash Investigations (SCI) group of the National Highway Traffic Safety Administration with instructions to deploy the SCI team. SCI assigned the case to Dynamic Science, Inc., in July 2017. That same day, the SCI team conducted an on-scene inspection of the damaged guardrail and end terminal. Caltrans personnel were present during the scene inspection to provide lane closure using two trucks and traffic cones.

The guardrail end terminal in this crash was an ET -Plus extruder-type end terminal. The rectangular impact face measured 71 x 38 cm (28.0 x 15.0 in) and the guide chute exit measured 50 cm (20.0 in) high. The ET-Plus was configured with a metal ground strut measuring 190 cm (75.0 in) long located between Posts 1 and 2, an anchor cable attached to Post 1 and an anchor bracket attached to the W-beam between Posts 1 and 2. The wooden guardrail Posts 1 to 8 measured 15 x 20 cm (6.0 x 8.0 in); the I-beam configured steel Posts 8 to 12 measured 15 x 10 cm (6.0 x 4.0 in). All the posts were assembled with wood offset blocks measuring 15 x 20 cm (6.0 x 8.0 in). Post spacing averaged 180 cm (71.0 in), and W-beam height measured top to ground was 69 cm (27.0 in).

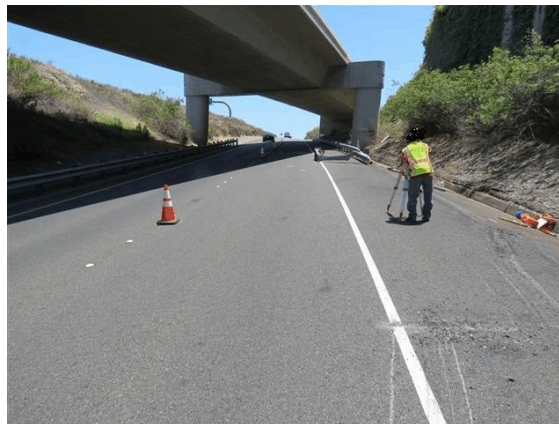
Figure 3. Crash site looking north to guardrail end terminal

The crash site was a two-lane on-ramp to a southbound State highway (Figure 3). The roadway curved left in a radius measuring 466.0 m (1,529.0 ft) at the right fog line. The roadway orientation changed from left curve to straight at Post 5, approximately 8.0 m (26.0 ft) south of the guardrail end terminal. The roadway profile was an uphill positive slope measuring 8.2 percent with a positive super-elevation measuring 6.0 percent. The roadway, paved with asphalt in good condition, was dry at the time of the crash. The two travel lanes measuring 3.5 m (11.5 ft) wide were separated by a dashed white painted stripe. The roadway was bordered by a solid white painted fog line on the right and a solid yellow painted fog line on the left. The right edge was bordered by a paved asphalt shoulder measuring 2.2 m (7.2 ft) wide followed by a paved asphalt drainage swale measuring 1.7 m (5.6 ft) wide. The swale descended from the shoulder at a negative slope of 18 percent measured lateral to Post 1 of the guardrail. All the guardrail posts were located on the swale. On the field side of the swale, an unpaved ascending embankment had an uphill slope measuring 58.3 percent.

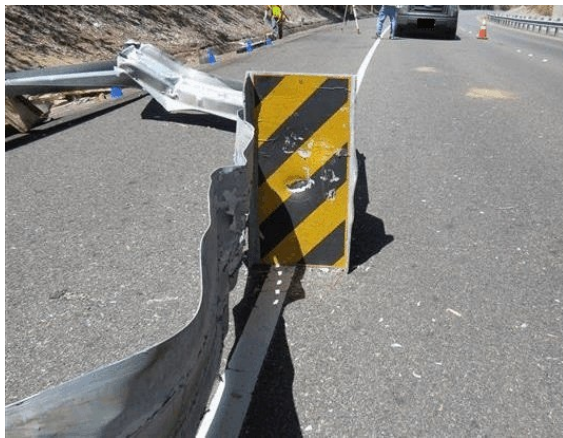
Figure 4. ET-Plus impact head end terminal

The crash included two events: the guardrail end terminal impact and an overpass pier impact. The EDR report recovered four events, all of which were captured in a single First Record: a locked frontal event, a locked side event, a locked rollover event, and a fuel cutoff level 1. The Ford's front plane struck the ET-Plus guardrail end terminal (Figure 4) in a head-on configuration (Event 1) at an EDR-reported speed of 109.0 km/h (67.6 mph). The end terminal yielded when a section of the metal W-beam measuring 221 cm (87.0 in) long extruded through the head, and the first four guardrail posts fractured. The rail kinked in four places, beginning at Post 2 and ending at Post 5. The driver and front passenger frontal air bags deployed the first stage at impact at an EDR-reported time of 267 ms. The driver's retractor pretensioner actuated at the time. The Ford reached its EDR-reported maximum longitudinal delta V for the guardrail impact at 272 ms, and the driver's anchor pretensioner actuated soon at 273 ms. The Ford was displaced right to the field side of the guardrail and traveled in a southbound trajectory along an unpaved ascending embankment. The embankment sloped upward at a 30.3-degree angle, and

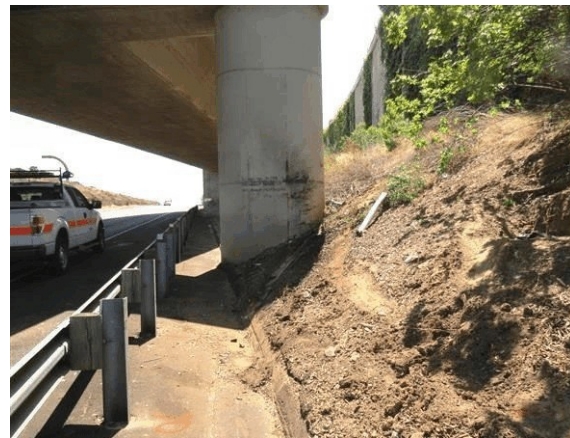
Figure 5. Struck overpass pier, looking south on field side of guardrail

The Ford continued traveling southbound until the front plane struck a large concrete pier supporting an overpass (Figure 5) (Event 2). The pier measured 2.4 m (8.0 ft) in diameter and was located 25.4 m (83.3 ft) east of Post 1. The Ford's left and right seat-mounted side air bags and IC air bags deployed at 1,062 ms and triggered in response to the severe frontal impact with the pier. The pier impact was the more severe of the two events, and damage to the Ford's frontal plane caused in the second event overlapped and masked the damage caused by the first event. The Ford's right-side tires deposited a furrow mark in the embankment measuring 20.6 m (67.6 ft) that ended 1.8 m (5.9 ft) south of the point of impact, indicating that the Ford was displaced slightly right after impacting the pier. The Ford came to rest on the embankment and facing south near the pier.

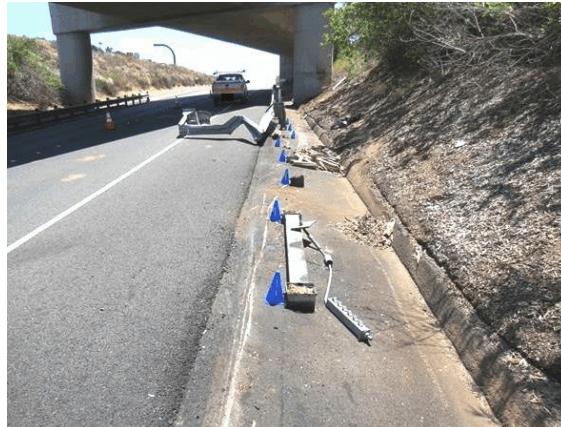
Figure 6. Guardrail impact damage looking south, Post 1 in the foreground

At impact with the guardrail end terminal, a section of the W-beam measuring 2.2 m (7.2 ft) long extruded on the traffic side of the guardrail. The W-beam kinked in three areas beginning at Post 2 and ending at Post 5, and the total damaged length of W-beam measured 6.0 m (19.7 ft). The guardrail impact head, anchor cable, and bracket were displaced. Posts 1 to 4 were fractured through, and the remaining posts were undamaged (Figure 6). The Ford was displaced to the field side of the guardrail and continued traveling in an eastbound trajectory until it struck an overpass pier where it came to rest. The complete In-Service End Terminal Evaluation Data Collection Forms are included in this report as Appendix A.

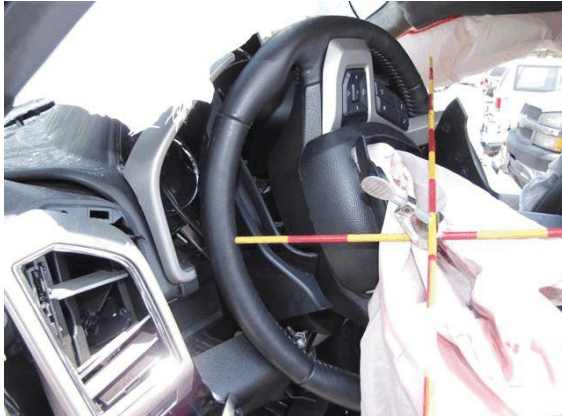
Figure 8. Bent steering wheel rim, driver contact point, the 2017 Ford F-250

displaced by impact forces. Driver contact caused steering wheel rim deformation in all four quadrants and steering column displacement to the left and upward. The top half of the steering wheel rim was bent 10 cm (3.9 in) forward, and the steering wheel rim was displaced 15 cm (5.9 in) to the left (Figure 8). Driver loading caused scuffing and stretching of the seat belt webbing. Driver loading caused seat cushion movement at the left aspect of 6 cm (2.4 in) and seat back movement at the left aspect 5 cm (2.0 in) outboard and rearward of their original positions. The Ford sustained front-row longitudinal intrusion of the left, center, and right instrument panel, the left and right toe pans, and the accelerator and brake pedals.

His face and head contacted the steering wheel, deforming the spokes and rim, and displacing the column to the right that caused unspecified fractures to the face and cerebral bleeding. His hands and forearms were displaced forward, contacting the left instrument panel and causing injuries described only as "wrist fractures." His right foot contacted the toe pan, causing an injury described only as "ankle fracture." He also sustained numerous unspecified abrasions. The driver slumped to the left, contacting the frontal and seat-mounted side air bags and depositing blood on both.

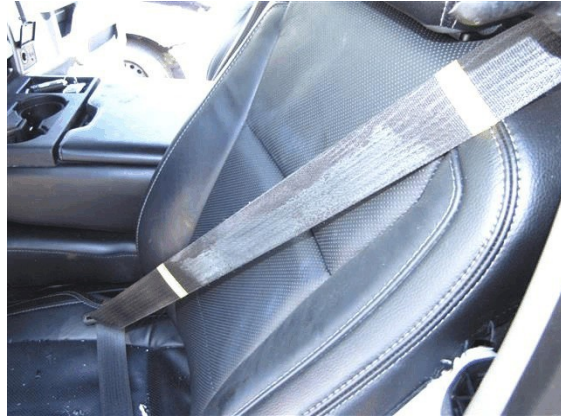
Figure 9. Scuffed and stretched seat belt, driver loading point, the 2017 Ford F-250

The front row of the Ford was equipped with driver and front passenger lap and shoulder seat belts. The driver's belt was equipped with continuous loop belt webbing, a sliding latch plate, an emergency locking retractor (ELR), and an adjustable upper anchor that was adjusted to the full-down position. The front-row seat belts were equipped with retractor-mounted and anchor-mounted seat belt pretensioners. The Ford inspection, combined with the EDR report, determined that the driver was belted and both pretensioners actuated during the crash. The EDR report indicated that the driver's seat belt pretensioner actuated at the retractor position at 267 ms at impact with the guardrail end terminal and at the anchor position at 274 ms. Driver loading of the seat belt webbing caused scuff marks and stretch marks extending from 110 cm to 165 cm (43.3 in – 65.0 in) above the stop loop (Figure 9).

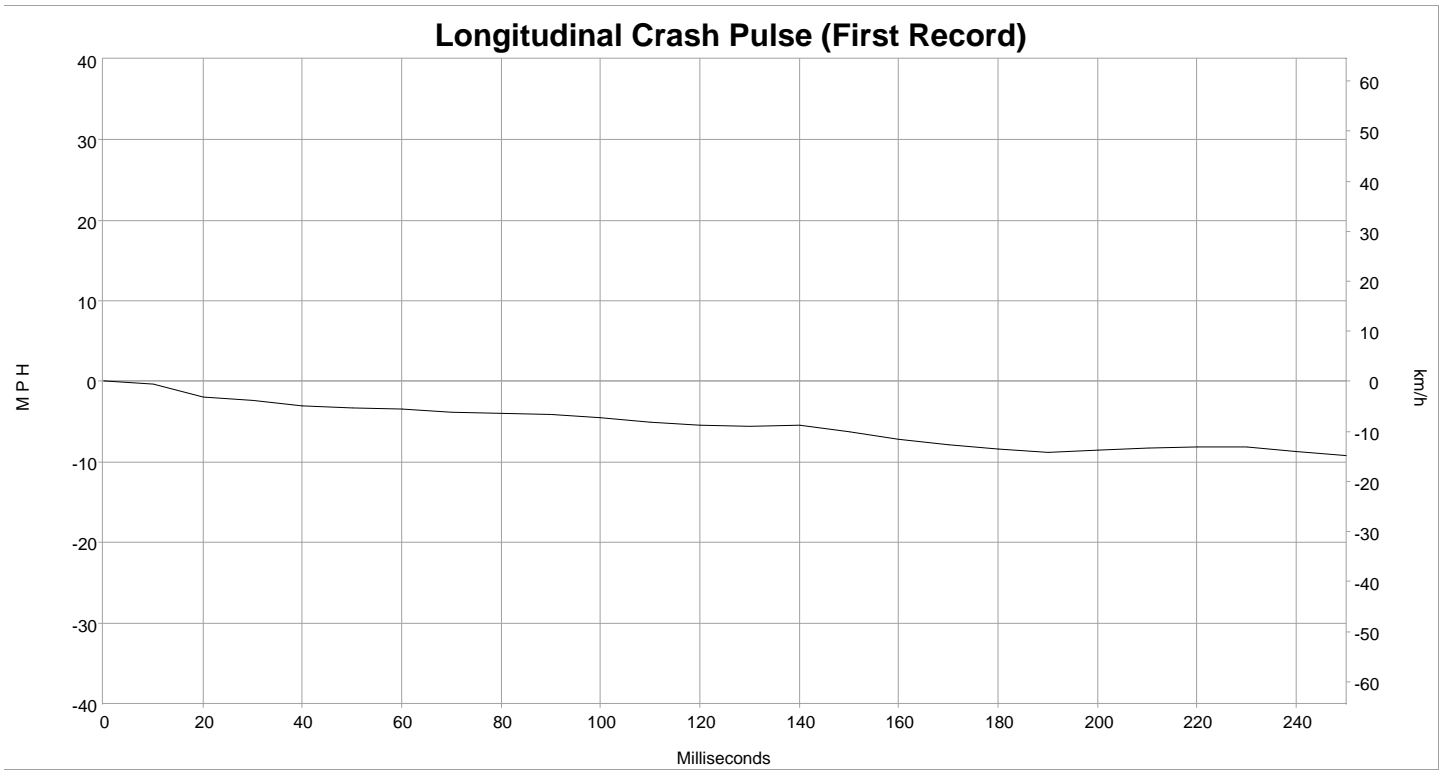
Longitudinal Crash Pulse (First Record)

For the First Record, the deployment data included air bag deployment times for the six deployed air bags (two each for frontal, side, and IC), and two actuated seat belt pretensioners. It reported a maximum longitudinal delta V of -17.35 km/h (-10.78 mph) at 272.0 ms.

Time (msec)	Delta-V, longitudinal (MPH)	Delta-V, longitudinal (km/h)
0	0.00	0.00
10	-0.35	-0.57
20	-1.89	-3.04
30	-2.37	-3.81
40	-3.09	-4.97
50	-3.36	-5.40
60	-3.47	-5.58
70	-3.79	-6.10
80	-3.98	-6.41
90	-4.11	-6.61
100	-4.49	-7.22
110	-5.08	-8.17
120	-5.51	-8.86
130	-5.63	-9.06
140	-5.48	-8.82
150	-6.21	-10.00
160	-7.23	-11.64
170	-7.85	-12.64
180	-8.44	-13.59
190	-8.76	-14.09
200	-8.48	-13.64
210	-8.25	-13.28
220	-8.08	-13.01
230	-8.15	-13.12
240	-8.69	-13.99
250	-9.24	-14.87
