# **Special Crash Investigations Remote Non-Traffic Surveillance Hyperthermia Investigation Vehicle: 2014 Toyota Camry Location: California Incident Date: July 2014**

**Special Crash Investigations**  
**Remote Non-Traffic Surveillance**  
**Hyperthermia Investigation Case Number: DS17007**  
**Vehicle: 2014 Toyota Camry**  
**Location: California**  
**Incident Date: July 2014**

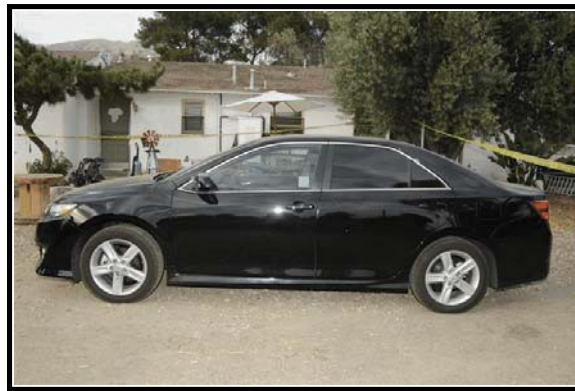
**Figure 1.** Incident site looking north, 2014  
Toyota Camry and residence (police photo)

The interest in this Remote Non-Traffic Surveillance (NTS) Hyperthermia Investigation is the heat-related death of an unattended 3-year-old male who died after entering a 2014 Toyota Camry (**Figure 1**). The incident was identified during a review of a website that tracks hyperthermia-related child fatalities. The website includes incidents where the child enters a vehicle and remains inside the vehicle because the child cannot self-extricate. In these incidents the child is not left alone in a child safety seat in the vehicle by a parent or caregiver. The Special Crash Investigations (SCI) team obtained the police report and images for the incident and the case was initiated by the SCI group of the National Highway Traffic Safety Administration on April 27, 2017.

This incident occurred in July 2014 at approximately 1500 hours at a private residence in California. Six family members resided at the home and five were present at the time of the incident, including the father, mother, two brothers, and the 3-year-old male involved in the incident. Prior to the incident, the father and the 3-year-old male were in the back yard and the others were inside the home. At some point the child went inside the residence to take a nap with his mother. While his mother slept, the child exited the residence and entered the Toyota Camry, which was unlocked with all the windows closed and parked in the driveway.

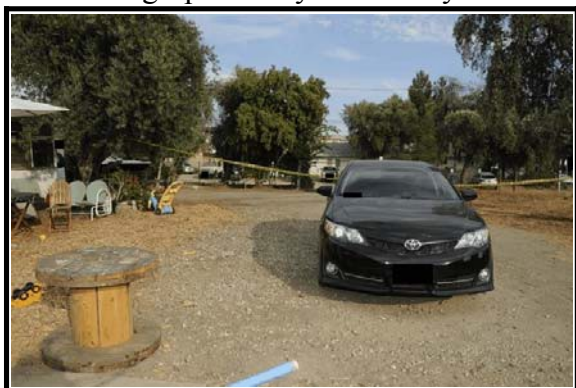
**Figure 2.** Incident site looking north, 2014 Toyota Camry and residence (police photo)

indicate no source of shade was likely present at the time of the incident (**Figure 2**). Family members stated to police that it was customary for both Toyota vehicles to be left unlocked while on the property and that sometimes the 3-year-old child played inside the vehicles. He knew how to open the vehicle doors using the outside and inside handles. He also knew how to buckle and unbuckle safety belts.

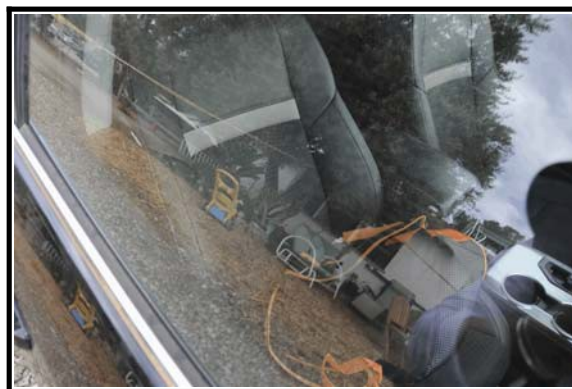
**Figure 3.** Child location, 2014 Toyota Camry (police photo)

The father went outside and looked through the side glass of the Toyota Camry and discovered the child lying in the front row right passenger seat on top of a backpack (**Figure 3**). He opened the right front door, removed the child from the vehicle and carried him inside the house.

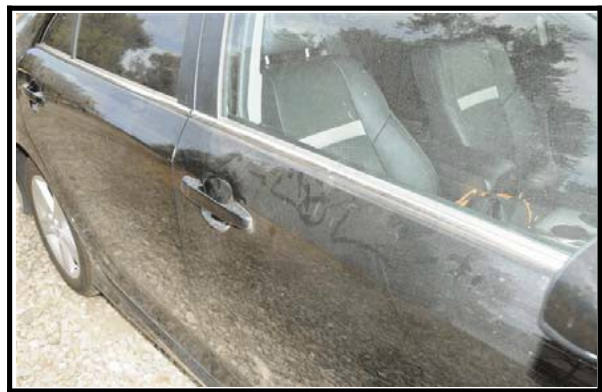
Figure 4. Exterior and interior colors, 2014 Toyota Camry (police photo)

direct sunlight for a prolonged period and the vehicle's exterior (black) and interior (gray) color may have been contributing factors in increased interior temperatures (**Figure 4**). Ambient air temperature as indicated by the nearest recorded time of w15 minutes after his arrival at the hospital.
