DOT HS 812 533

Special Crash Investigations Remote Non-Traffic Surveillance Hyperthermia Investigation Vehicle: 2011 Ford Fiesta Location: Idaho Incident Date: June 2015

Special Crash Investigations
Remote Non-Traffic Surveillance Hyperthermia Investigation
Case Number: DS16022
Vehicle: 2011 Ford Fiesta
Location: Idaho
Incident Date: June 2015

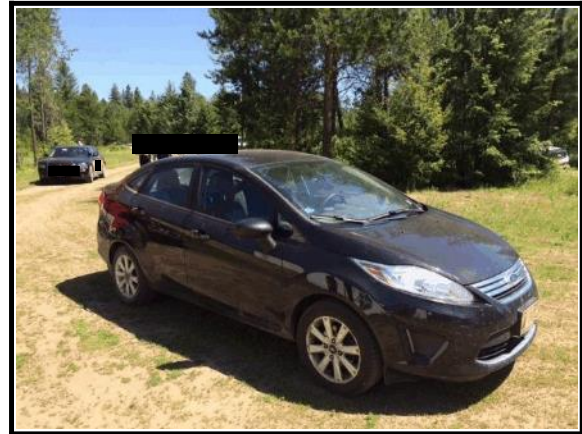
Figure 1. 2011 Ford Fiesta, looking southwest (police image)

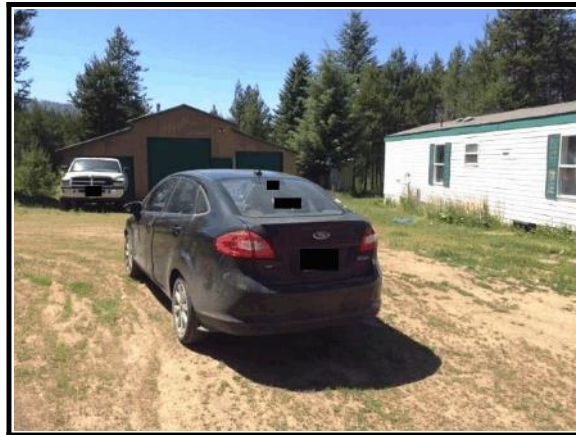
The incident occurred in the driveway of a private residence located near an unpaved county road in a rural area in Idaho (**Figure 2**). The driveway was unpaved, hard-packed ground and scattered grass with a mostly level profile. It was generally oval in shape originating and ending at the roadway that fronted the south edge of the residential property. The Ford was parked in close proximity and south of the residence. The child had a clear path from the residence to the vehicle. The vehicle was visible from a doorway and three windows on the south side of the residence. Mature trees were present on the property and particularly within the area of the driveway but a high midday sun precluded shading directly on the vehicle. During the time the child was inside the vehicle, the sun was high above the horizon and passed directly overhead.¹ A detached garage was located on the property and west of the residence. Another vehicle identified only as a white, full-size pickup was parked facing east on the east side of the garage.

Figure 2. Incident site looking west with subject vehicle in center and residence on right (police image)

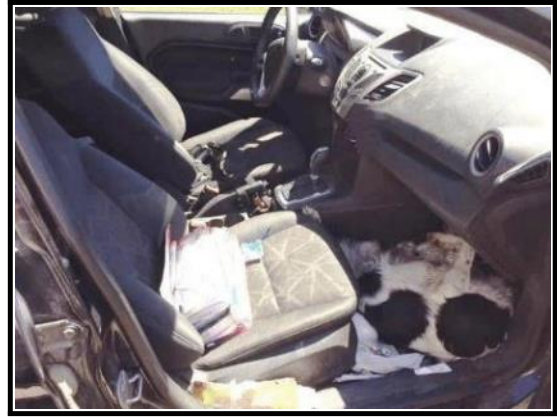
The mother began looking and found the child in the vehicle where he and both dogs were unresponsive at approximately 1245 hours (**Figure 3**). The child was found lying on the console between the front row seats with his head on the center instrument panel and his feet in the second row.

Figure 3. Interior front row, 2011 Ford Fiesta (police image)

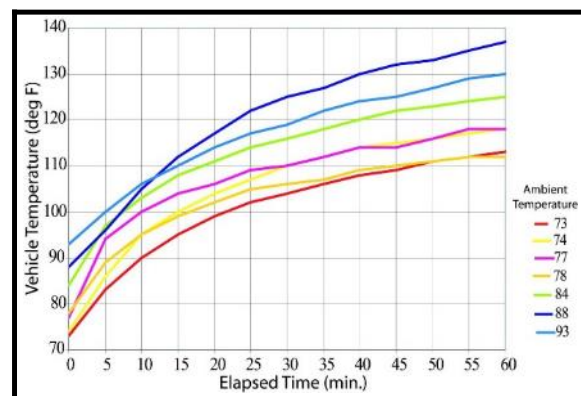
The length of time the child spent inside the vehicle on the day of the incident is unknown. His mother was last aware of his presence in the home at 0830 hours and the adult male was discovered the child and dogs absent from the home at 1030 hours. This suggests the child was possibly inside the vehicle from at least 1030 to 1245 hours. At 1030 hours, the ambient air temperature at the incident site was 22.0 degrees C (71.6 degrees F). At this moderate temperature, on average interior vehicle temperatures will increase 1.7 to 1.9 degrees C per 5 minutes (**Figure 4**). Within 30 minutes 80 percent of the temperature increase is accounted for and within 60 minutes the vehicle has reached peak temperature.

Figure 4. Representative vehicle temperature rise over time²

The data suggests that at 1130 hours the vehicle's interior temperature had reached at or above 45.0 degrees C (113.0 degrees F). At 1130 hours, the ambient temperature at the incident site was 24.0 degrees C (75.2 degrees F). The data suggests the vehicle's interior temperature at 1230 hours was at or above 47.8 degrees C (118.0 degrees F). The vehicle's interior color is a significant factor in intensifying interior temperatures. The interior color of the Ford was
