DOT HS 812 535

# **Special Crash Investigations On-Site Rollover Investigation Vehicle: 2015 Chevrolet Cruze Location: California Crash Date: December 2015**

**On-Site Rollover Investigation  
Case Number DS16005  
Vehicle: 2015 Chevrolet Cruze  
Location: California  
Crash Date: December 2015**

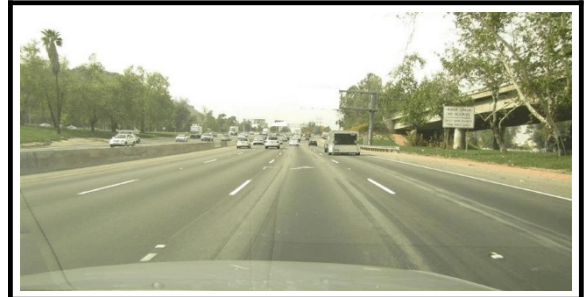
**Figure 2.** Crash site, northbound approach view

The crash occurred on a four-lane, northbound interstate highway in California (**Figure 2**). The roadway was concrete-surfaced and was configured with paved shoulders measuring 1.2 m (4.0 ft) on the left edge and 3.0 m (10.0 ft) in width on the right edge. The lanes were separated by dashed white painted stripes and the roadway was bordered by a solid yellow painted stripe on the left edge and a solid white painted fog line on the right edge. This roadway was straight and level, and the posted speed limit was 105 km/h (65 mph) for two-axle vehicles and 89 km/h (55 mph) for heavy trucks. The investigating police officer noted no unusual conditions present at the time of the crash. The vehicles were moved prior to police investigation and final rest positions of the vehicles was unknown.

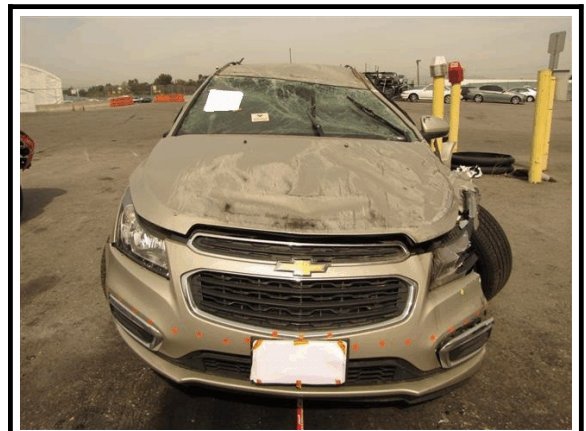
**Figure 3.** Front plane crush measurements, 2015 Chevrolet Cruze

The Chevrolet sustained moderate severity crush damage to the front plane caused during the impact with the Mack and moderate severity crush damage to the roof caused during the rollover. For the frontal impact, the damage was located on the front bumper fascia, front left headlamp, left front fender and left front tire/wheel assembly. The left front tire was restricted. Direct damage to the bumper fascia began at the front left bumper corner and extended 17.0 cm (6.7 in) to the right. Direct damage down the left side extended from the front left bumper corner to the left front fender and measured 50.0 cm (19.7 in). The Field L extended from bumper corner to bumper corner and measured 160.0 cm (63.0 in) (**Figure 3**). Six crush measurements were calculated at bumper level as follows:  $C_1 = 3.0$  cm (1.2 in),  $C_2 = 0$  cm,  $C_3 = 0$  cm,  $C_4 = 0$  cm,  $C_5 = 0$  cm,  $C_6 = 0$  cm. Maximum

crush was located at C<sub>1</sub> and the Collision Deformation Classification (CDC) for the Chevrolet in Event 1 was 12FLEE3.

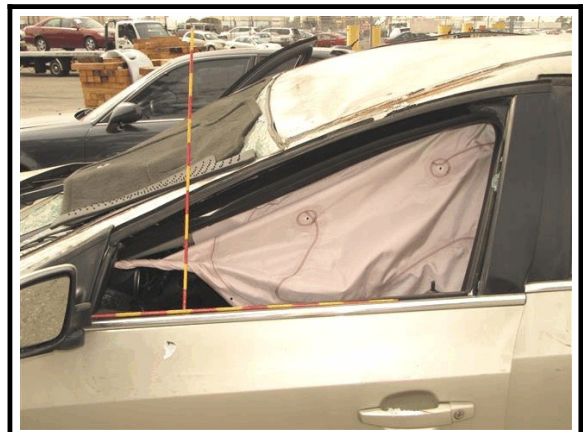
**Figure 7.** Deployed left IC air bag, area of coverage and tether location on A-pillar, 2015 Chevrolet Cruze

The vehicle's IC air bags revealed design features including combination deployment capability in both side impact and rollover crashes, large areas of coverage over the side glass both longitudinally and vertically, and tethering near the base of the A-pillars (**Figure 7**) to assist in keeping the deployed IC air bags in place and occupants within the occupant compartment. Additionally, the vehicle manufacturer states in the owner's manual that both IC air bags will deploy in any of the following three conditions: when either side of the vehicle is struck, if the sensing system predicts that the vehicle is about to rollover on its side, or in a severe frontal impact.

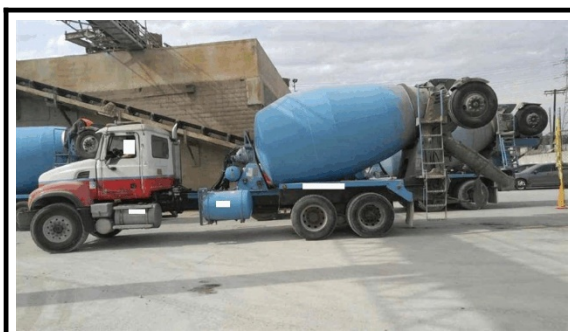
**Figure 9.** 2001 Mack CV500 left side view (owner image)

The 2001 Mack CV500 (**Figures 8 and 9**) was identified by the Vehicle Identification No. 1M2AG03C81Mxxxxxx. The Mack was a medium-heavy single-unit straight truck cement mixer in a four-axle configuration and a GVWR greater than 4,536 kg (10,000 lb). It was equipped with a Mack E7-350 diesel engine and air brakes.

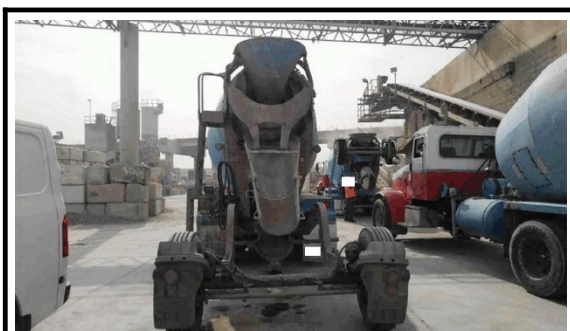
**Figure 8.** 2001 Mack CV500 back view (owner image)

According to the police report, the Mack sustained minor damage to the back plane including, but not limited to, a bent rear fender near the third axle. The vehicle was not available for inspection and no further data on exterior damage was obtained.
