Special Crash Investigations Remote Vehicle Fire/ Child Restraint System Investigation

Vehicle: 1995 Chevrolet Astro

Location: California

Crash Date: January 2012

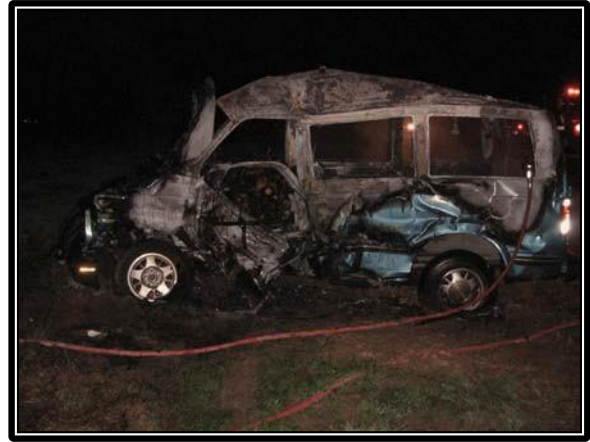
Figure 1. 1995 Chevrolet Astro van (police photo)

The interest of this Remote Vehicle Fire/Child Restraint System (CRS) Investigation is the post-impact fire in a 1995 Chevrolet Astro (**Figure 1**) involved in an angled crash with another vehicle, and the two child occupants of the Chevrolet who were seated in CRSs. The investigation was intended to determine the events leading to the fire, how quickly the fire spread to the occupant compartment, the magnitude of the fire, how quickly EMS and other responders arrived on-scene, occupant restraint usage, injury and CRS data. The crash was identified during a review of Fatality Analysis Reporting System (FARS) crash reports. The case was initiated by the Special Crash Investigations (SCI) group of the National

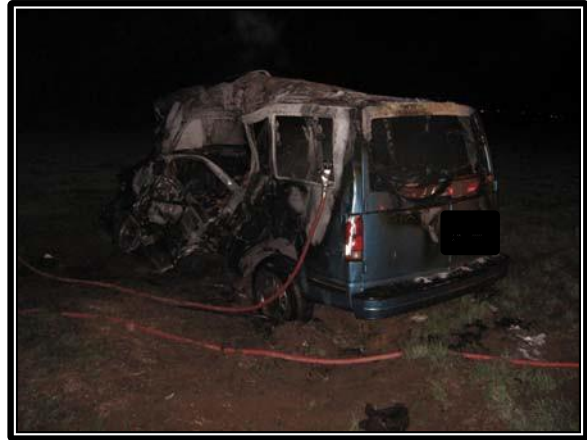
Exterior images of the Chevrolet taken by the police were used to conduct a partial exterior vehicle inspection. The Chevrolet sustained moderate left plane damage from the impact with the front plane of the Ford (**Figure 3**). The Collision Deformation Classification (CDC) was 10LYEW3. The vehicle also sustained moderate damage to the left, top, and right planes due to the fire (**Figure 4**).

Figure 3. Left side damage, 1995 Chevrolet Astro (police photo)

The interior of the Chevrolet was configured with seating for eight occupants. The front row was configured with box-mounted type seats. The second and third rows were configured with bench seats with folding backs. The vehicle sustained moderate left side damage due to lateral intrusion. The entire interior was consumed by fire with the seats being burned down to their metal frames.

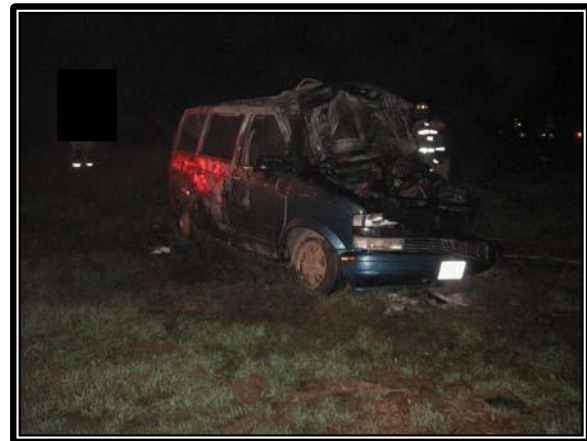
Figure 4. Burn damage, 1995 Chevrolet Astro (police photo)

A search using the year/make/model revealed seven recalls and three investigations. Three of the recalls were fuel-system-related. NHTSA Campaign Number 94V188000 indicated the fuel lines attached to the fuel tank were not properly tightened and this could cause a fire. In this crash, the source of the fire was restricted to the front of the vehicle, though there was fire damage to the interior and all planes. Campaign Number 06E041000 indicated that certain replacement fuel return lines have a bleed valve that was not installed at the proper torque. It is not known if this vehicle had the replacement return lines. Campaign Number 06E043000 indicated that certain replacement fuel filters were not manufactured to specification and the O-ring might not seat correctly on the fuel line. It is not known if the vehicle used the replacement fuel filter.

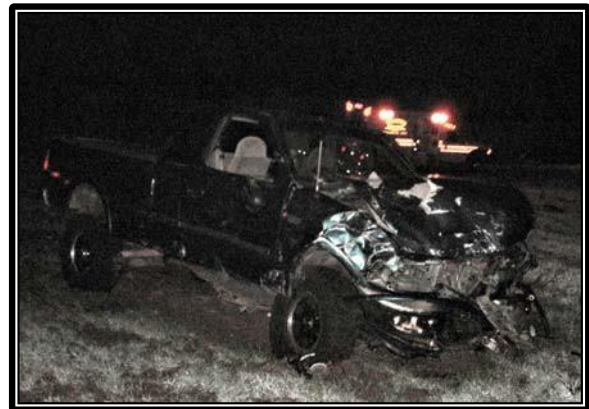
The Ford sustained moderate front plane damage from the impact with the Chevrolet (**Figure 4**). The CDC was 01FDEW1. The vehicle was towed due to damage.

Figure 5. 1997 Ford F150 (police photo)
