DOT HS 812 543

**Special Crash
Investigations
Remote Non-Traffic
Surveillance
Hyperthermia Investigation
Vehicle: 2004 Dodge Ram
1500
Location: Louisiana
Incident Date: June 2016**

INDIANA UNIVERSITY
Transportation Research Center
Remote Non-Traffic Surveillance Hyperthermia Investigation
Case Number: In16035
Location: Louisiana
Vehicle: 2004 Dodge Ram
Incident Date: June 2016

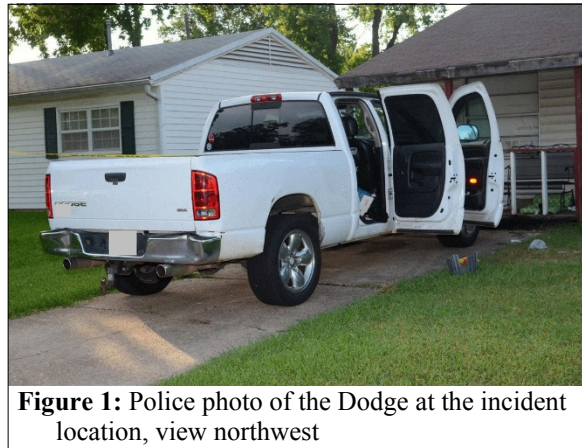
Figure 1: Police photo of the Dodge at the incident location, view northwest

The interest of this investigation is the heat stroke deaths of a 3-year-old female and a 3-year-old male in a parked, unoccupied, 2004 Dodge Ram 1500 (**Figure 1**). This incident investigation was initiated by the National Highway Traffic Safety Administration on September 28, 2016. The qualifying criteria for a hyperthermia case of interest is that the child was not in a child restraint system (CRS) and that the child either entered an unattended vehicle or was left in an unattended vehicle and succumbed to heat stroke. This investigation was assigned on December 6, 2016, following preliminary investigation by the Special Crash Investigation (SCI) Team at the Indiana University Transportation Research Center in

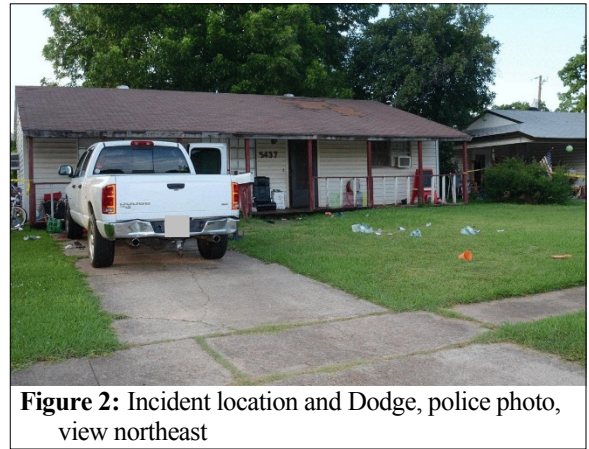
Figure 2: Incident location and Dodge, police photo, view northeast

This incident occurred in a suburban, residential area in a driveway (**Figure 2**) located in front of the children's residence. The weather conditions during the time that the incident likely occurred were clear to scattered thunderstorms with 16 kilometers (10 miles) visibility and variable winds at 6 to 11 km/h (4 to 7 mph).

The Dodge was parked facing northwest in the driveway of the residence immediately in front of the front porch and near the front door. The windows were closed and the doors reportedly locked. Two CRSs were secured in the second row in the left and right seating positions and a booster seat was located between them. The front row right seat position, floor, and second row floor of the vehicle were cluttered with an assortment of trash and items. The vehicle was equipped with second row child safety door locks and the lock on the left rear door was engaged according to the police incident report. The Incident Diagram is included at the end of this report on page 5. The Not-In-Traffic Surveillance data forms are attached to the end of this report as Appendix A.

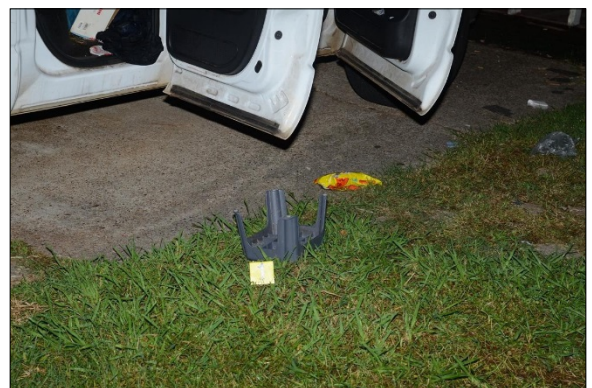
Figure 3: Police photo showing small plastic stool found on right side of Dodge

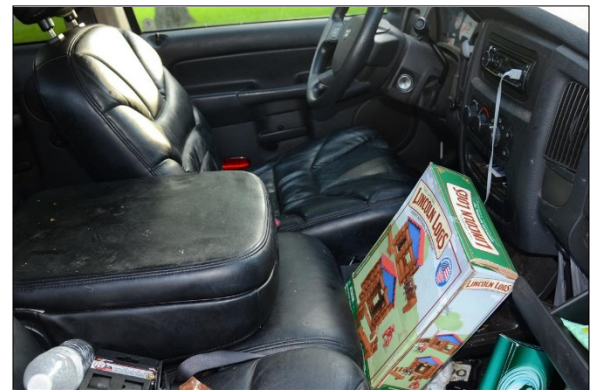
Figure 4: Box of Lincoln Logs in front row of Dodge

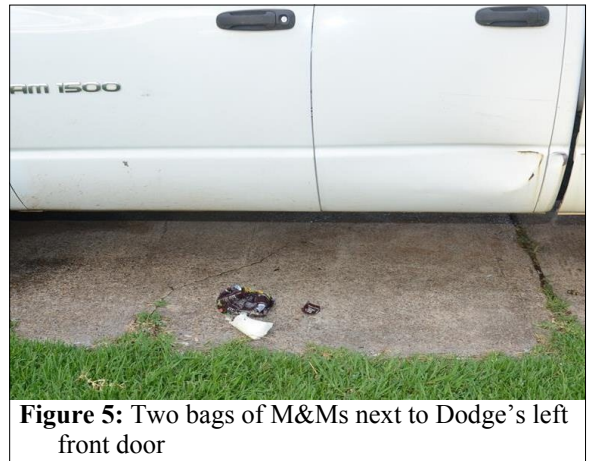
Figure 5: Two bags of M&Ms next to Dodge's left front door

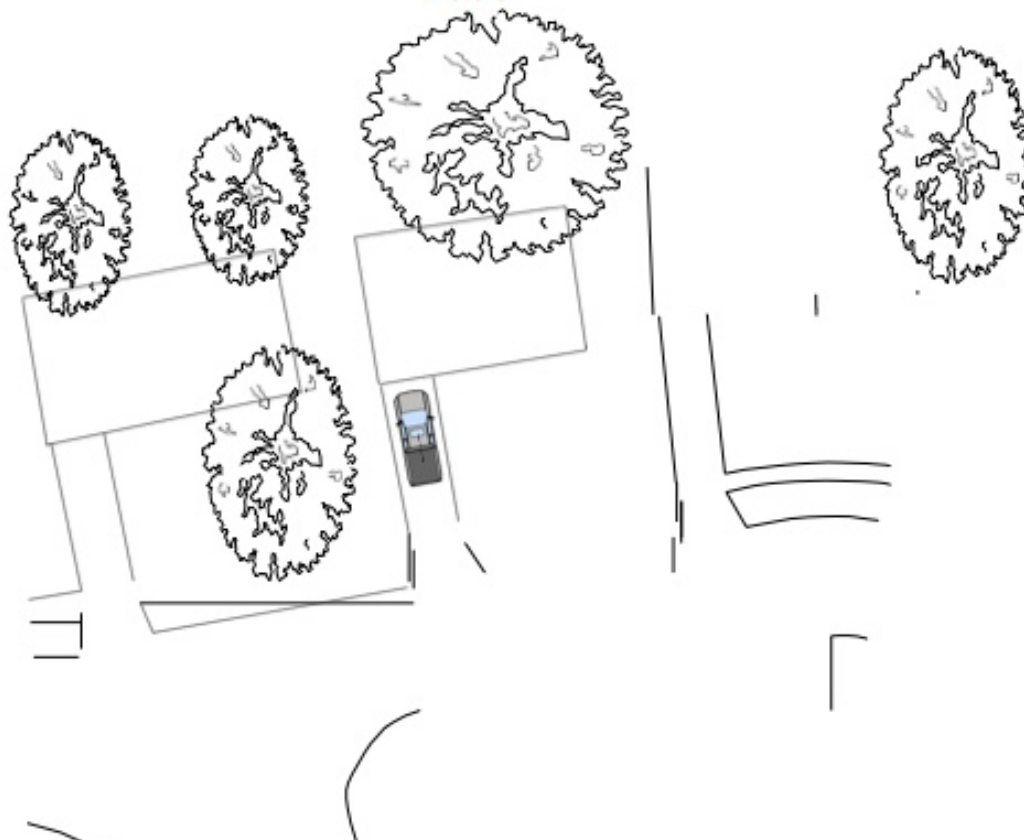
Incident Diagram

Clear to Scattered Thunderstorms

Temperature Range = 31.7 - 33.9 °C (89 - 93 °F)

Heat Index = 38.9 - 42.8 °C (102 - 109 °F)

1 = 2004 Dodge Ram 1500
