Special Crash Investigations Alleged Inadvertent Frontal Air Bag Deployment Crash Investigation

Vehicle: 2014 RAM 1500

Location: Maryland

Crash Date: October 2015

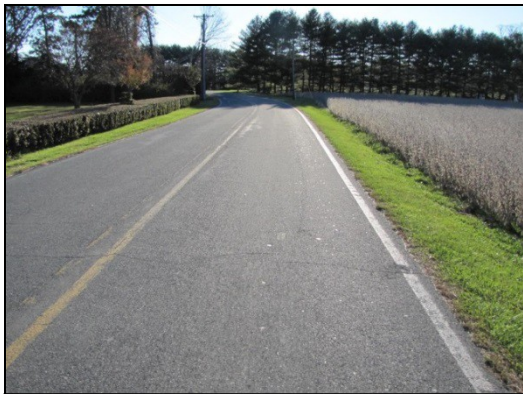
Figure 2: South-facing view of the roadway for the RAM's pre-crash travel trajectory.

On the west side of the roadway was a 1.9 m (6.2 ft) wide grass swale that separated the roadway from an expansive soybean field (**Figure 2**). Near the entrance to the curve was a wooden utility pole located 5.3 m (17.4 ft) west of the roadway edge. The pole was supported by a cable guy wire, which was anchored into the ground by a large steel augured stake. Approximately perpendicular to the roadway in the area of the left curve's exit was a line of trees. They were planted evenly-spaced in two rows, beginning 7.6 m (24.9 ft) west of the roadway edge and extending west along the south side of the soybean field. The individual

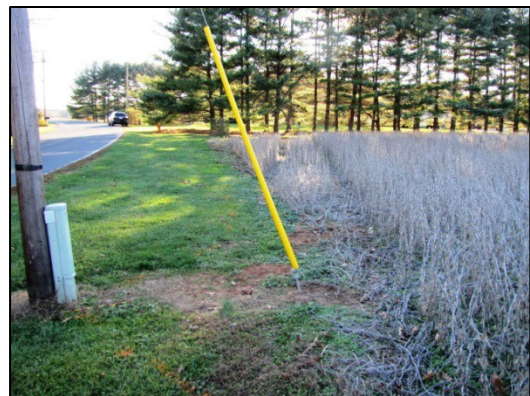
Figure 3: Location of the guy wire (Event 1) impact and the RAM's trajectory through the soybean field.

The first crash event occurred as the front plane of the RAM struck the guy wire in the west roadside. This impact was located 52.6 m (172.6 ft) along the RAM's travel path from the roadway's edge (**Figure 3**). Associated forces deformed the guy wire's steel ground anchor and sheared the guy wire from the ground anchor's eyelet, but didn't affect the RAM's trajectory or induce a kinematic response from the driver. The RAM maintained its forward trajectory and continued south through the soybean field. The RAM exited the south side of the soybean field, traversed across a 4.0 m (13.1 ft) wide lawn area, and approached the line of trees. The second impact event occurred as the front plane of the RAM struck a large diameter tree in the first row, 36.6 m (120.0 ft) from the previous guy wire impact (in a straight-line trajectory). The struck tree was located 94.5 m (310 ft) south of the RAM's initial roadside departure, 14.5 m (47.6 ft) west of the roadway. Associated forces sheared the tree's roots and trunk immediately below ground level, which displaced the tree and deformed multiple front plane components of the RAM. Corresponding engagement induced a clockwise rotation to the RAM as it maintained forward momentum.

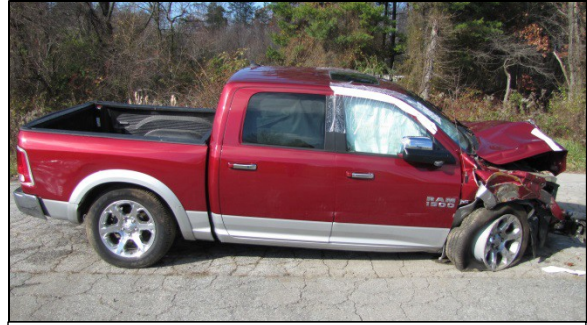
Figure 5: Right plane view of the 2014 RAM 1500.

The RAM (**Figure 5**) was powered by a 5.7 liter V-8 gasoline engine linked to an 8-speed automatic transmission. The vehicle had a 356 cm (140.0 in) wheelbase with a gross vehicle weight rating of 3,130 kg (6,900 lb). Both the front and rear gross axle weight ratings were 1,770 kg (3,900 lb). According to the registration information, the RAM's curb weight was 2,530 kg (5,578 lb). The vehicle manufacturer's recommended tire size was P275/60R20 front and rear, with recommended cold tire pressures of 269 kPa (39 PSI). At the time of the SCI inspection, the RAM was equipped with Goodyear Wrangler SR-A tires of the recommended size mounted on all four wheels OEM aluminum-alloy wheels. The tires had matching Tire Identification Numbers of M6YN JD1R 3414. Specific tire data at the time of the SCI inspection were as follows.

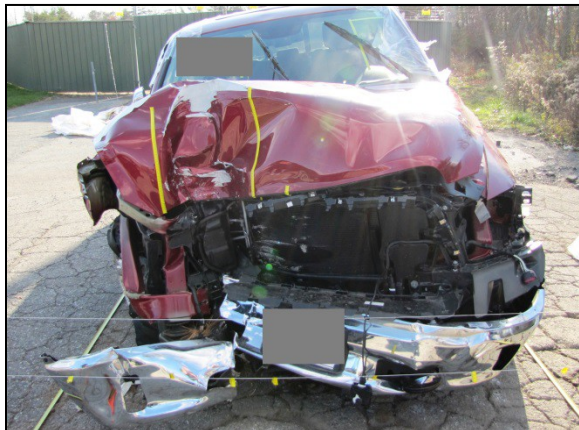
Figure 6: View of the RAM's front crush profile and the Event 2 deformation pattern.

Direct contact damage associative to the first large diameter tree impact (Event 2) measured 36 cm (14.2 in) in width. It began on the leading edge of the hood, 17 cm (6.7 in) right of center, and extended to the right. This damage was a distinct U-shaped deformation that represented the shape and size of the large diameter tree. In the damage pattern, the front bumper beam, hood, and surrounding components were deformed longitudinally (**Figure 6**). The grille and polymer bumper trim were disintegrated and separated from the vehicle. Underhood components, inclusive of the radiator support and heat exchanger, were also

deformed rearward. The steel bumper beam was partially fractured in the area of greatest deformation.

With exception to the minor severity guy wire event, Event 2 was the only impact to the RAM's frontal plane that was located between the vehicle's frame rails. Therefore, a residual crush profile documented to the RAM's deformed bumper beam produced valid measurements from the C1 through C5 locations. Using a direct and induced damage (Field-L) width of 172 cm (67.7 in) across the end width of the RAM's front bumper beam, the crush profile produced the following resultant measurements: C1–C2 = 0 cm (0 in), C3 = 9 cm (3.5 in), C4 = 24 cm (9.5 in), C5 = 1 cm (0.4 in), and C6 = 0 cm (0 in). Maximum crush measured 40 cm (15.7 in), located 30 cm (11.8 in) right of center between C4 and C5. The CDC assigned to the RAM for the Event 2 damage pattern was 12FZEN2. Using the damage algorithm of the WinSMASH model, a reconstruction of the Event 2 impact was performed. The calculated velocity change (ΔV) was 18 km/h (11.2 mph), with respective longitudinal and lateral components of -18 km/h (-11.2 mph) and zero. These results appeared reasonable.

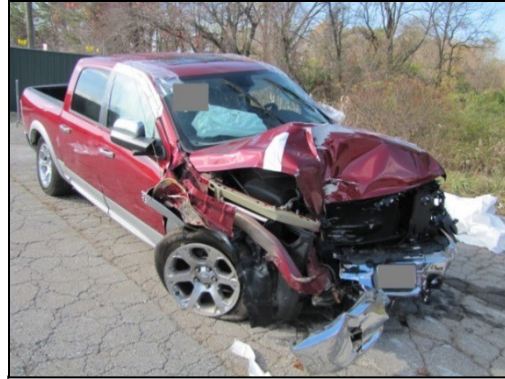
The second large diameter tree impact (Event 3) was located on the right aspect of the front plane, outboard of the right frame rail. In the damage pattern, the front bumper beam was deformed, the right headlight assembly was disintegrated, and the right front fender was crushed longitudinally and laterally. Suspension components of the right front wheel/axle position were fractured and deformed rearward, and the right front tire was deflated.

Figure 7: Front right oblique view of the RAM and the damage associative to Event 3.

Figure 7 depicts an oblique view of the RAM and the Event 3 damage. It should be noted that the right corner of the RAM's bumper beam was deformed forward during the vehicle's recovery from in-between the trees. No crush measurements could be obtained for the side-swiping-type Event 3 damage. The CDC assigned to the RAM for the Event 3 impact was 12FRES5. Due to the location of the impact, insufficient deformation data, and the sideswiping nature of the damage pattern, no WinSMASH calculations for Event 3 could be performed.

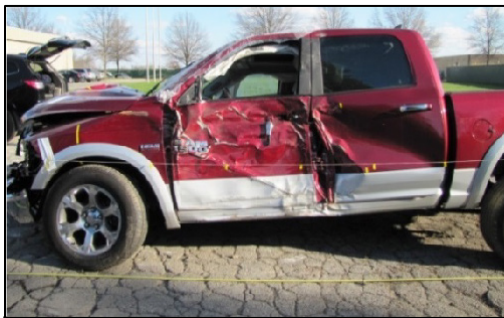
Figure 8: Left plane view of the RAM and the Event 4 deformation pattern from the third tree impact.

Damage from the third large diameter tree impact (Event 4) was located on the RAM's left plane. Direct contact began 10 cm (3.9 in) forward of the left front axle position and extended 222 cm (87.4 in) rearward to 148 cm (58.3 in) forward of the left rear axle position on the left rear door. In the damage pattern was lateral deformation to the left front fender and both left doors, with corresponding occupant compartment intrusion (**Figure 8**). The left front glazing was disintegrated by the Event 4 impact. Using a Field-L of 282 cm (111.0 in) from 10 cm (3.9 in) forward of the left

front axle position to the rear edge of the left rear door, a residual crush profile was documented using the body contour method. This produced the following resultant measurements: C1 = 0 cm (0 in), C2 = 8 cm (3.1 in), C3 = 16 cm (6.3 in), C4 = 10 cm (3.9 in), C5 = 4 cm (1.6 in), and C6 = 0 cm (0 in). Maximum crush was observed at the C3 measurement location on the left front door. The CDC assigned to the RAM for the Event 4 damage profile was 11LYAW2. A borderline reconstruction of the Event 4 impact was performed for analysis purposes using the barrier algorithm of the WinSMASH model. The calculated velocity change (ΔV) was 14 km/h (8.7 mph), with respective longitudinal and lateral components of -14 km/h (-8.7 mph) and 5 km/h (3.1 mph). These results appeared to be reasonable.

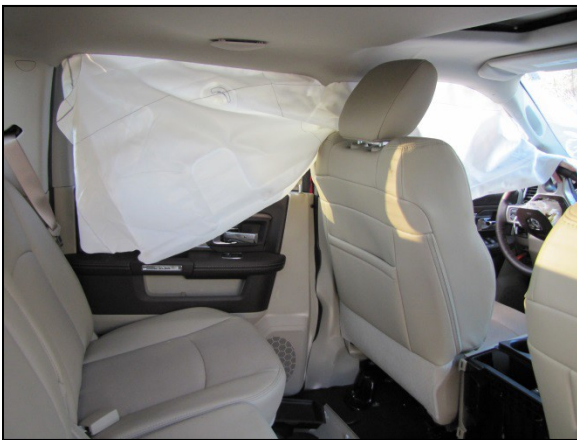
The interior of the RAM was inspected for crash-related damage that consisted of passenger compartment intrusion and occupant contact. Intrusion into the RAM's interior was associated with the fourth impact event with the third large diameter tree on the left plane of the vehicle. This consisted of lateral intrusion of the left front door, left B-pillar, and left rear door. Measured maximum magnitudes of the intrusions were 12 cm (4.7 in), 7 cm (2.8 in), and 11 cm (4.3 in), respectively. In their intruded states, the left front door and the left B-pillar were engaged against the left aspects of the driver's seat cushion and seat back (**Figure 10**).

Figure 10: View of the RAM's interior and the left B-pillar engaged against the driver's seat.

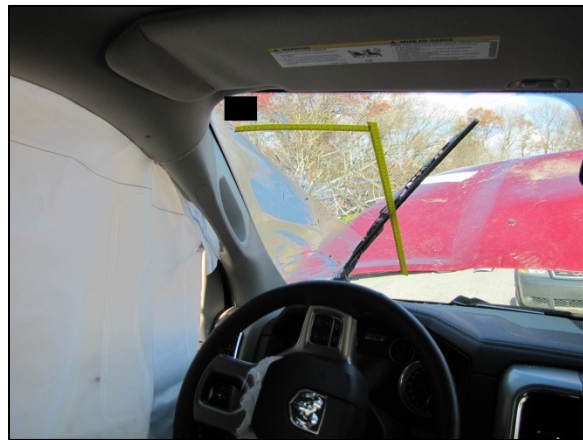
Figure 11: Fracture pattern to the windshield glazing resultant from driver contact during the crash.

Occupant contact in the RAM was identified on frontal components, associative to the multiple event crash sequence. There was a 3 cm (1.2 in) tall by 4 cm (1.6 in) wide scuff on the right aspect of the left lower instrument panel, attributable to contact and loading from the driver's right knee. A large fracture was also observed to the windshield glazing above and slightly left of the steering wheel (**Figure 11**), attributable to contact and loading from the unrestrained driver's head/face. All of the vehicle's doors remained closed during the crash. Both left doors were jammed shut by deformation relative to the Event 4 impact, while both right doors remained operational. Aside from the occupant contact to the windshield and the disintegration of the left front glazing relative to the Event 4 impact, none of the vehicle's glazing was damaged during the crash.

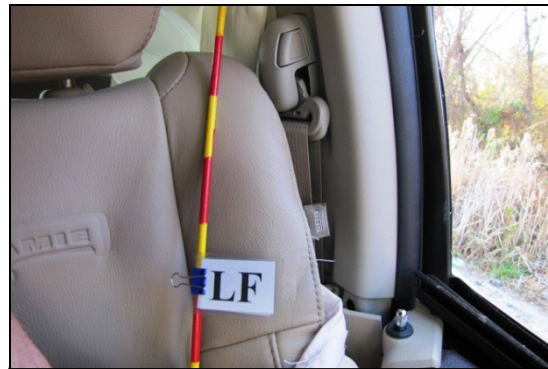
The webbing of the driver's seat belt system was observed during the SCI vehicle inspection with the retractor locked in position as a result of pretensioner actuation. The webbing was pulled taut and compressed between the intruded B-pillar and the driver's seatback (**Figure 12**). Based on the post-crash condition of the driver's seat belt system observed during the SCI inspection, and in conjunction with the data imaged from the RAM's EDR, it was apparent that the driver's seat belt system was not in use at the time of the crash.

Figure 12: The RAM driver's 3-point lap and shoulder seat belt system.

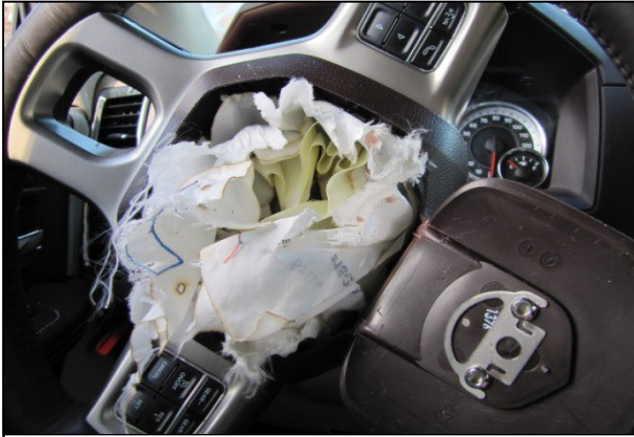
At the time of the SCI vehicle inspection, an unknown individual had cut driver's frontal air bag fabric and removed it from the vehicle. The driver's frontal air bag deployed from the steering wheel hub-mounted module through the cover flaps. The driver provided a post-crash image of the deployed driver's frontal air bag. No dimensions of the air bag were available. The image provided by the RAM's driver depicted multiple areas of blood on the fabric, attributable to the facial lacerations sustained as a result of the driver's contact with the windshield glazing. There was no evidence of occupant contact to the steering wheel or the remnants of the air bag at the time of the SCI vehicle inspection.

Figure 13: Driver frontal air bag fabric cut from the module in the RAM at the time of the SCI inspection.

Figure 13 depicts the remnants of the driver's frontal air bag at the time of the SCI vehicle inspection, while **Figure 14** depicts the deployed driver air bag in an image supplied to the SCI investigator by the RAM's driver.

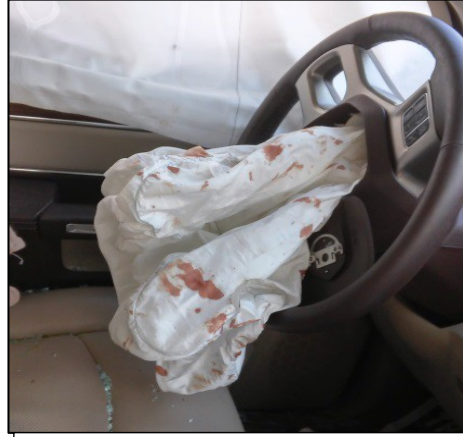
Figure 14: Deployed driver frontal air bag in the RAM. Image supplied by the driver.

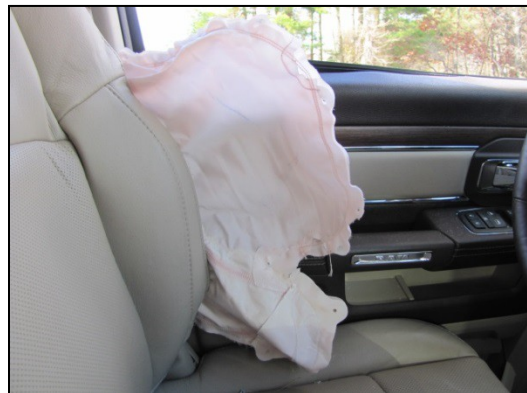
The driver's seat-mounted side-impact air bag (**Figure 15**) deployed through 56 cm (22.0 in) of stitching on the leading outboard aspect of the seatback. The air bag consisted of two primary fill portions: an upper portion and a lower portion. In their deflated states, the upper portion of the air bag measured approximately 27x30 cm (10.6x11.8 in) and the lower portion measured approximately 25x20 cm (9.8x7.9 in) in width by height, respectively. A vent was located at both the forward upper aspect and forward lower aspect of the air bag's upper portion. There was no discernable occupant contact to the face of the driver's seat-mounted air bag.

Figure 15: Deployed driver's seat-mounted side impact air bag in the 2014 RAM 1500.

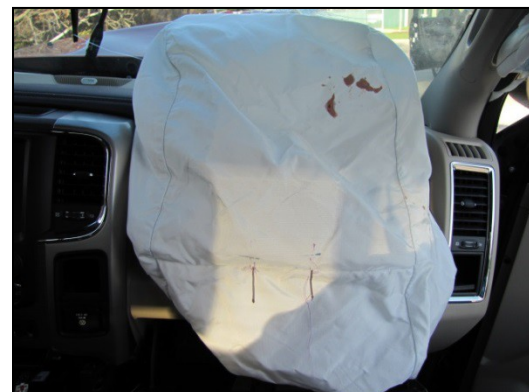
The front right air bag deployed from the right upper instrument panel-mounted module through the H-configuration cover flaps without damage. In its deflated state, the air bag measured 36 cm (14.2 in) wide and 56 cm (22.0 in) in height. The air bag extruded a maximum of 40 cm (15.7 in) rearward at its center aspect. A 6 cm (2.4 in) diameter vent was located on each side of the air bag. Several spots of blood were visible on the deflated front right air bag (**Figure 16**), attributable to contact from the driver

Figure 16: Deployed front right air bag in the RAM.

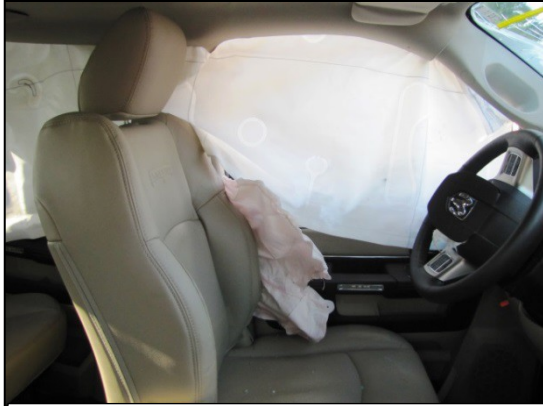
Figure 17: Left IC air bag and deployed driver's seat-mounted air bag in the 2014 RAM 1500.

The IC air bags deployed from the roof side rails through the edge of the headliner and provided protection for all outboard positions of the RAM. In their deflated states, the IC air bags measured 230 cm (90.6 in) in overall length. They were affixed to their respective upper A-pillars by a 14 cm (5.5 in) fabric tether. The IC air bags provided 60 cm (23.6 in) of vertical coverage at the front row and second row positions, and 52 cm (20.5 in) of vertical coverage at the B-pillar. There was no discernable occupant contact to either of the IC air bags.

Figure 17 depicts the left IC air bag and its coverage for the driver.

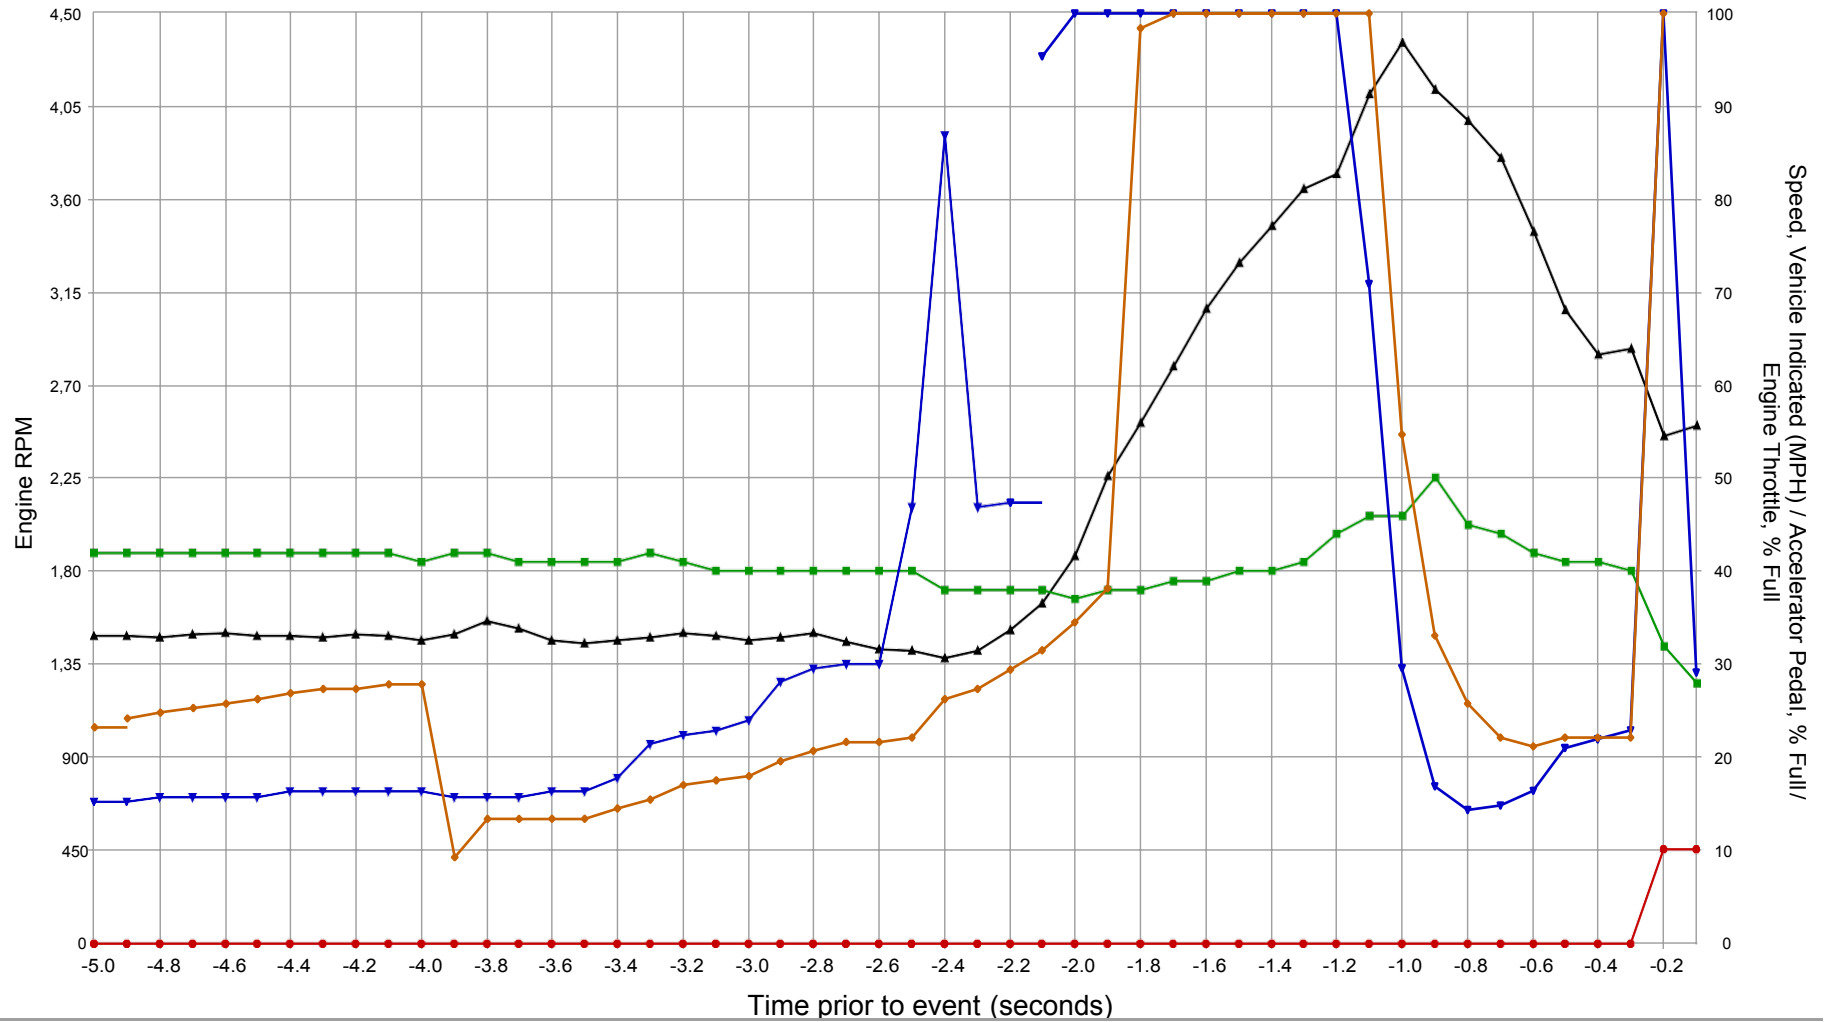
Pre-Crash Data (Most Recent Event)

▲ Engine RPM ■ Speed, Vehicle Indicated (MPH) ● Service Brake (0=Off/10=On) ▼ Accelerator Pedal, % Full ◆ Engine Throttle, % Full
