DOT HS 812 566

**Special Crash Investigations  
On-Site Small Overlap/Oblique  
Impact Investigation  
Vehicle: 2015 Chrysler 200  
Location: Missouri  
Crash Date: September 2016**

**INDIANA UNIVERSITY**  
**TRANSPORTATION RESEARCH CENTER**  
**ON-SITE SMALL OVERLAP/OBLIQUE IMPACT INVESTIGATION**  
CASE NUMBER - IN16026  
LOCATION - MISSOURI  
VEHICLE - 2015 CHRYSLER 200  
CRASH DATE - SEPTEMBER 2016

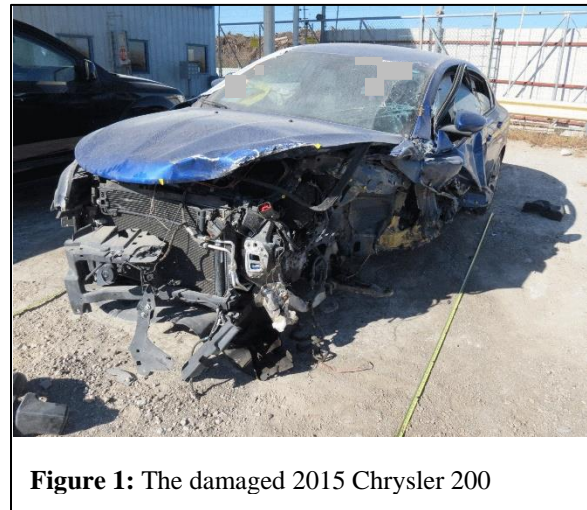
**Figure 1:** The damaged 2015 Chrysler 200

The interest of this on-site investigation is the small overlap/oblique impact to a 2015 Chrysler 200 (**Figure 1**) and the injuries sustained by the driver. This crash investigation was initiated by the National Highway Traffic Safety Administration on November 8, 2016, after the crash was identified by the Special Crash Investigation (SCI) team at the Indiana University Transportation Research Center through an online search of Missouri crash report abstracts. This investigation was assigned on November 10, 2016, when permission for the vehicle inspection was obtained from the insurance company. This crash occurred in September 2016, at 1115 hours, in Missouri and was investigated by a local police agency. The crash involved the Chrysler and a 2002 Ford Taurus. The Chrysler, Ford, and crash scene were inspected on November 15 and 16, 2016. The driver of the Chrysler refused the SCI request for an interview.

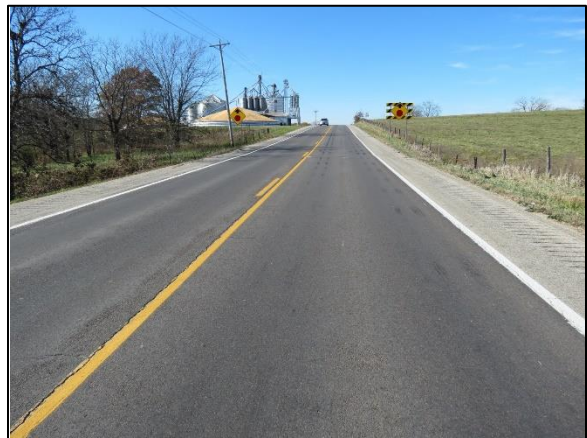
**Figure 2:** Westbound approach of the Chrysler

The Ford was traveling east in the eastbound lane and the driver intended to continue eastbound. The Chrysler was traveling west in the westbound lane (**Figure 2**) at an EDR-reported speed of 107 km/h (67 mph) at -5.0 sec prior to algorithm enable (AE). The vehicle then gradually decelerated with the brake switch circuit reported as “On” to -3.2 sec at which point the speed was 98 km/h (61 mph). The EDR-reported steering input at -3.2 sec also indicated a gradual left steering input, suggesting the driver was possibly distracted or beginning to fall asleep. The vehicle continued to decelerate to 84 km/h (52 mph) at -0.1 sec, which was the end of the pre-crash recording. A witness, who was traveling behind the Chrysler, stated that the Chrysler drifted into the Ford’s travel lane.

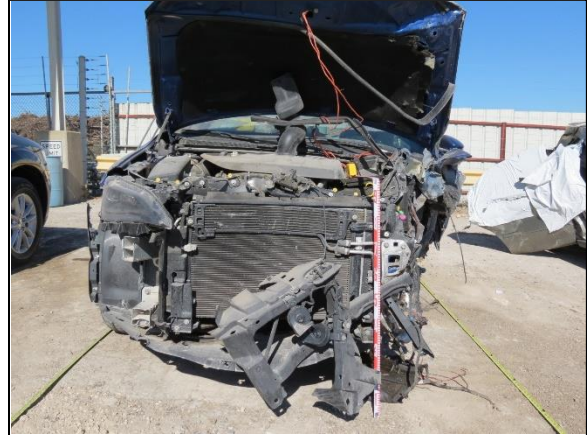
**Figure 3:** Damage to the front plane of the Chrysler from impact with the front plane of the Ford

The front left corner of the Chrysler (**Figure 3**) struck the front left corner of the Ford (**Figure 4**, event 1). The impact occurred 2.2 m (7.2 ft) into the Ford’s travel lane. The force direction on the Chrysler was within the 12 o’clock sector and the impact resulted in stage 1 - 3 deployment of both of the vehicle’s frontal air bags. Both knee, left IC, and driver’s seat-mounted side

The entire front plane and front half of the left plane sustained direct and induced damage during the impact with the front plane of the Ford. The direct damage on the front plane of the Chrysler involved the left portion of the front bumper, headlamp/turn signal assembly, grille, and hood. The direct damage also extended down the left plane involving the fender, left front wheel, which was displaced from the vehicle, and the left front door. The direct damage to the front plane began at the left corner of the front bumper and was estimated to be 61 cm (24 in) long. The estimation was based on the direct damage to the hood since the bumper bar, bumper fascia, and most of the structure forward of the radiator were displaced from the vehicle and not present at the SCI vehicle inspection. Measurements of the crush to the front plane were also not possible due to these missing components.

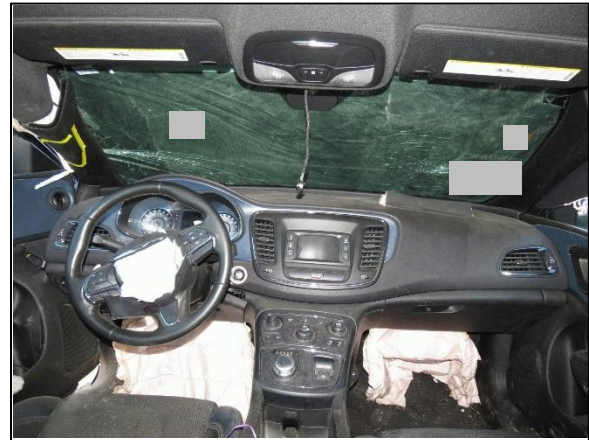
**Figure 6:** Overview of occupant contact of left A- pillar (yellow tape), steering wheel, and instrument panel

The driver was not restrained by the lap and shoulder safety belt. The seat track was adjusted between the middle and rear-most positions and the seat back was reclined 30 degrees aft of vertical. The front plane impact to the Chrysler resulted in a stage 1 - 3 deployment of the driver's frontal air bag. The driver's seat-mounted side impact, knee, and the left IC air bags also deployed. The impact displaced the driver forward and to the left and his face and chest loaded the frontal air bag and his knees loaded the knee air bag. The driver continued forward and to the left and his head contacted the left A-pillar resulting in a concussion with brief loss of consciousness. The driver's left knee loaded through the knee air bag and contacted the lower left instrument panel resulting in a contusion and laceration to the knee. The driver then rebounded and was redirected to the right as the vehicle rotated CCW and decelerated to final rest. The driver's medical records reported that he was out of the vehicle and walking when emergency responders arrived at the crash scene. The left front door was jammed shut, so the driver probably exited the vehicle through the right front door. It is not known if he exited under his own power or with assistance. The driver was transported by ambulance to a hospital where he was treated in the emergency room for moderate severity injuries and released.

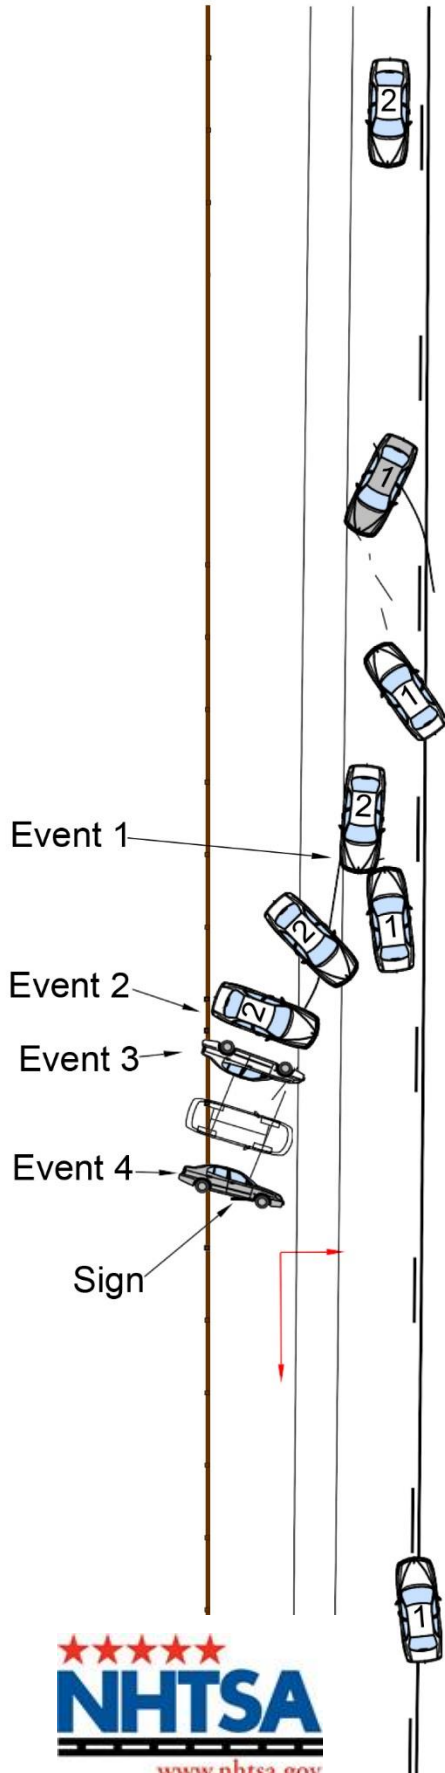
# CRASH DIAGRAM DETAIL VIEW

Daylight, Clear and Dry  
Bituminous Roadway  
Speed Limit = 97km/h (60 mph)

1 = 2015 Chrysler 200  
2 = 2003 Ford Taurus

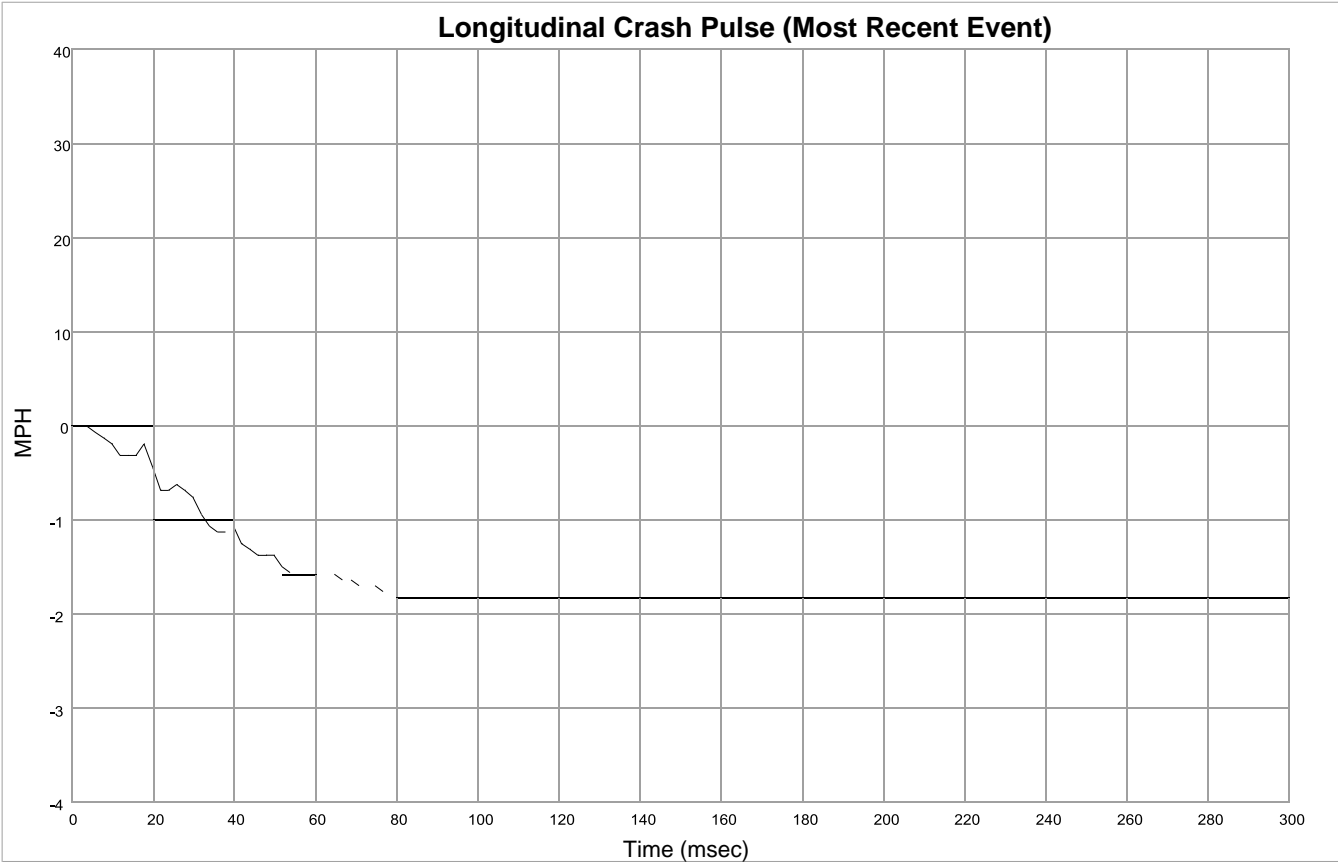
### Longitudinal Crash Pulse (Most Recent Event)

Time (msec)	Delta-V, Longitudinal (MPH [km/h])
0	0.0 [0]
2	0.0 [0]
4	0.0 [0]
6	-0.6 [-1]
8	-1.2 [-2]
10	-1.9 [-3]
12	-3.1 [-5]
14	-3.1 [-5]
16	-3.1 [-5]
18	-1.9 [-3]
20	-4.3 [-7]
22	-6.8 [-11]
24	-6.8 [-11]
26	-6.2 [-10]
28	-6.8 [-11]
30	-7.5 [-12]
32	-9.3 [-15]
34	-10.6 [-17]
36	-11.2 [-18]
38	-10.6 [-17]
40	-10.6 [-17]
42	-12.4 [-20]
44	-13.0 [-21]
46	-13.7 [-22]
48	-13.7 [-22]
50	-13.7 [-22]
52	-14.9 [-24]
54	-15.5 [-25]
56	-15.5 [-25]
58	-16.2 [-26]
60	-16.2 [-26]
62	-16.2 [-26]
64	-16.2 [-26]
66	-16.8 [-27]
68	-16.8 [-27]
70	-17.4 [-28]
72	-17.4 [-28]
74	-17.4 [-28]
76	-18.0 [-29]
78	-18.0 [-29]
80	-18.0 [-29]
82	-18.0 [-29]
84	-18.0 [-29]
86	-18.0 [-29]
88	-18.0 [-29]
90	-18.0 [-29]
92	-18.0 [-29]
94	-18.0 [-29]
96	-18.0 [-29]
98	-18.6 [-30]

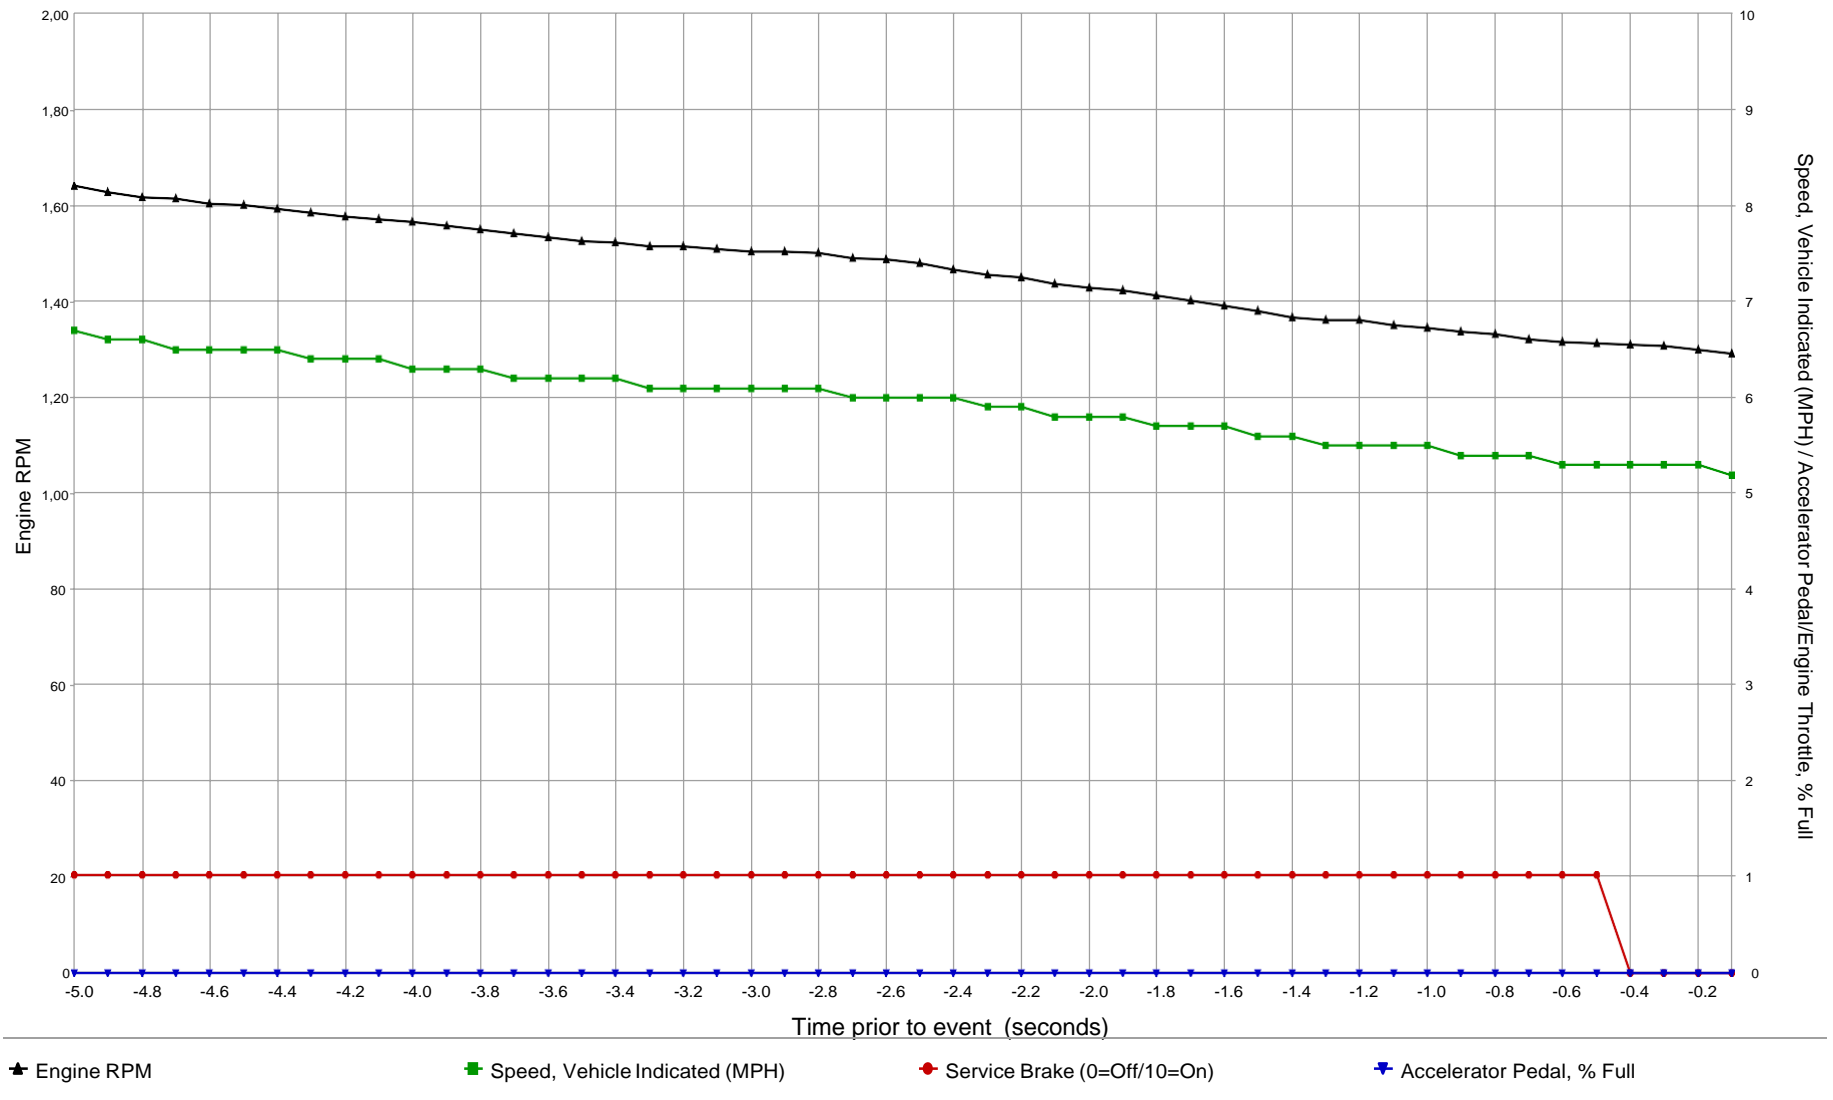
**Pre-Crash Data (Most Recent Event)**

SNA values will not be plotted on the graph
