Special Crash Investigations On-Site Rollover Investigation

**Vehicle: 2016 GMC Yukon
Denali**

Location: Florida

Crash Date: October 2016

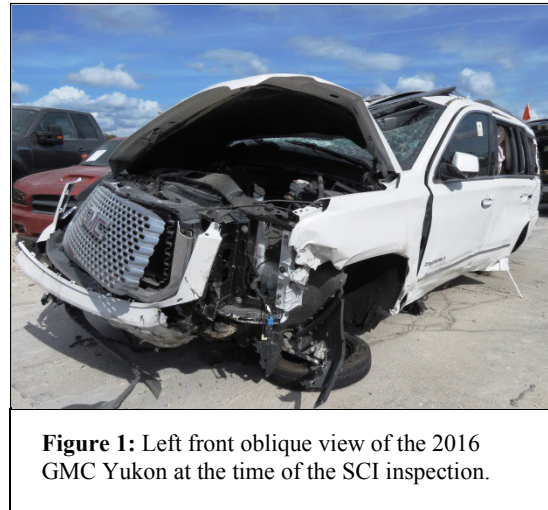
Figure 1: Left front oblique view of the 2016 GMC Yukon at the time of the SCI inspection.

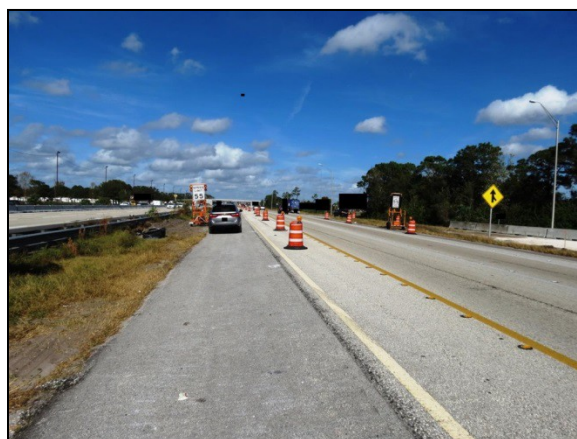
Figure 2: Northbound trajectory view of the crash site at the time of the SCI inspection.

ft) wide grass median. The median barrier consisted of 10x15 cm (4x6 in) steel I-beam posts that were spaced on 1.8 m (6.0 ft) nominal centers with composite block outs on both sides of the posts. The barrier was offset in the median, located 5.4 m (17.7 ft) from the edge of the northbound lanes' west shoulder. The northbound travel lanes were all approximately 3.7 m (12.1 ft) in average width, delineated by broken white lane lines, a single solid-yellow median edge line, and a single solid-white right edge line. Tactile warning (rumble strips) were cut into the shoulders immediately outboard of the travel lane edge lines. The median (west) shoulder was 2.2 m (7.2 ft) in width, while the emergency (east) shoulder was 3.6 m (11.8 ft) wide. All travel lanes and shoulders were bituminous (asphalt) surfaced. The roadway was straight and level in the vicinity of the crash, with a normal (non-construction) posted speed limit of 113 km/h (70 mph).

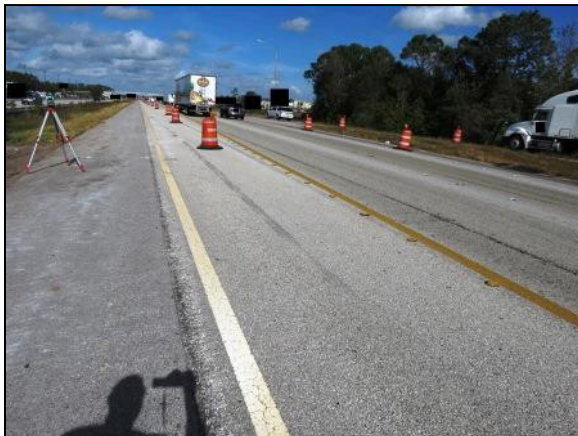
The first impact event occurred as the front right corner area of the RAM struck the left rear corner of the GMC. Directions of force were in the 1 o'clock sector for the RAM and the 7 o'clock sector for the GMC. The brief engagement of the vehicles induced a counterclockwise rotation to the GMC as its center of gravity continued in a northerly direction. This impact event resembled a PIT maneuver,¹ displacing the GMC from its tracking trajectory. Following the initial impact, the RAM initiated emergency braking and was brought to a controlled stop straddling the yellow edge line of the left travel lane. This was evidenced by two braking tire marks on the roadway surface that measured 47.1 m (154.5 ft) in length (**Figure 3**).

Figure 3: Northbound view of the braking tire marks from the RAM.

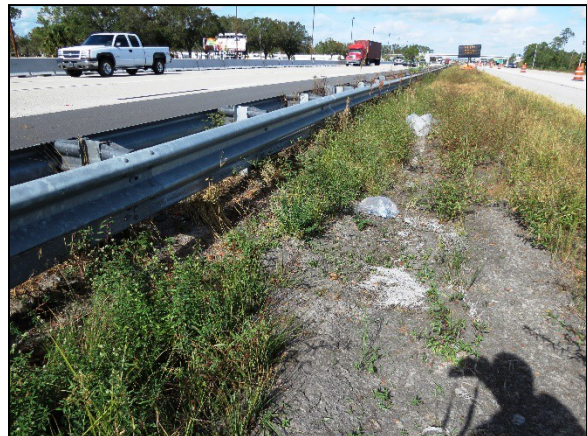
Figure 4: Northwest-facing view of the guardrail barrier system, replaced following the crash.

The GMC entered a counterclockwise yaw and traversed across the left travel lane, over the left shoulder, and into the grass median. As it maintained the counterclockwise rotation, it began to achieve a right side-leading attitude. The GMC's front plane then struck the face of the guardrail barrier system (Event #2), with an 11 o'clock direction of force. **Figure 4** depicts the replaced section of guardrail at the time of the SCI crash site inspection. According to data imaged from the GMC's EDR, the driver initiated braking action approximately 1.5 seconds prior to impact. The EDR-reported speed of the GMC at impact with the guardrail barrier system was 100 km/h (62 mph).

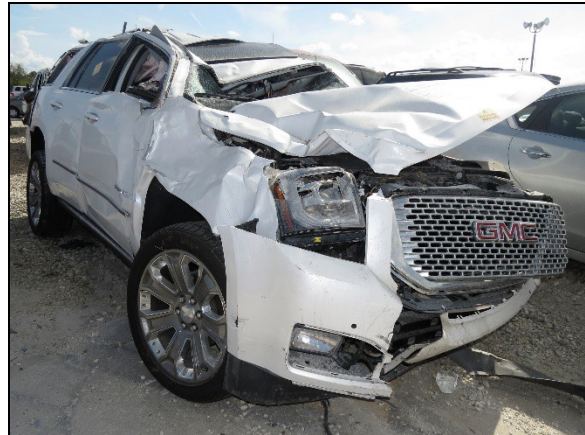
The 2016 GMC Yukon (**Figure 6**) was a sport utility vehicle (SUV) manufactured in November 2015 and identified by the VIN 1GKS1CKJ9GRxxxxxx. A reading from the vehicle's electronic odometer could not be obtained during the SCI inspection due to electrical system inoperability. The rear-wheel drive GMC had a 295 cm (116 in) wheelbase. It was powered by a 6.2-liter, V-8 gasoline engine linked to an 8-speed automatic transmission, with a column-mounted shifter. A placard declared that the GMC's gross vehicle weight rating (GVWR) was 3,221 kg (7,100 lb). Front and rear gross axle weight ratings (GAWR) were 1,452 kg (3,200 lb) and 1,905 kg (4,200 lb), respectively. The GMC's curb weight was 2,487 kg (5,482 lb).

Figure 6: Front right oblique view of the 2016 GMC Yukon at the time of the SCI vehicle inspection.

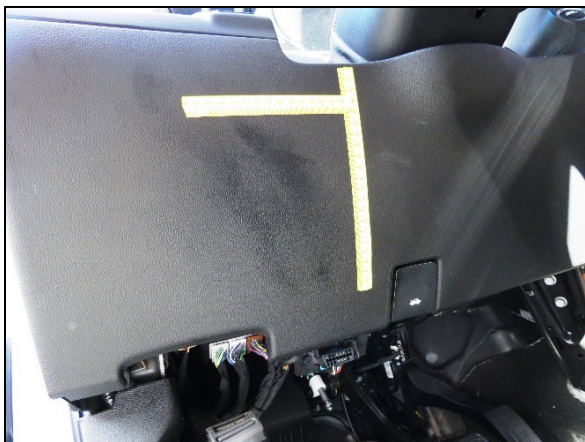
The interior of the GMC sustained significant damage that included intrusion of multiple components as a result of exterior deformation incurred during the Event 2 rollover. Although the combination of the driver’s seat belt usage and the deployment of multiple air bags limited the driver’s contact with interior components, minor contact evidence from the driver was documented in the vehicle’s interior. The driver contacted the left IC air bag, resulting in a blood stain at the middle aspect of the IC air bag at the driver’s position. Further contact evidence included a scuff to the lower instrument panel/knee bolster left of the steering column from the driver’s left knee (**Figure 11**).

Figure 11: Driver left knee contact to the left lower instrument panel.

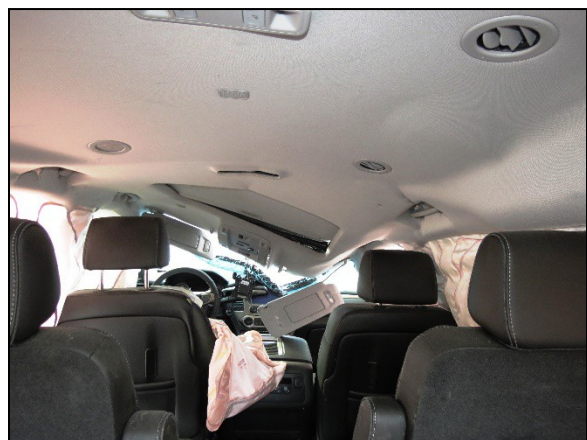
Figure 12: Forward-facing view of the GMC’s interior depicting the significant vertical intrusion of the roof.

Intrusions into the occupant compartment of the GMC included vertical, lateral, and longitudinal displacement of the roof structure. Maximum intrusion was observed to the roof above the front row center position (**Figure 12**), which measured 32 cm (12.6 in) in magnitude. Additional intrusions documented during the SCI inspection included:

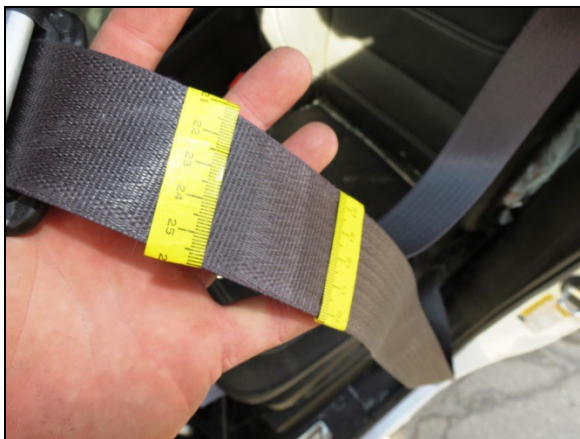
Figure 13: Frictional abrasion on the GMC’s lap belt webbing from driver loading against the latch plate.

Frictional abrasions to the driver’s manual seat belt system at the location of the D-ring and the latch plate evidenced driver loading. Latch plate loading evidence was located 76-81 cm (29.9-31.9 in) above the floor anchor (**Figure 13**). The D-ring abrasion was located 158 cm (62.2 in) above the referenced floor anchor. At the time of the SCI inspection, the webbing was locked in the worn position as a result of retractor pretensioner actuation. In total, a length of 158 cm (62.2 in) of excess webbing was extended from the retractor,

consistent with driver usage. It was apparent to the SCI investigator, based on the post-crash condition of the seat belt webbing and corroborated by the imaged EDR data, that the driver was restrained by the manual seat belt system at the time of the crash.

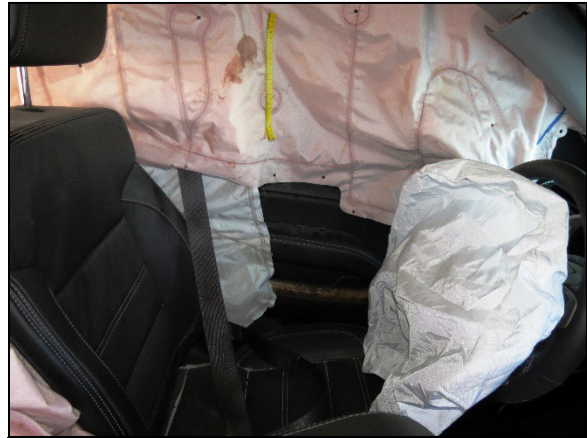
The GMC was equipped with multiple inflatable supplemental restraints. The first of these systems was a Certified Advanced 208-Compliant (CAC) frontal air bag system for the driver and front row right positions. It consisted of a steering wheel hub-mounted driver air bag and a top instrument panel-mounted passenger's frontal air bag. The CAC system incorporated seat belt buckle switch sensors, a front right occupant presence (weight) sensor, and front seat belt retractor pretensioners. Additional occupant protection in the GMC consisted of front seat-mounted side impact air bags, a center air bag mounted in the right aspect of the driver's seat, and dual sensing roof side rail-mounted IC air bags. The driver's frontal, both driver's seat-mounted, and both IC air bags deployed during the crash (**Figure 14**).

Figure 14: View of the deployed driver's frontal, driver's seat-mounted side-impact, left IC, and center seat-mounted air bags within the GMC.

The driver's frontal air bag deployed from the steering wheel hub-mounted module without damage or occupant contact to the module cover flaps. In its deflated state, the air bag measured 70 cm (27.6 in) in overall diameter. It was tethered internally with an oval shape stitch pattern on the face of the air bag that measured 16 x 8 cm (6.4 x 3.2 in). In its deflated state, the rearward excursion at the tether stitching was 34 cm (13.4 in). Two 5 cm (2.0 in) vent ports were located on the back side of the air bag at the 11 and 1 o'clock sectors. There was no damage or evidence of driver contact to the frontal air bag. A label identified the air bag as the following: "GM K2 XX DAB," "P621505800GG09," and "JTJ5X2S1BCM."

The front left seat-mounted side impact air bag deployed from the outboard aspect of the driver's seatback. The seat seam separated over a vertical length of 55 cm (21.7 in). In its deflated state, the air bag measured 62 cm (24.4 in) tall by 30 cm (11.8 in) wide. There was an 8 cm (3.2 in) vent port at the upper forward aspect of the air bag. No damage or contact evidence to the air bag was discernable. Identifying nomenclature on the air bag included: "AUTOLIV AIRBAG MODULE," "(0080) 0080.P1.12.0003," "SAB ASP-2 AQW," "625569101C L," "23425293," "4730701000000L," "813016342," and "UU152945293S01431."

The center seat-mounted air bag deployed through the right aspect of the driver's seatback with 55 cm (21.7 in) of separation of the stitching. Deflated, the air bag measured approximately 66 cm (26.0 in) in height and 48 cm (18.9 in) in width (longitudinal). This air bag provided protection against occupant-to-occupant interaction. There was no damage or contact evidence to the

The left and right IC air bags deployed from the roof side rails through the headliner. In their deflated states, both air bags measured approximately 277 cm (109.1 in) in overall length, extending from the A-pillar to the D-pillar. Although a small void existed at the location of the A-pillar, an externally sewn wide band tether was present between the IC air bag and the mid aspect of the upper A-pillar to fill this void. The vertical coverage of the IC air bags extended below the level of the beltline. At the mid aspect of the front row seat positions, the IC air bag measured 62 cm (24.4 in) in height. It was 54 cm (21.3 in) in height at the B-pillar, 58 cm (22.8 in) in height at the mid aspect of the second row, and 56 cm (22.0 in) in height between the C-pillar and D-pillar across the third row. A blood stain was present at the mid aspect of the left IC air bag adjacent to the driver’s position, covering 10 x 20 cm (4.0 x 8.0 in) area. There were no physical restrictions or damage to the IC air bags.

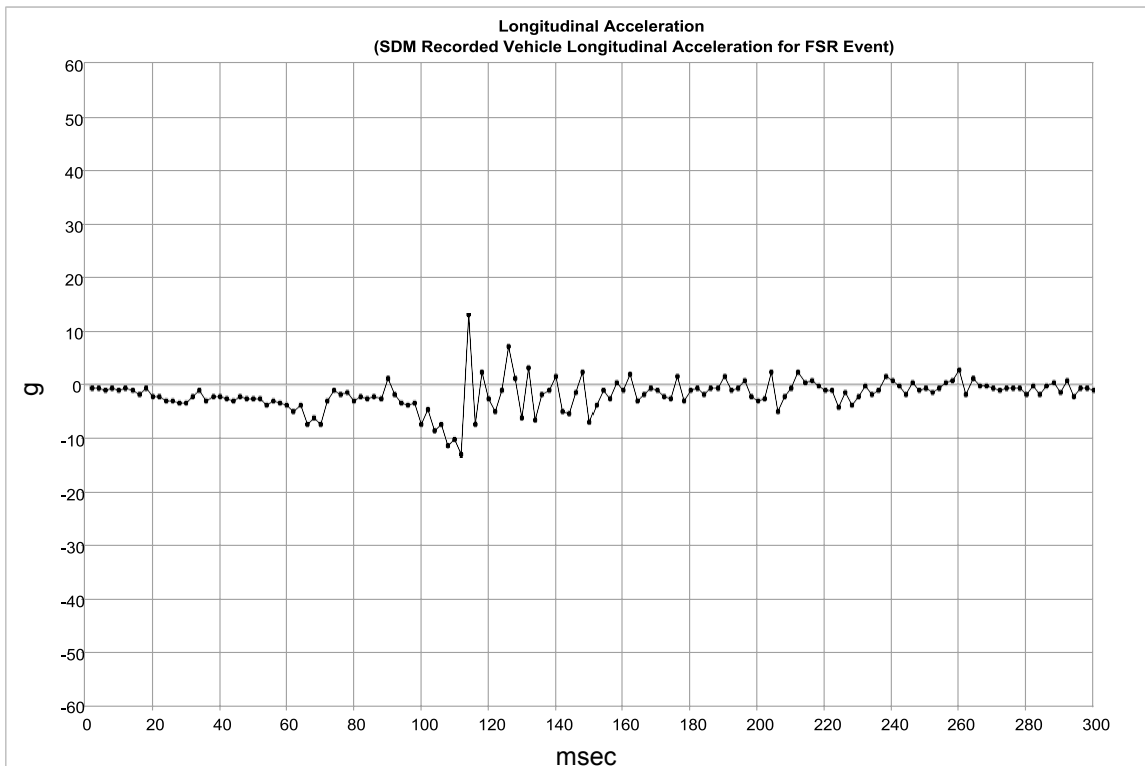
Longitudinal Crash Pulse (Event Record 1)

Event Record 1 was a front crash event with a reported a longitudinal delta-V of -18 km/h (-11 mph) and a lateral delta-V of 5 km/h (3 mph). These maximums occurred at 298 milliseconds and 180 milliseconds after algorithm enable (AE), respectively. The supplement restraint system deployment/actuation commands associated with Event Record 1 are listed in the following table:

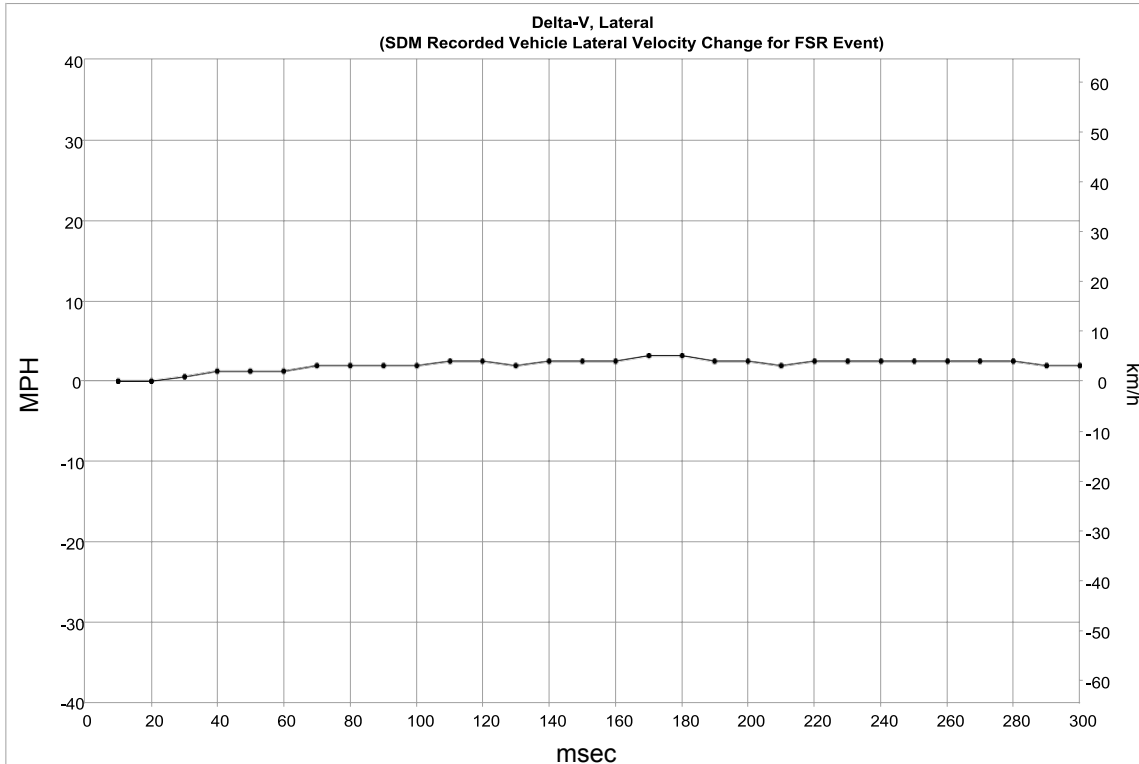
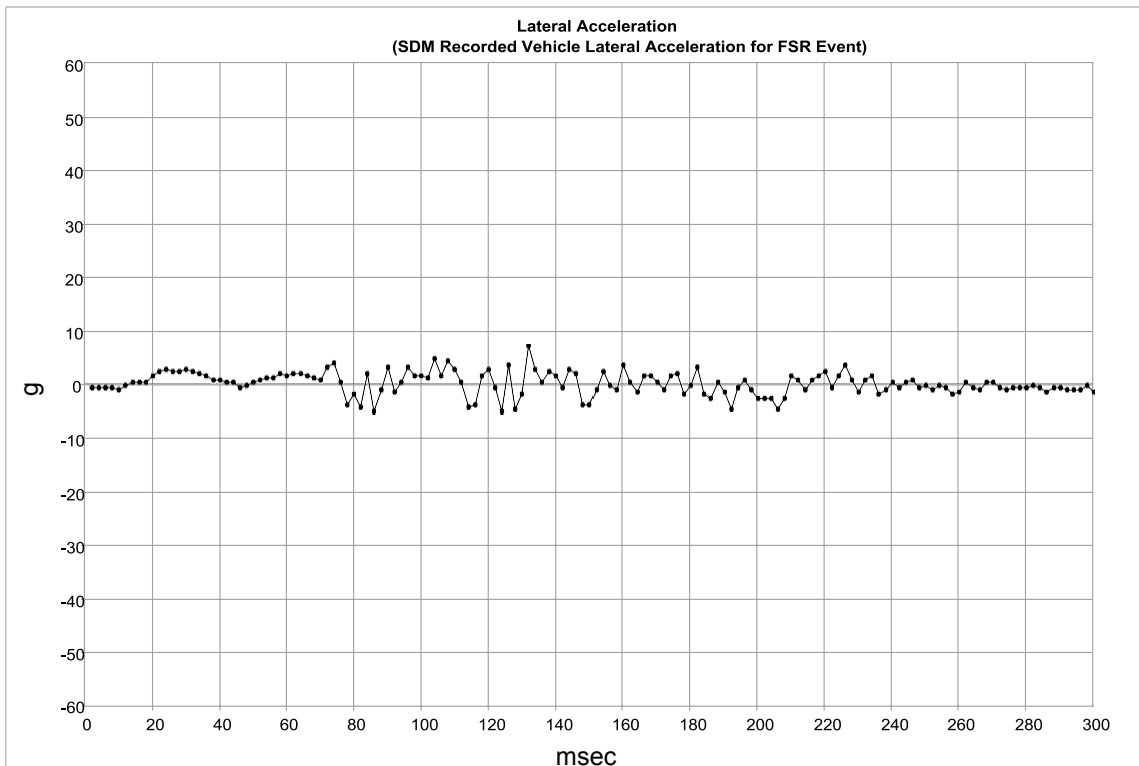
Lateral Crash Pulse (Event Record 1)

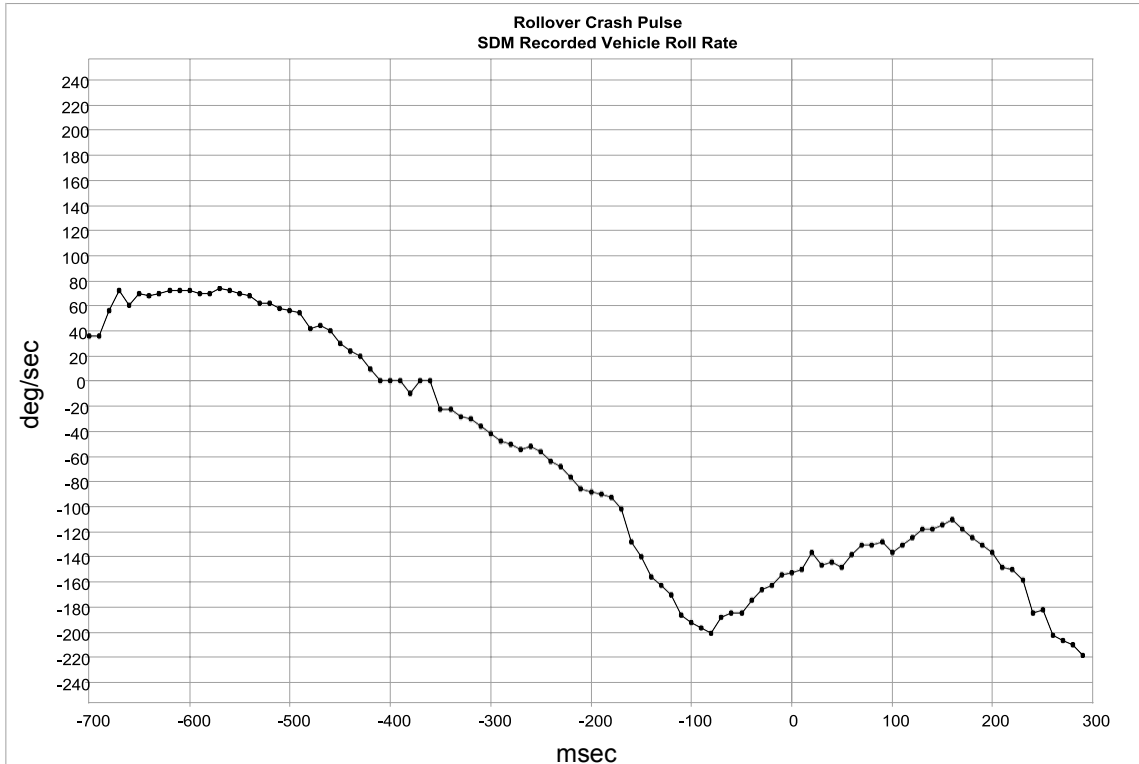
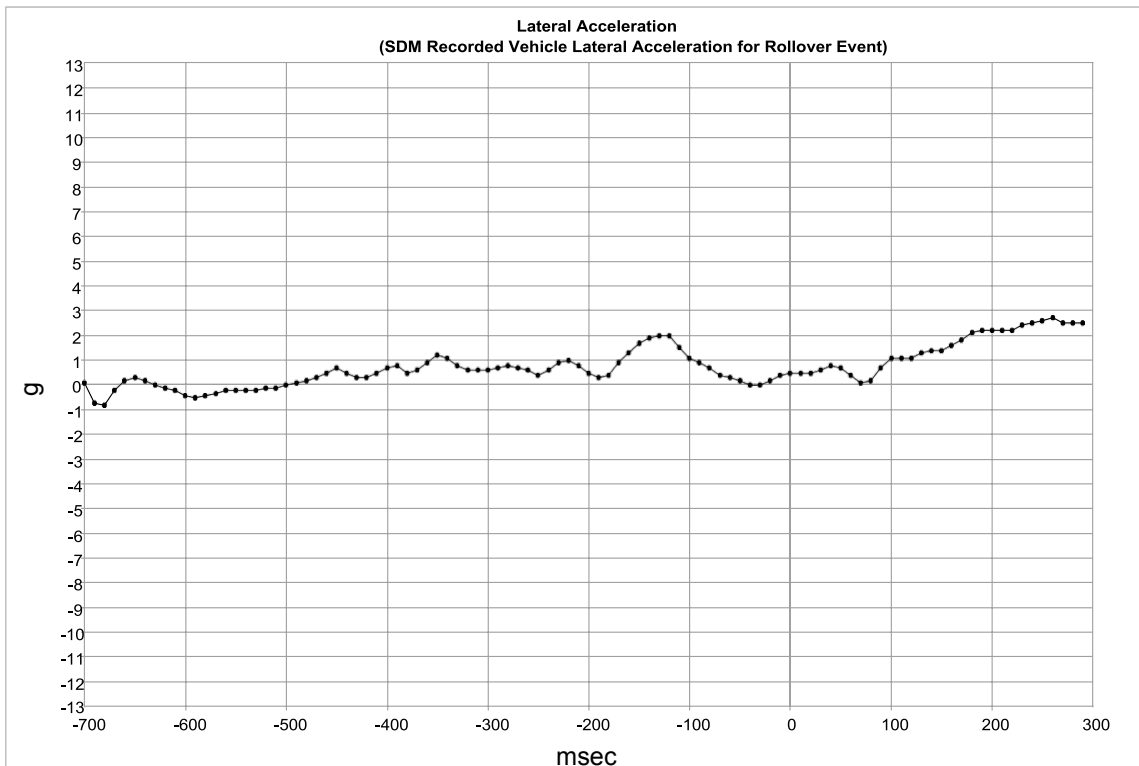
Rollover Crash Pulse (Event Record 2)

Event Record 2 was a rollover event type that was recognized 0.04 seconds after Event Record 1. There was no longitudinal or lateral delta-V data associated with the event. However, roll angle data indicated that the GMC initiated a right side-leading roll (positive roll angle) that transitioned into a left side-leading roll (negative roll angle) as a result of the vehicle’s continued counterclockwise rotation. Supplemental restraint system actuation/deployment commands associated with Event Record 2 are listed in the following table:
