DOT HS 812 608

**Remote Non-Traffic  
Surveillance Hyperthermia  
Fatality Investigation  
Vehicle: 2002 Ford  
Econoline  
Location: Kansas  
Crash Date: July 2016**

**INDIANA UNIVERSITY**  
**TRANSPORTATION RESEARCH CENTER**  
**REMOTE NON - TRAFFIC SURVEILLANCE**  
**HYPERTHERMIA INVESTIGATION**  
CASE NUMBER - IN16033  
LOCATION - KANSAS  
VEHICLE - 2002 E150 ECONOLINE VAN  
INCIDENT DATE - JULY 2016

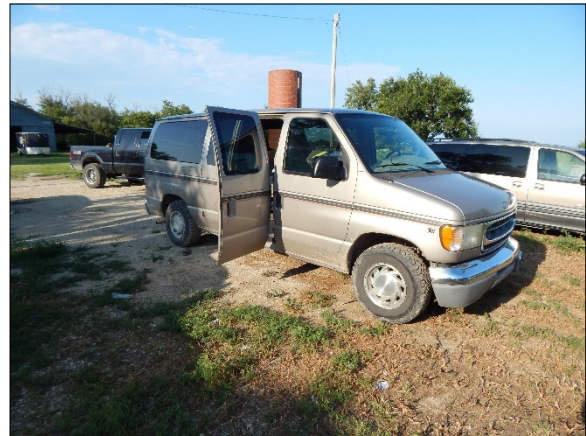
**Figure 1:** Police photo of the 2002 Ford E150 Econoline Wagon Van; view northeast

This report documents the remote investigation of the heat stroke death of a 19-month-old female who entered a parked, unoccupied 2002 Ford Econoline van (**Figure 1**) and was unable to exit the vehicle. This incident investigation was initiated by the National Highway Traffic Safety Administration on September 28, 2016. This investigation was assigned on December 6, 2016, following preliminary investigation by the Special Crash Investigation (SCI) Team at the Indiana University Transportation Research Center, in which the police incident report was obtained and the victim's mother was interviewed. Police on-scene photographs were subsequently obtained on December 28, 2016. Attempts to arrange an inspection of the involved vehicle and incident scene were unsuccessful and a remote investigation was conducted. This incident occurred in a residential driveway in July 2016 between 1400 and 1800 hours in Kansas and was investigated by the local police agency.

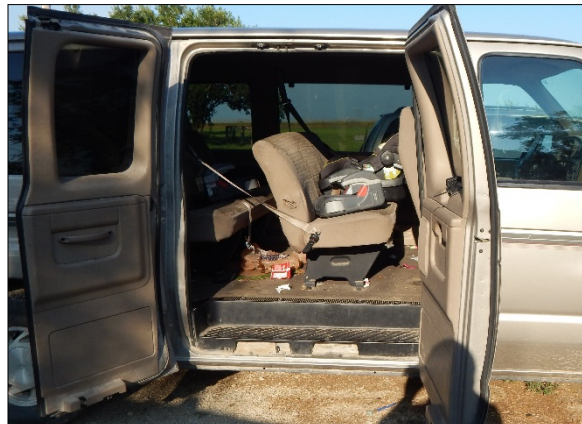
**Figure 3:** Police photo showing step in right rear door frame

It was revealed in the police incident report through interviews with family members that the victim and her 3-year-old brother enjoyed playing together. The victim was described as the brother's "side kick" by the mother. It was also reported that the 3-year-old liked to pretend driving a vehicle and had done so previously in the inoperable Pontiac (no indication this occurred on the day of the incident) that was parked next to the Ford. It was also reported by the father that "the children liked to play with the keys." The 3-year-old was capable of opening the side doors to the Ford and demonstrated this to police during their investigation. He was also capable of opening the doors to the residence. According to the mother, the victim was capable of entering the Ford on her own by climbing onto the step in the door frame (**Figure 3**) and then

climbing into the vehicle. It was determined that the 3-year-old was outside the residence during the time the victim went missing since the father reported seeing him enter the residence while the father was in the kitchen just prior to the discovery that the victim was missing. The available information indicated that at some time after 1400 hours the victim followed her 3-year-old brother outside to play as she was known to do. It is believed that the 3-year-old opened the right rear door to the Ford and they entered the vehicle. The right rear door was considered the most likely door of entry since the victim's and brother's child restraint systems were located in the second row seat. Therefore, the right rear door was likely the normal door through which they entered the vehicle. At some point after entering the vehicle, the 3-year-old exited the vehicle and closed the door leaving the victim in the vehicle who subsequently succumbed to heat stroke.
