DOT HS 812 618

**Special Crash Investigations  
Non-Traffic Surveillance  
Remote Hyperthermia  
Fatality Investigation  
Vehicle: 2004 Chevrolet  
TrailBlazer  
Location: Georgia  
Crash Date: May 2014**

**Non-Traffic Surveillance  
Special Crash Investigations  
Case No. CR16037  
Remote Hyperthermia Fatality Investigation  
Vehicle: 2004 Chevrolet Trailblazer  
Location: Georgia  
Incident Date: May 2014**

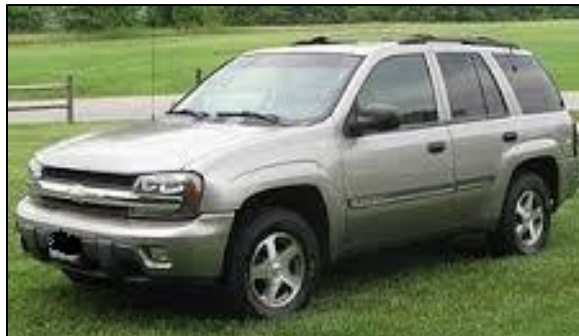
**Figure 1: Exemplar 2004 Chevrolet TrailBlazer.**  
(Image obtained from the Internet.)

This report documents the remote investigation and the circumstances surrounding the hyperthermia-related fatality of a 2-year-old (27 months) female who was found inside a 2004 Chevrolet TrailBlazer sport utility vehicle (SUV) (**Figure 1**). The Chevrolet was parked on an asphalt parking lot of an apartment complex. The child's mother returned home with the Chevrolet after transporting the child and her twin sibling. The mother alleged that she removed the sibling from the vehicle and left the 2-year-old outside under the supervision of a family member. She further stated to the police that she left one of the vehicle doors open. The 2-year-old apparently climbed back in the Chevrolet and the door closed. She was later found in the closed vehicle unconscious. Police and emergency medical services (EMS) responded to the scene and initiated cardiopulmonary resuscitation. The child was transported by ambulance to a pediatric trauma center where she was pronounced deceased. The police investigation found the vehicle doors, windows, and locking systems to be in proper working order.

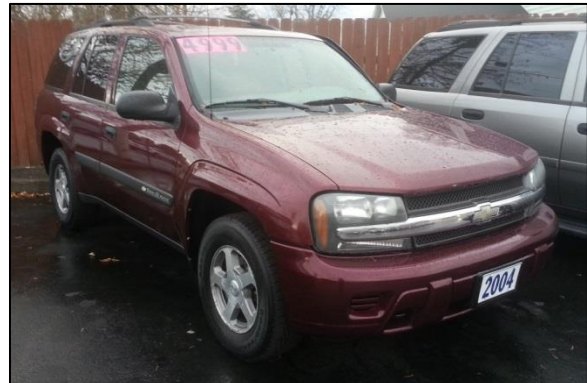
The 2004 Chevrolet TrailBlazer was a 4-door SUV with the LS trim level. **Figure 3** is an exterior view of an exemplar 2004 Chevrolet TrailBlazer. The Chevrolet was identified by Vehicle Identification Number (VIN) 1GNDS13S342xxxxxx. Although there were no images available for this vehicle, the VIN decoding identified the platform as rear-wheel drive, powered by a 4.2-liter, V-6 gasoline engine linked to a 4-speed automatic transmission. The police incident report listed the exterior color as black. The interior color is unknown. Standard features included front bucket seats with adjustable head restraints, a split second-row bench seat with adjustable head restraints in the left and right positions.

**Figure 3. Exterior view of an exemplar 2004 Chevrolet TrailBlazer.**

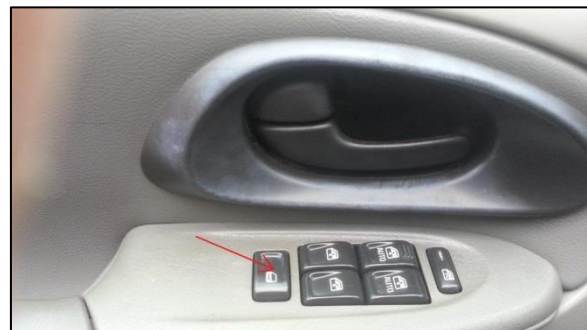
The Chevrolet's interior power locking system consisted of front door panel-mounted rocker switches (**Figure 4**). The switches were 4 x 2 cm (1.5 x 0.75 in) in dimension and were horizontally mounted on the forward extension of the armrest and the integrated door close pull handle. A door image with a key icon identified the power locking rocker switch. The outer aspect (with respect to the vehicle interior) of the switch provided the locking mode while the inner aspect of the rocker provided the unlock mode. It should be noted that the power lock feature remained active and fully functional without the ignition energized. The second-row doors were not equipped with power lock switches. Due to the location of the power locking switches on the front door panels, a child could inadvertently

**Figure 4. Exemplar vehicle driver's power door lock switch (arrow).**

lock the vehicle when playing in the vehicle by kneeling on the armrest-mounted switch and engaging the lock function.

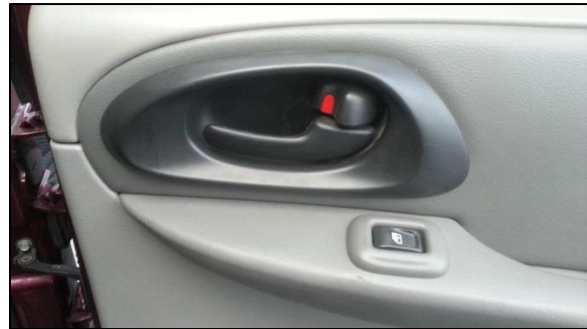
Manual locking/unlocking of the vehicle was achievable by rotating the locking levers that were positioned directly above the hinge aspect of the door release levers on the interior door panels. These locking levers were color-matched (gray) to the door release levers and the trim pocket. The leading edge of the lever displayed a high visibility orange bar when rotated to the unlocked position (**Figure 5**). When rotated to the locked position, this orange highlight was concealed in the trim pocket for the door release lever. These levers also rotated to the respective positions by the activation of the power locking system. Manually rotating the locking lever would only unlock the respective door when all four doors were in the locked mode. In the locked mode, none of the doors would unlock by pulling on the interior door release levers. The locking levers had to be rotated to the unlock position to open the doors.

**Figure 5. Unlocked position of the manual rotating lock lever of an exemplar vehicle.**

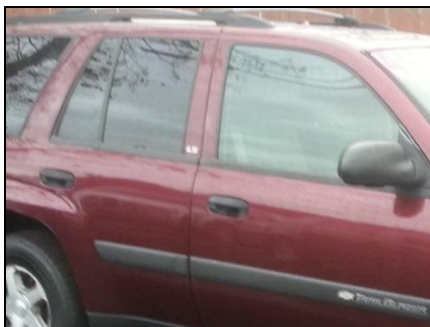
The exterior door handles of the Chevrolet were flush mounted in the upper aft aspect of the doors and required a vertical pull to open. The top-hinged handles were of polymer composition. Based on the SCI inspection of an exemplar vehicle, the front door handles were 97 cm (38.25 in) above the pavement while the rear door handles were 102 cm (40.0 in) above the ground surface. A vertical pull force was required to unlatch the door latch with 3 cm (1 in) of vertical movement of the handle. A horizontal pull force is then required to open the doors. The driver's door was equipped with a keyed door lock in the aft aspect of the door handle. **Figures 6 and 7** are images of the exterior door handle from an exemplar vehicle.

**Figure 6. Exterior door handles of an exemplar vehicle.**

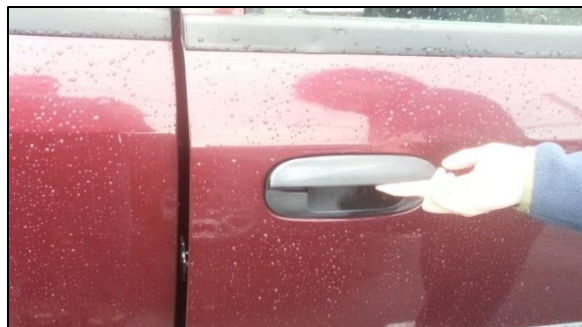
**Figure 7. Exemplar vehicle exterior door handle in the open/unlatched position.**

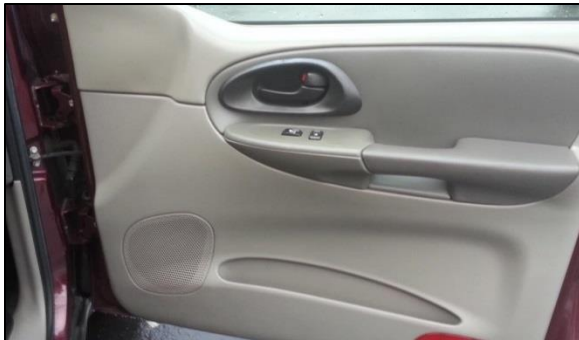
The interior door release levers of the Chevrolet were recessed into the door panels and positioned at the forward upper quadrant of the door panels. The levers required a horizontal pull force to unlatch the door latch mechanism. **Figures 8 and 9** depict the interior door release levers, front row and second row respectively.

**Figure 8. Front row right interior door release lever of an exemplar vehicle.**

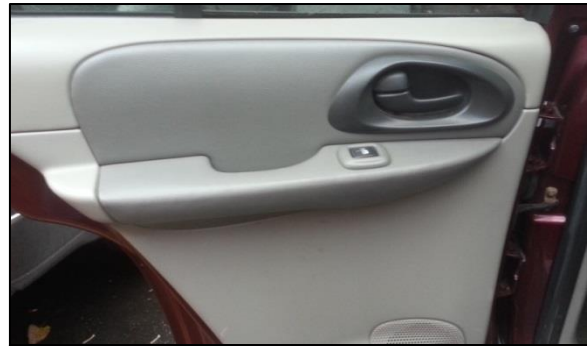
**Figure 9. Second row left interior door release lever of an exemplar vehicle.**

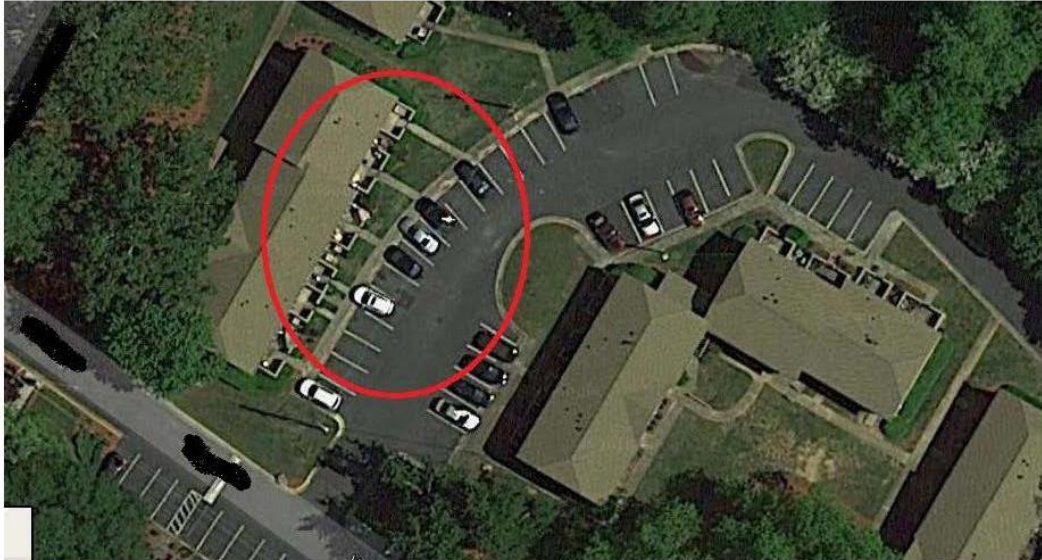
Incident Site:  
Apartment Complex Parking Lot

V1: 2004 Chevrolet Trailblazer
