Special Crash Investigations On-Site Guardrail End Treatment Investigation Vehicle: 2016 Chevrolet K1500 Silverado Location: Missouri Crash Date: February 2017

16. <i>Abstract</i> This report documents the on-site investigation of a Chevrolet pickup truck that struck an X-Lite guardrail end terminal, a crash of interest to the Federal Highway Administration. This crash occurred on the median roadside of a four-lane, divided interstate highway. The Chevrolet K1500 Silverado was a 4-door, double cab pickup truck equipped with frontal air bags, seat-mounted side impact air bags, rollover/side impact inflatable curtain air bags, and an event data recorder. A belted 59-year-old male driver occupied the vehicle. The Chevrolet was traveling east in the left lane when the vehicle departed the left side of the road and the front plane struck the end terminal. The end terminal penetrated the engine compartment and contacted the engine resulting in the guardrail separating from the end terminal and penetrating through the cowl and instrument panel and into the driver's seating area. The guardrail then struck the driver and displaced him and his seat out of the vehicle through the back of the

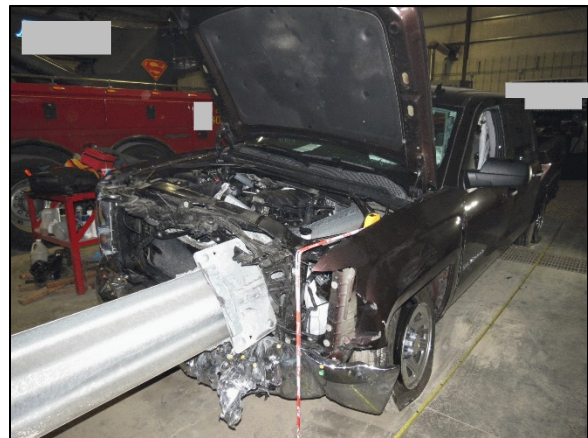
Figure 1: The damaged 2016 Chevrolet K1500 Silverado

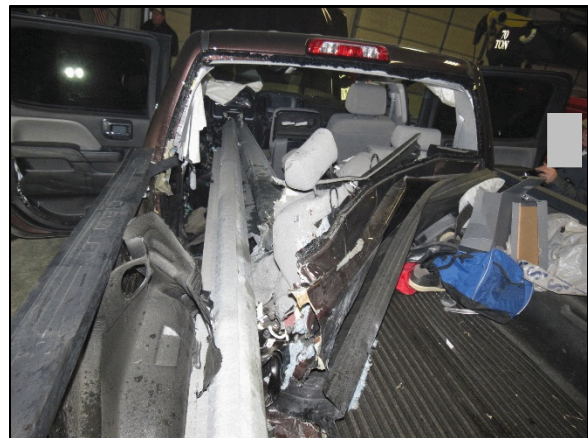
Figure 2: Back view of the guardrail penetration through the cab of the Chevrolet

through the cowl and instrument panel and into the driver's seating area. The guardrail then contacted the driver and displaced him and his seat out of the vehicle through the back of the cab as nine sections of guardrail penetrated through the vehicle. The driver sustained fatal injuries and was dismembered during the crash. The Chevrolet came to final rest heading east impaled by the guardrail. The driver was pronounced deceased at the crash scene. The vehicle was towed from the crash scene due to damage.

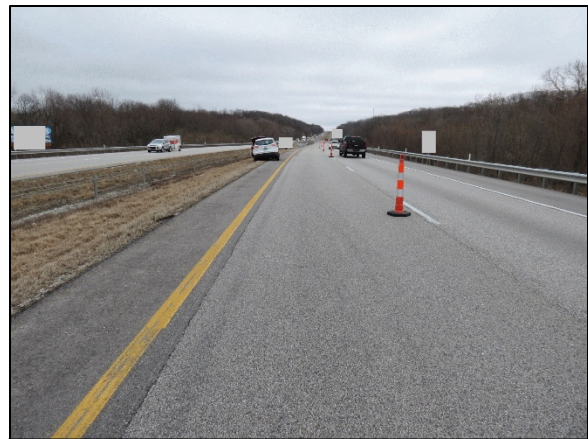
The Chevrolet was traveling east in the left lane (**Figure 3**) at an EDR-reported speed of 131 km/h (81 mph) from -5.0 sec to -1.0 sec prior to Algorithm Enable (AE). The reported speed was 129 km/h (80 mph) at -0.5 sec, which was the end of the pre-crash reporting. The service brake was reported as "Off" for the entire pre-crash reporting and the cruise control was not active from -2.0 to -0.5 sec, which was the extent of the reporting for the cruise control status. A non-involved vehicle was traveling behind the Chevrolet in the right lane. The police crash

Figure 3: Eastbound approach of the Chevrolet

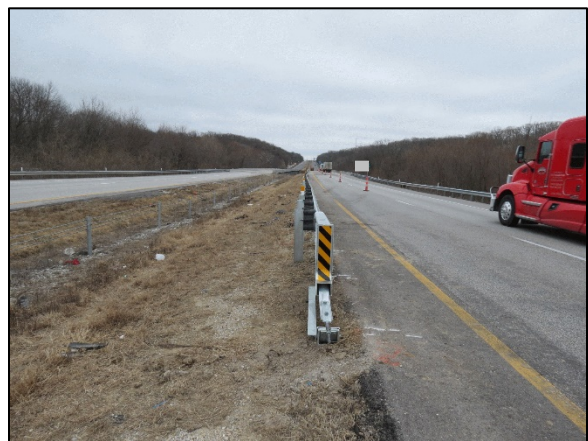
Figure 4: Area of impact with the guardrail, which had been replaced by a Soft Stop system, view east

Crash: The front plane of the Chevrolet struck the face of the end terminal (**Figure 4**) at an estimated speed of 127 km/h (79 mph).¹ The impact orientation was head-on to the end terminal, resulting in a force direction on the vehicle in the 12 o'clock sector. The EDR-reported maximum longitudinal and lateral velocity changes were -23.0 km/h (-14.3 mph) and 7.0 km/h (4.3 mph), respectively, occurring at 290 msec. The impact actuated the driver's seat belt pretensioner, stage one and two deployment of the driver's frontal air bag, and both IC air bags. Damage analysis of the vehicle and the damaged guardrail by a MoDOT engineer and the SCI investigator determined the end terminal deflected vertically up off the bumper as the bumper was crushed. The end terminal rotated counterclockwise and penetrated the vehicle's grille and radiator, and struck the left portion of the engine (**Figure 5**). Rail two then telescoped along rail one and struck the end terminal. Rail three telescoped along rail two and struck the anchor cable bracket and bolt on the slider bracket on rail two (**Figure 6**), resulting in rails two and three wedging together and separating from the end terminal and rail one. Rails two and three then penetrated the cowl and the left instrument panel, passing directly through the steering column tunnel and into the driver's seating area (**Figure 7**). The driver was struck by rails two and three as indicated by a transfer of blood and tissue on both rails. The driver and his seat were then displaced out of the vehicle through the back of the cab. Rail one also separated from the end terminal when the four mounting bolts were pulled through the bolt holes on the end terminal, and rail one followed rails two and three into the passenger

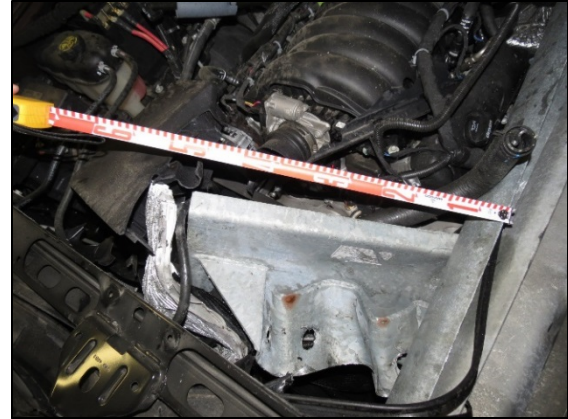
Figure 5: The end terminal entrapped in the Chevrolet's engine compartment, view from front left corner

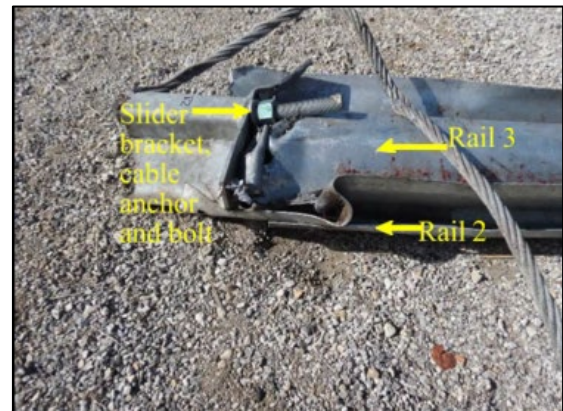
Figure 6: Rails 2, 3, and anchor cable bracket and bolt

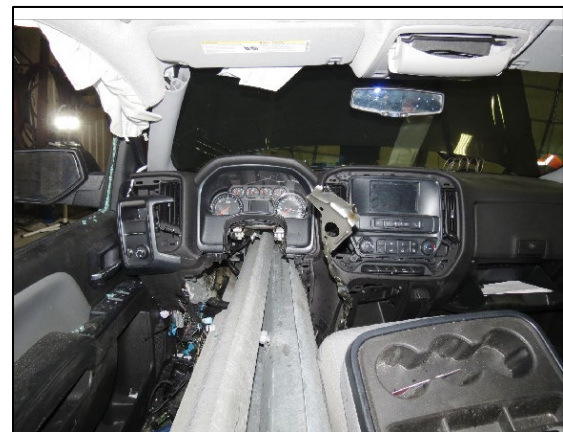
Figure 7: Path of guardrail penetration into the driver's seating position

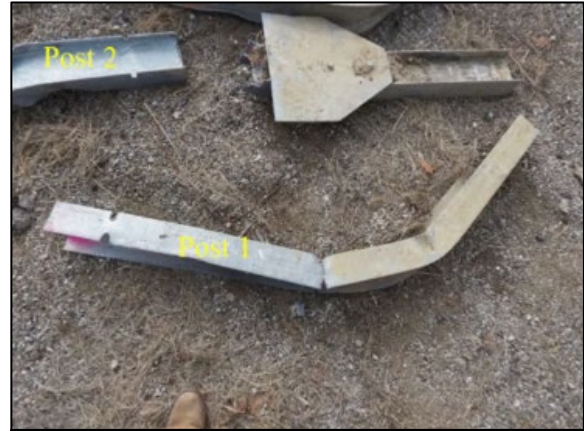
The damaged X-Lite and guardrail had been replaced by MoDOT with a "Soft Stop" guardrail end treatment system prior to the SCI crash site inspection. The damaged guardrail components, including all bolts and posts, were transported to a MoDOT maintenance facility where they were inspected by the SCI investigator and MoDOT engineer. The inspection revealed that the crash damaged and displaced 27 posts and four 3.8 m (12.5 ft) long guardrail panels and five 7.6 m (25.0 ft) long guardrail panels for a total of 53.2 m (175.0 ft) of guardrail. Post 1 was bent in the downstream direction at the crimp in the post. Post 2 was similarly bent but the post was fractured just above the soil plate and was in two pieces (**Figure 8**). The dirt line on the soil plate appeared to indicate that approximately 2 cm (0.8 in) of the soil plate was above ground level.

Figure 8: Damaged posts 1 and 2

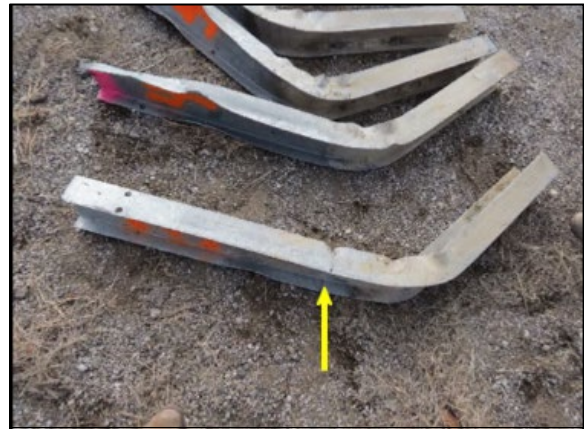
Figure 9: Post 3; arrow shows crimp in post remains closed

The ground strut remained bolted to post 2. Post 3 was also bent in the downstream direction, but the bend was at ground level, not at the crimp point (**Figure 9**). Posts 4 - 13 were also bent in the downstream direction to a similar extent as posts 1 -3. The remaining posts were bent to a much lesser extent (**Figure 10**). A sheared bolt head from the yellow shear bolts was found at the crash scene at posts 12, 28, and 34 of the replacement guardrail and at the final rest location of the Chevrolet. The FHWA guardrail form is attached to the end of this report as **Appendix A**.

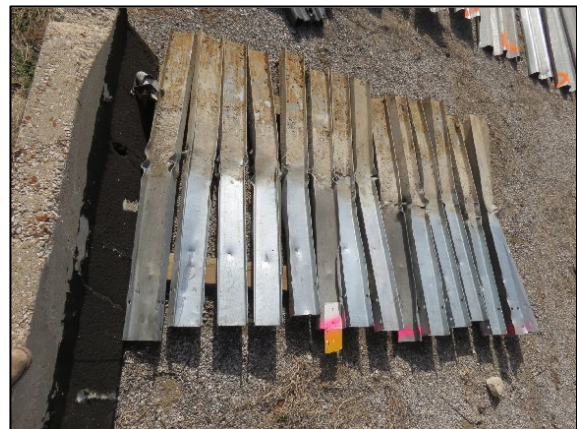
Figure 10: Remaining damaged posts

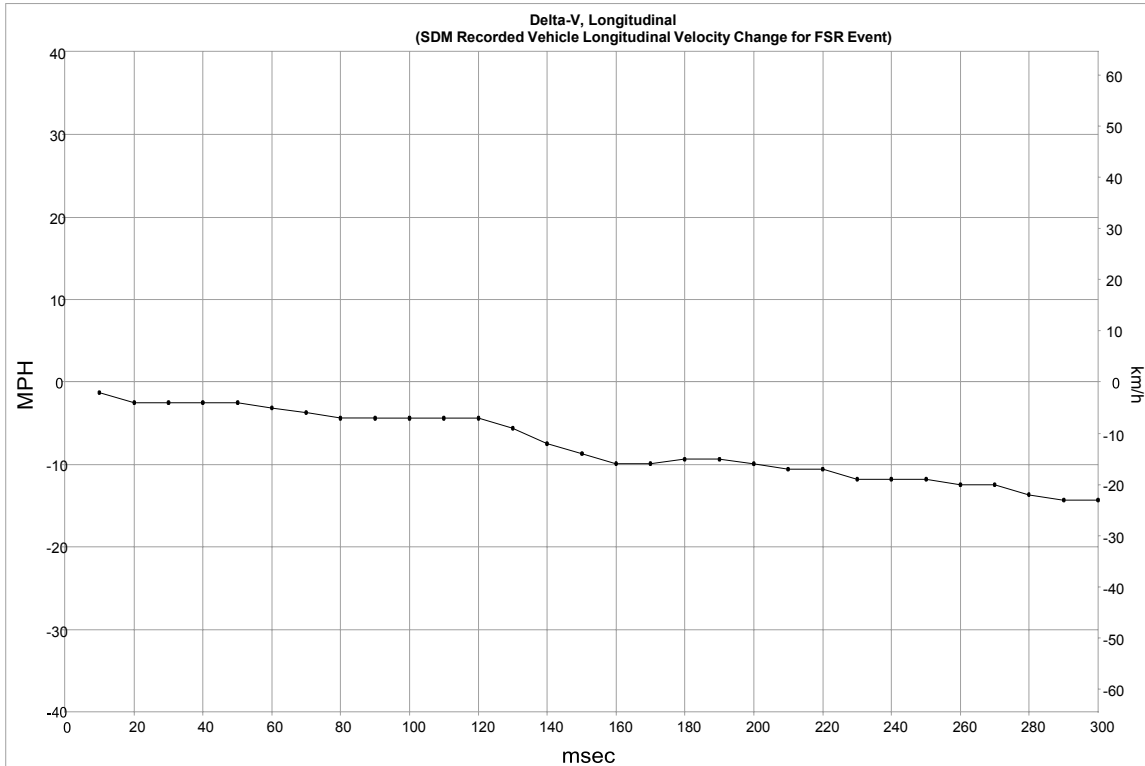
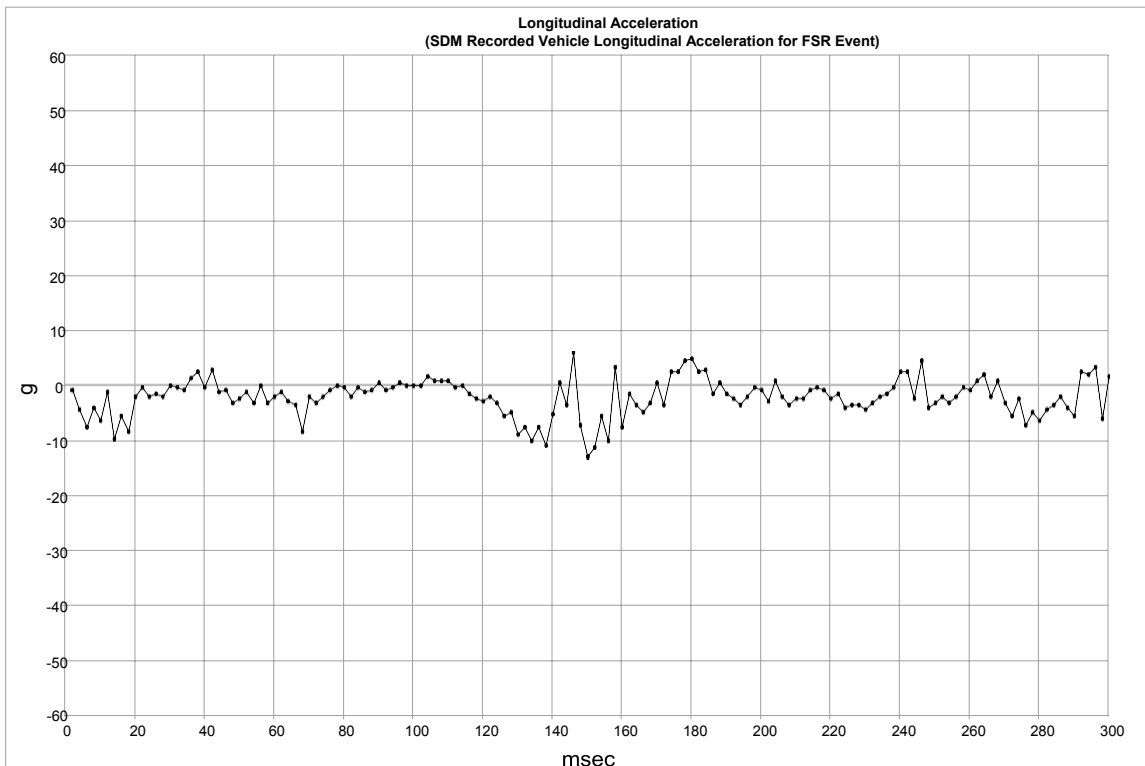
Longitudinal Crash Pulse (Event Record 1)

Time (msec)	Delta-V, Longitudinal (SDM Recorded Vehicle Longitudinal Velocity Change for FSR Event) (MPH)	Delta-V, Longitudinal (SDM Recorded Vehicle Longitudinal Velocity Change for FSR Event) (km/h)
10	-1.2	-2.0
20	-2.5	-4.0
30	-2.5	-4.0
40	-2.5	-4.0
50	-2.5	-4.0
60	-3.1	-5.0
70	-3.7	-6.0
80	-4.3	-7.0
90	-4.3	-7.0
100	-4.3	-7.0
110	-4.3	-7.0
120	-4.3	-7.0
130	-5.6	-9.0
140	-7.5	-12.0
150	-8.7	-14.0
160	-9.9	-16.0
170	-9.9	-16.0
180	-9.3	-15.0
190	-9.3	-15.0
200	-9.9	-16.0
210	-10.6	-17.0
220	-10.6	-17.0
230	-11.8	-19.0
240	-11.8	-19.0
250	-11.8	-19.0
260	-12.4	-20.0
270	-12.4	-20.0
280	-13.7	-22.0
290	-14.3	-23.0
300	-14.3	-23.0

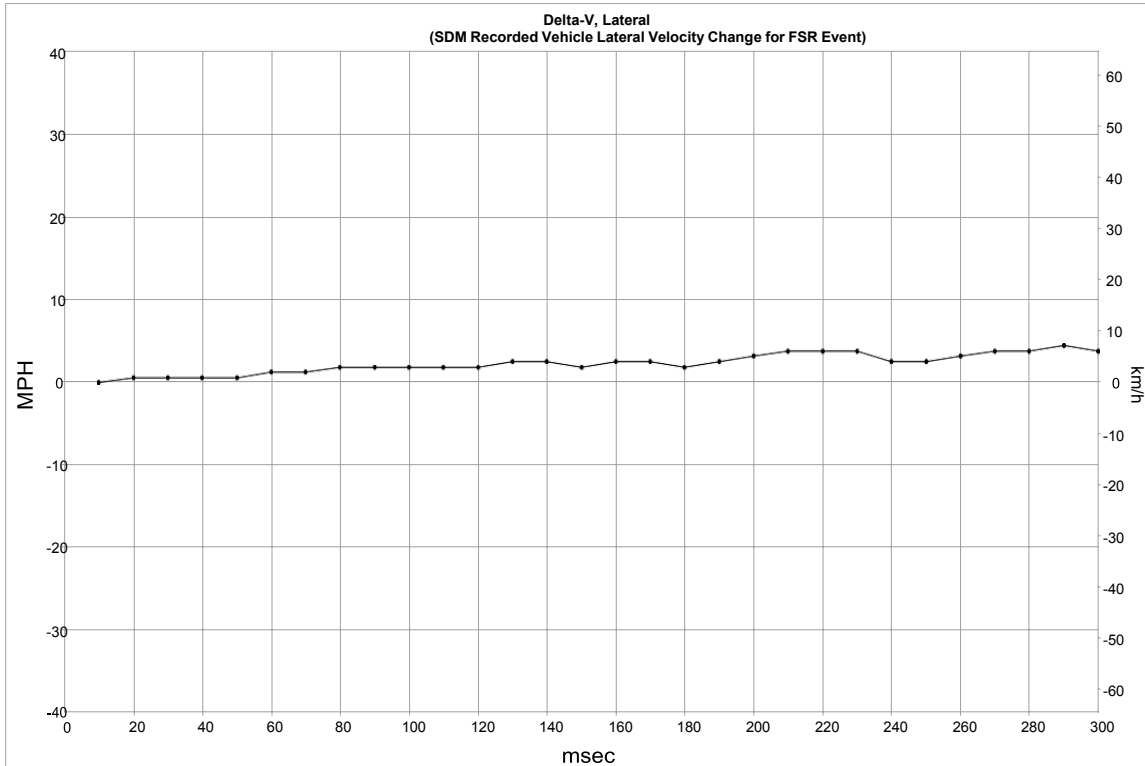
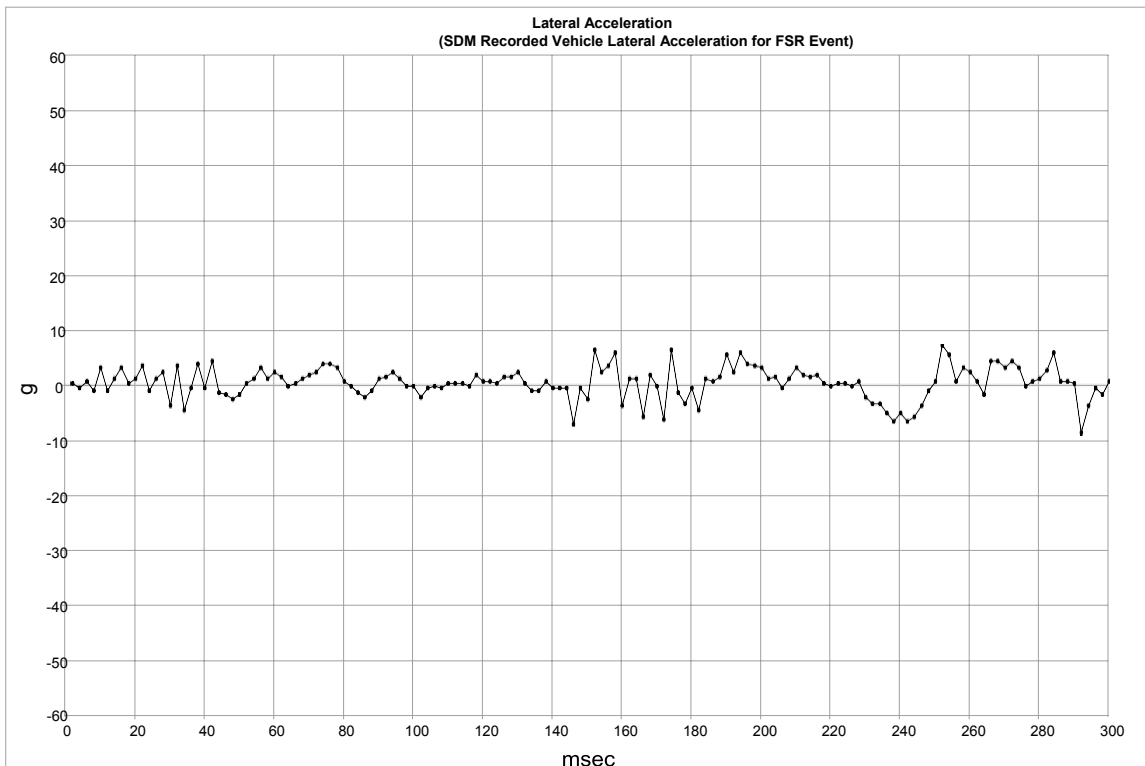
Lateral Crash Pulse (Event Record 1)

Time (msec)	Delta-V, Lateral (SDM Recorded Vehicle Lateral Velocity Change for FSR Event) (MPH)	Delta-V, Lateral (SDM Recorded Vehicle Lateral Velocity Change for FSR Event) (km/h)
10	0.0	0.0
20	0.6	1.0
30	0.6	1.0
40	0.6	1.0
50	0.6	1.0
60	1.2	2.0
70	1.2	2.0
80	1.9	3.0
90	1.9	3.0
100	1.9	3.0
110	1.9	3.0
120	1.9	3.0
130	2.5	4.0
140	2.5	4.0
150	1.9	3.0
160	2.5	4.0
170	2.5	4.0
180	1.9	3.0
190	2.5	4.0
200	3.1	5.0
210	3.7	6.0
220	3.7	6.0
230	3.7	6.0
240	2.5	4.0
250	2.5	4.0
260	3.1	5.0
270	3.7	6.0
280	3.7	6.0
290	4.3	7.0
300	3.7	6.0
