Special Crash Investigations Alleged Unintended Acceleration Crash Investigation

Vehicle: 2015 Toyota Yaris

Location: California

Crash Date: December 2015

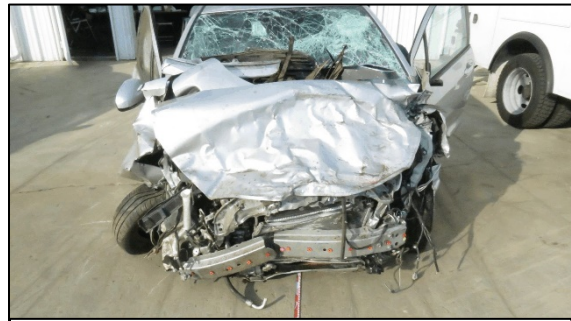
Figure 1. 2015 Toyota Yaris, frontal damage.

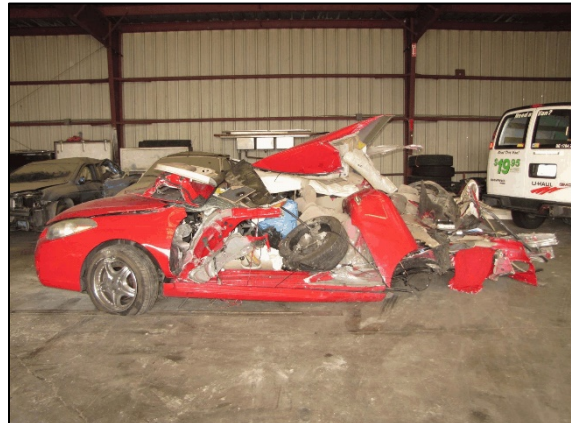
Figure 2. 2007 Toyota Solara, left side damage.

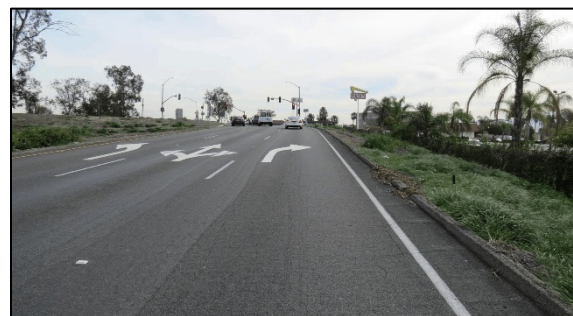
Figure 3. Eastbound approach along ramp.

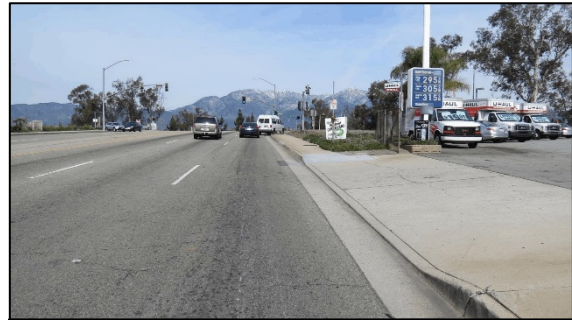
Figure 4. Northbound approach.

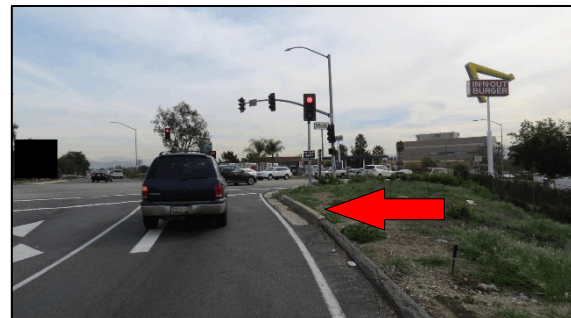
As the Yaris neared the intersection and the roadway angled to the left, the Yaris continued forward and struck a concrete curb (**Figure 5**) on the right side of the roadway (Event 1).

Figure 5. Right curb impact.

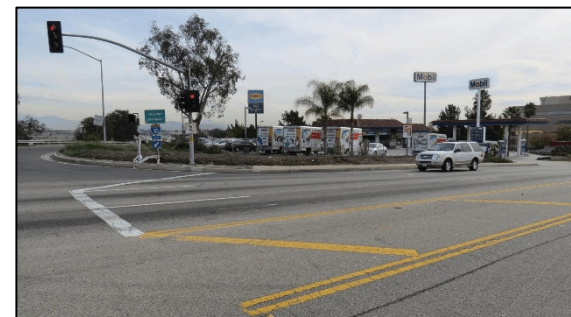
After impacting the curb, the Yaris steered left, began a slight counterclockwise yaw, continued in a southeast direction into the intersection, crossed the southbound travel lanes, and entered the northbound travel lanes south of the intersection (**Figure 6**). The Solara was traveling northbound in the right lane approaching the four-leg intersection. The Yaris crossed the first two northbound travel lanes and did not brake before striking the left plane of the Solara with its front plane (Event 2). The missing vehicle algorithm¹ of the WinSMASH program calculated a total delta-V of 74 km/h (46 mph) for the Yaris. The longitudinal and lateral components were -74 km/h (-46 mph) and -13 km/h (-8 mph), respectively. The results are borderline. The

Figure 6. Yaris path southeast into northbound travel lanes.

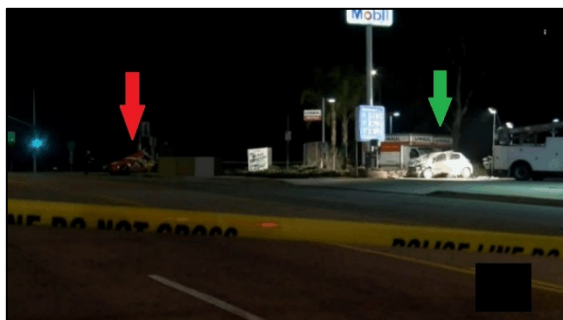
Figure 8. Final rest positions, looking northeast (police photo); 2015 Toyota Yaris (green arrow), 2007 Toyota Solara (red arrow).

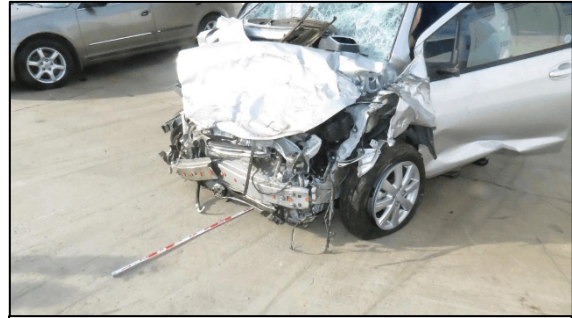
The Yaris sustained major front plane damage from the impact to the left plane of the Solara (Figure 9). The direct damage began at the left bumper corner and extended to the right bumper corner. The Field L began at the left bumper corner and extended 115 cm (45.2 in) to the right. Fourteen measurements were taken at bumper level by the Nikon Total Station and the Faro Blitz program computed crush measurements in six increments as follows: C1 = 36 cm (14.1 in), C2 = 31 cm (12.2 in), C3 = 31 cm (12.2 in), C4 = 29 cm (11.4 in), C5 = 29 cm (11.4 in), C6 = 39 cm (15.3 in). The CDC was 12FDEW3.

Figure 9. 2015 Toyota Yaris, frontal damage.

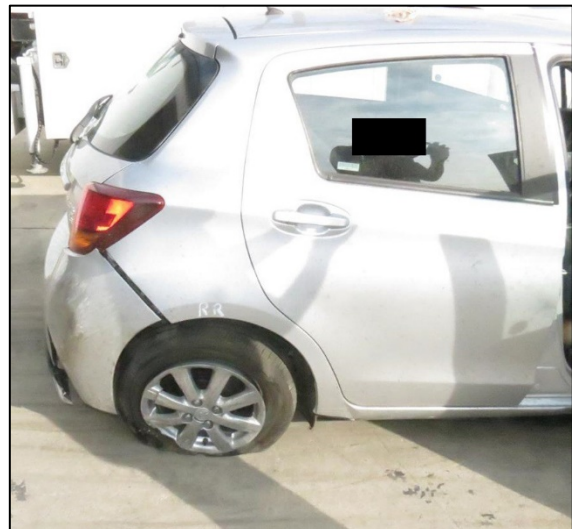
The Yaris sustained minor damage to the right rear wheel that occurred when the vehicle rotated counterclockwise into a concrete curb (Figure 10). The CDC for this impact was 03RBWN1. There was damage along the fender above the wheel that was likely caused when the vehicle traveled through a fence later in the crash sequence.

Figure 10. 2015 Toyota Yaris, right rear wheel damage.

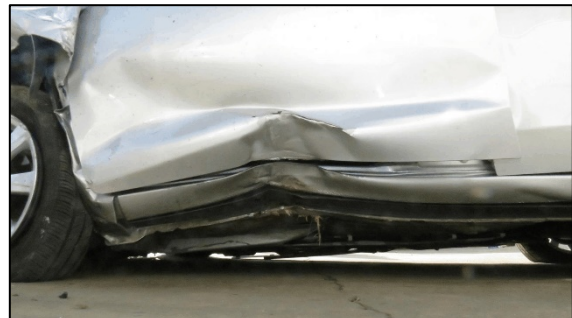
The Yaris sustained minor damage to the left plane along sill as it rotated over the planter box adjacent to the parking area (Figure 11). The direct damage was located 143 cm (56.2 in) forward of the rear axle and extended 31 cm (12.2 in) forward. The CDC for this impact was 09LPMN1.

Figure 11. 2015 Toyota Yaris, left sill damage.

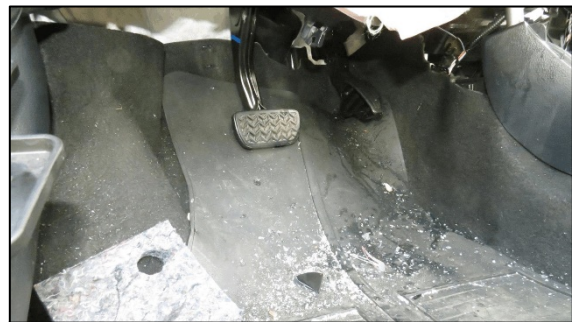
Figure 12. Toe pan, 2015 Toyota Yaris.

conducted a full mechanical tear-down and inspection. The initial status of the floor controls and a floor mat is shown in **Figure 12**. There was some movement of the carpet to the right of the foot controls that occurred while the EDR was being removed by the police. The driver’s floor mat was a non- original equipment manufacturer (OEM) after-market product. The rubber mat was 68 cm (26.7 in) in length and 44 cm (17.3 in) in width. The vehicle was designed with floor mounted mat attachments located immediately in front of the driver’s seat track. The mat was not

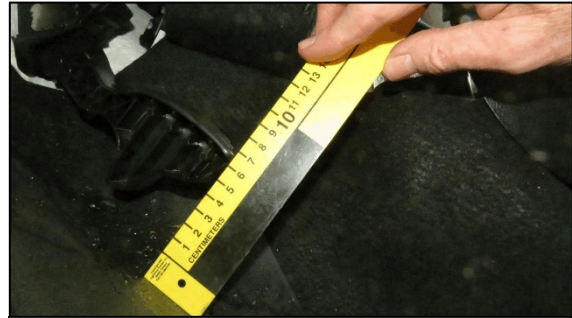
During the inspection, the vehicle was powered up and the accelerator operated. The butterfly valve at the throttle body was somewhat restricted due to damage but did exhibit motion. The accelerator pedal, the throttle body, and the electronic control module were removed from the vehicle by the police and placed into evidence. The only way to fully test the components would have been to install them on an exemplar vehicle. Toyota accessed the engine control module (ECM) to obtain post collision system and sensor data. The ECM maintains volatile memory only and has no fault code memory storage capability following an electrical system failure. Once battery power was lost, all historical trouble codes would have been lost.

Accessing the ECM through the DLC and utilizing Toyota diagnostic software, the accelerator/throttle system components were tested. The ECM did not report any data indicating a deficiency related to throttle operation. The vehicle was equipped with brake override software. The software would shut down throttle body operations whenever a brake application was performed, regardless of pedal position. The software uses ECM inputs from the brake lamp switch and brake system hydraulic pressure. The hydraulic system of the vehicle, as well as the brake lamp activation system, were found to be operating properly.

Figure 13. Accelerator pedal, up position, 2015 Toyota Yaris.

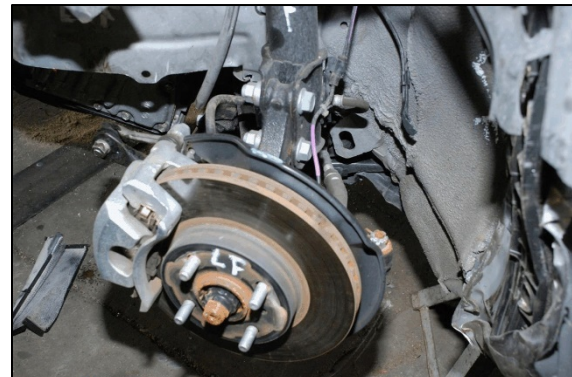
Figure 15. 2015 Toyota Yaris, left front rotor.

A visual inspection of front brake rotors did not reveal any overheating (**Figure 15**). There was no evidence of melted brake pad material found. The mechanical inspection by the police included a tear down of the service and emergency brakes. The vehicle was equipped with front disc and rear drum brakes. The front rotors exceeded the rotor manufacturer's minimum thickness specifications. The brake pads material thickness of each pad exceeded the Federal Vehicle In Use Inspection Standard (FVIUIS). The rear brake shoe linings were measured and exceeded the FVIUIS standard (**Figure 16**). When the service brake was applied the brakes operated as designed and the wheels could not be rotated. The vehicle was equipped with a hand actuated mechanical braking system. The system utilized several cables to actuate the service brake shoes at both sides of the rear axle. With the parking brake lever in the up (applied) position, the rear brake drums could not be rotated. With the parking brake lever in the released position, rotation of the drums was possible.

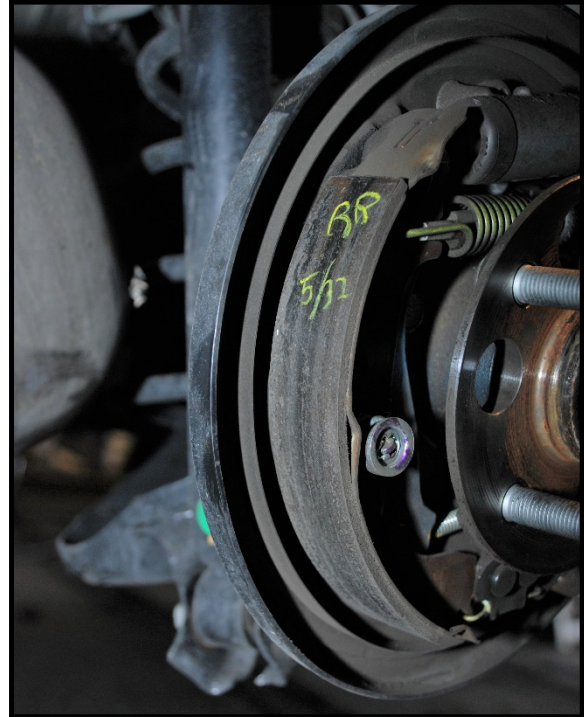
Figure 16. 2015 Toyota Yaris, right rear brake shoes.

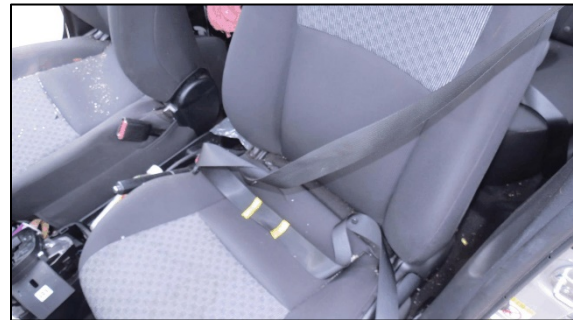
Inspection of the driver’s seat belt assembly revealed historical usage scratches on the latch plate and an area of abrasion that was located 33 cm (12.2 in) above the stop button (**Figure 17**). The vehicle’s EDR reported the driver’s seat belt status as “On.” Inspection of the passenger’s seat belt assembly revealed historical usage scratches on the latch plate and two areas of abrasion. The first measured 36 cm (14.1 in) and was located at the anchor (**Figure 18**). The second measured 16 cm (6.2 in) and was located 5 cm (1.9 in) above the stop button. The vehicle’s EDR reported the passenger’s seat belt status as “On.”

Figure 17. Driver’s seat belt, 2015 Toyota Yaris.

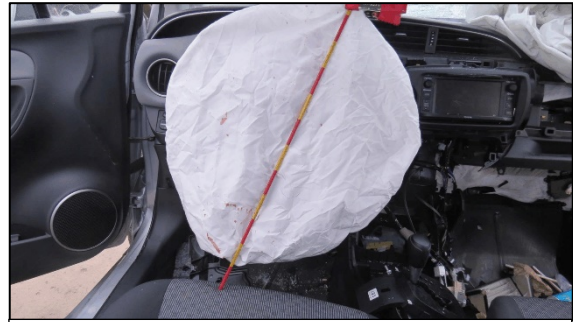
Figure 19. Driver air bag, 2015 Toyota Yaris.

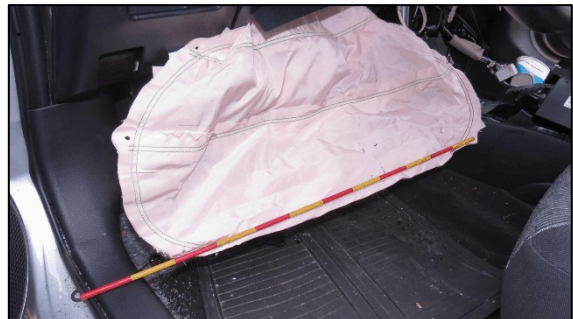
Figure 20. Driver's knee air bag, 2015 Toyota Yaris.

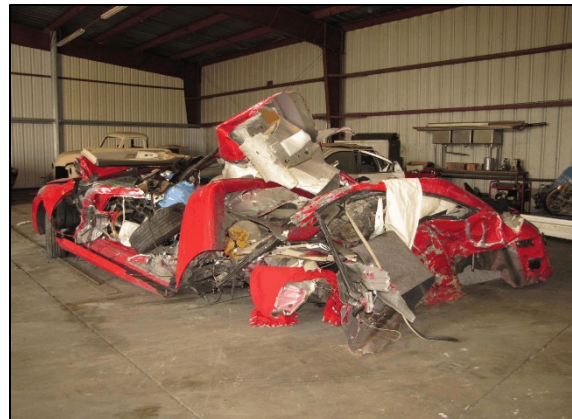
The Solara sustained catastrophic left plane damage as a result of the frontal impact of the Yaris (**Figure 21**). The damage could not be measured. The estimated CDC was 10LZAW9. The vehicle's right wheel was deformed as it struck a curb during rotation. The CDC for the tire impact was 03RBWN2. The vehicle also struck a wood signpost but that damage could not be located on the vehicle.

Figure 21. Back and left side damage, 2007 Toyota Solara.
