DOT HS 812 671

Special Crash Investigations On-Site Guardrail End Terminal Investigation Vehicle: 2010 Chevrolet Silverado Location: Missouri Crash Date: April 2016

**INDIANA UNIVERSITY
TRANSPORTATION RESEARCH CENTER
ON-SITE GUARDRAIL END TERMINAL INVESTIGATION
CASE NUMBER - IN16010
VEHICLE - 2010 CHEVROLET SILVERADO
LOCATION - MISSOURI
CRASH DATE - APRIL 2016**

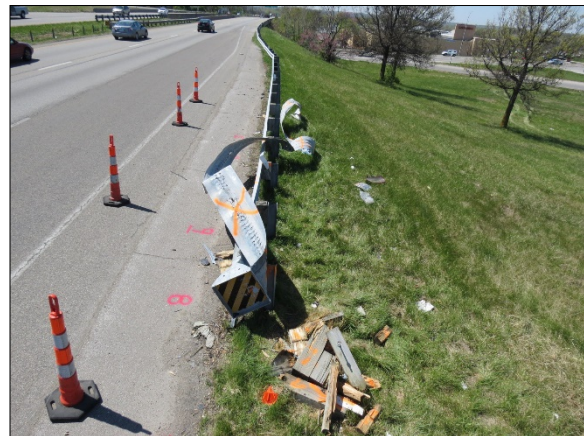
Figure 1: The damaged end terminal and guardrail, view west

This report documents the on-site investigation of an ET-2000 end terminal (**Figure 1**) that was struck by a 2010 Chevrolet Silverado crew cab pickup truck (**Figure 2**). This crash was identified by an engineer with the Missouri Department of Transportation (MoDOT), who submitted photographs of the vehicle and the damaged guardrail end terminal to the Federal Highway Administration. The FHWA determined that the guardrail end terminal and crash type were of interest. This crash investigation was then initiated by the National Highway Traffic Safety Administration in April 2016, and assigned to the Special Crash Investigation team at the Indiana University Transportation Research Center. This crash involved the Chevrolet and a 2006 Pontiac Montana. The crash occurred in Missouri in April 2016 at night and was investigated by a local police agency. The guardrail, crash scene, and Chevrolet were inspected in April 2016.

A sticker located on the end terminal identified the manufacturer as Syro, Inc.¹ The front plane impact of the Chevrolet to the ET-2000 resulted in only minor surface damage to the face of the extruder head (**Figure 8**). There was no damage to the connection of the feeder channel to the extruder head and no welds were broken. The impact extruded 14.8 m (48.7 ft) of guardrail (**Figure 9**) toward the field side of the guardrail. Wood posts 0 to 7² were fractured and separated from the ground and the guardrail (**Figure 10**). The anchor bolts for posts 1 to 7 were pulled through the guardrail. The remaining posts were constructed of steel and had wood offset blocks. Post 8 was slightly displaced in the ground and the offset block was fractured and displaced from the guardrail, but still attached to the post. The remaining posts were undamaged. The anchor cable was displaced from the guardrail and found at post 3. The total length of damaged guardrail was 17.9 m (58.7 ft). There were no kinks in the guardrail downstream of the end terminal. The feeder channel width of the end terminal was 13 cm (5.0 in) and the guide chute exit height was 39 cm (15.5 in). The FHWA guardrail form is attached to the end of this report as **Appendix A**.

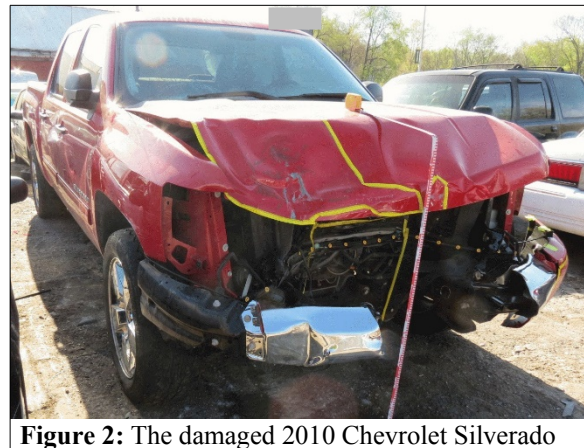
Figure 2: The damaged 2010 Chevrolet Silverado

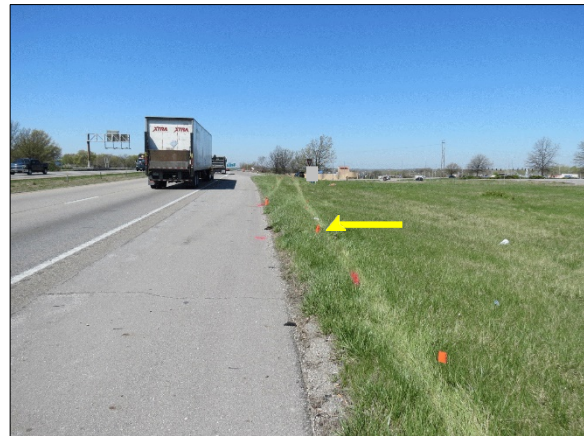
Figure 3: Northwest-bound approach of the Chevrolet to impact with a mile marker (arrow)

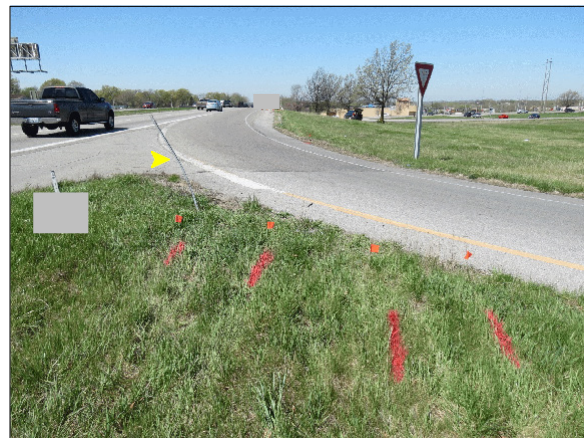
Figure 4: Impact with first delineator, view west

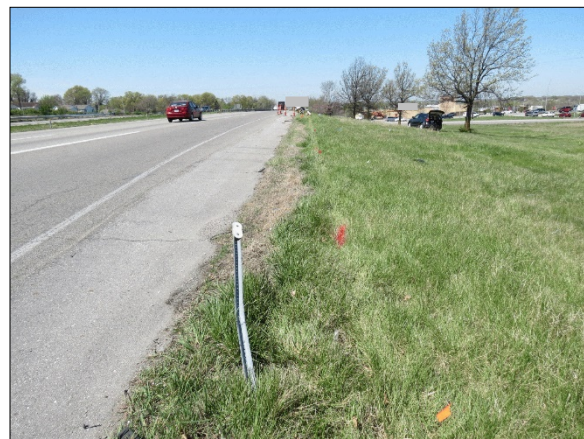
Figure 5: Impact with second delineator and approach to impact with end terminal, view west

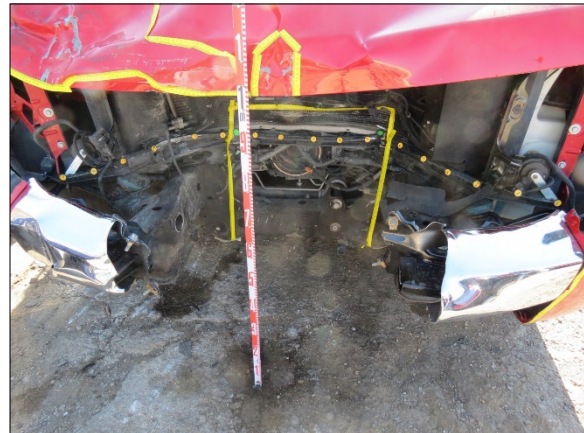
Figure 6: Damage to the front plane of the Chevrolet from impact with the end terminal

Exterior Damage Event 6: The impact with the end terminal involved the front plane of the vehicle and the direct damage was 51 cm (20.1 in) long beginning 59 cm (23.2 in) right of the left corner of the front bumper. The impact site on the bumper was located between the vehicle's frame rails and this section of the bumper was cut and displaced from the vehicle (**Figure 11**) by the impact. The end terminal then contacted the radiator and lower radiator frame crushing it rearward 32 cm (12.6 in). The total depth of penetration of the end terminal through the bumper and into the radiator was approximately 55 cm (21.7 in).

Damage Classification Event 6: The CDC was 12FCEW3 (0 degrees). The severity of the damage was moderate.

and right-side wheels on the grass for 30.1 m (98.7 ft) and the center of the front plane (**Figure 6**) struck the end terminal (**Figures 7 and 8**, event 6). The impact speed was estimated to be 84 km/h (52 mph)¹ based on the EDR-reported speed of the vehicle at -0.5 sec prior to AE, which was the end of the pre-crash recording. The impact resulted in actuation of the driver's safety belt pretensioner and a stage 2 deployment of the driver's frontal air bag and deployment of both IC air bags. The maximum EDR-reported longitudinal and lateral velocity changes were - 23.0 km/h (-14.3 mph) and 1.0 km/h (0.6 mph). The vehicle remained in contact with the ET- 2000 and 14.8 m (48.7 ft) of guardrail was extruded. The Chevrolet came to final rest heading west (**Figure 7**) with the ET-2000 remaining in contact with the damaged front plane. The police crash schematic showed the final rest position of the Pontiac on the shoulder of the entrance ramp.

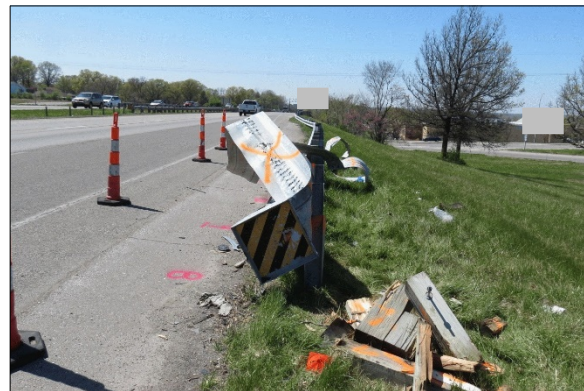
Figure 7: The damaged end terminal, extruded guardrail, and final rest location of the Chevrolet

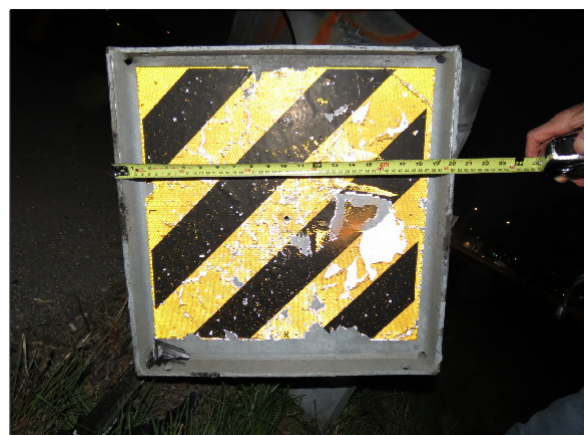
Figure 8: Minor damage to the face of the ET-2000

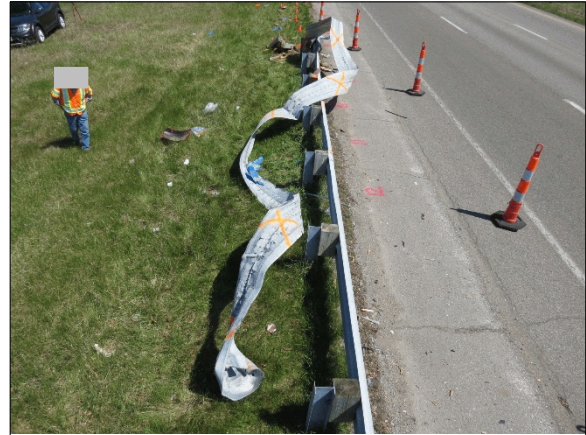
Figure 9: View upstream (east) to the extruded guardrail

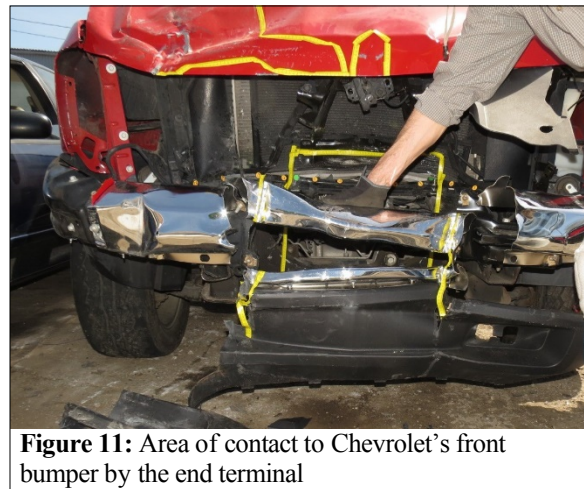
Figure 11: Area of contact to Chevrolet's front bumper by the end terminal
