# **Special Crash Investigations On-Site Ambulance Crash Investigation Vehicle: 2011 Ford E-350 Type III Ambulance Location: Ohio Crash Date: September 2016**

**Indiana University  
Transportation Research Center  
On-Site Ambulance Crash Investigation  
Case Number: IN16025  
Vehicle: 2011 Ford E-350 Type III Ambulance  
Location: Ohio  
Crash Date: September 2016**

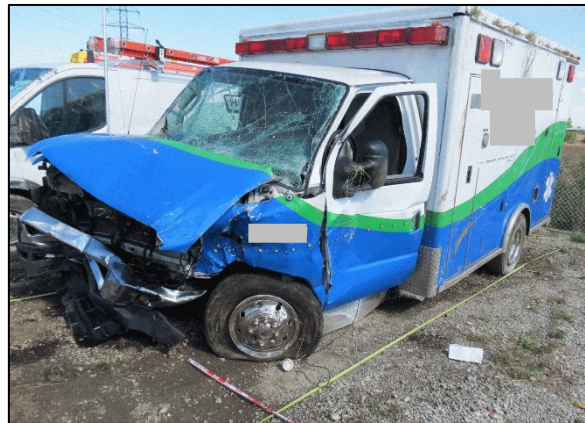
**Figure 1:** The damaged 2011 Ford Econoline E-350 Type III ambulance.

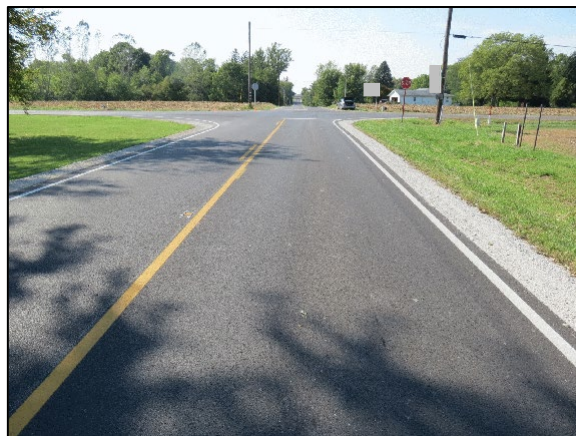
**Figure 3:** Westbound approach of the Dodge to the intersection.

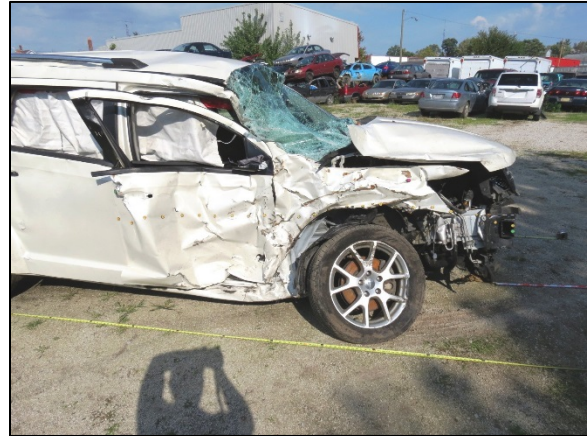
**Figure 5:** Damage to the right plane of the Dodge.

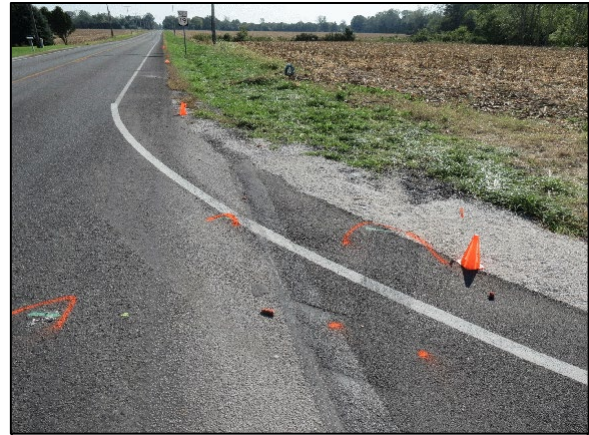
heading south partially in a corn field. The Dodge came to final rest in the corn field heading southwest. The ambulance traveled a total distance of approximately 20 m (66 ft) from the initial impact to final rest including approximately 15 m (49 ft) during the rollover. The Dodge traveled a total distance approximately of 47 m (154 ft) from the initial impact to final rest. The unbelted ambulance driver was ejected from the vehicle during the crash through the disintegrated left front glazing. Her final rest position is not known.

**Figure 6:** View southwest of both vehicles travel into corn field.

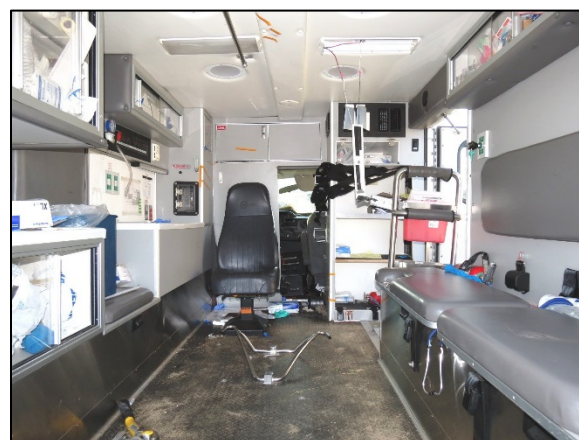
***Interior Damage, Patient Compartment:*** There was no intrusion of the patient compartment (**Figure 8**). The paramedic was seated in the rear-facing seat located at the front left of the patient

**Figure 8:** Interior of the patient compartment.

compartment. The wall panel behind this seat was displaced forward 8 cm (3.1 in) and scuffed from contact by the seatback as it was displaced forward during the initial impact. A scuff mark was located on the cabinet door above the seat and on the ceiling, probably from contact by the paramedic during the rollover. A scuff mark was also present on the wall of the oxygen compartment located on the left side of the patient compartment adjacent to the paramedic, probably from contact by the paramedic's right flank. The front left corner of the seat cushion of the rear-facing seat was scuffed and the wall of the storage compartment located at the front right of the patient compartment was dented from contact by the head end of the patient cot, which was displaced from its securement location during the initial impact. Blood spatter and blood deposits were also located in this area as well as on the wall and cabinets on the left side of the patient compartment.

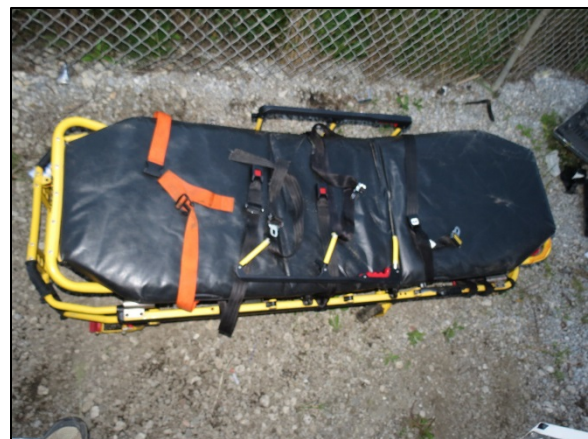
The patient was restrained on a Stryker model 6083 bariatric transport cot (serial number: 07023xxxx) (**Figure 9**). The cot was an X-frame design and the manufacturer's specifications stated the standard length, width, and weight were 203 cm (80 in), 74 cm (29 in), and 50 kg (111 lbs), respectively. The weight capacity of the cot was specified as 385 -725 kg (850 -1600 lbs). The cot was equipped with chest, waist, thigh, and lower leg restraints. The cot was not equipped with shoulder harness straps. The latch plate for the chest restraint was labeled "Rugged." The buckle and buckle webbing were manufactured by Morrison Medical and the model number was 1200BK, lot number 091409.

**Figure 9:** The Stryker Model 6083 Bariatric Transport cot.

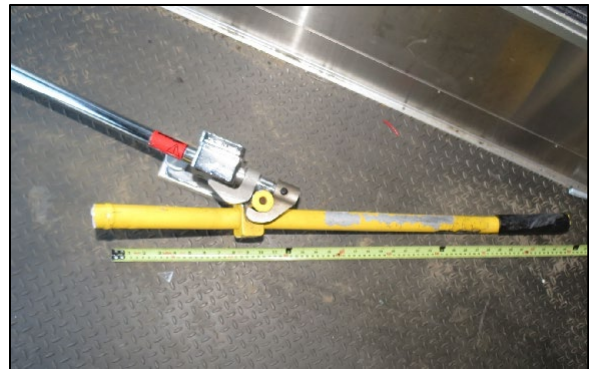
The rail clamp was not damaged other than a slight bend in the rod located aft of the floor anchor that may have been related to usage. The rail clamp securement bar on the cot was fractured and separated from the cot during the crash and remained locked in the rail clamp (**Figure 10**).

**Figure 10:** Cot's fractured rail clamp securement bar remained in rail clamp.

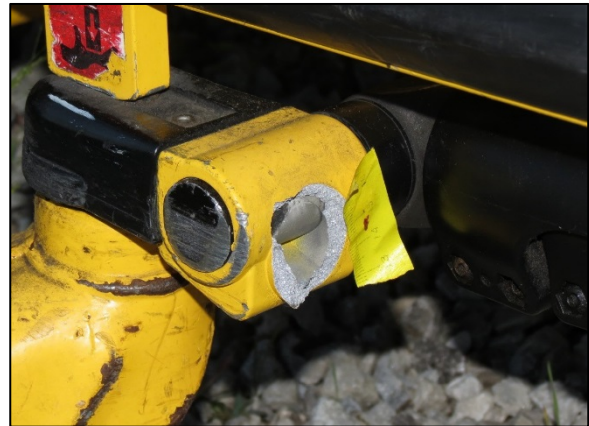
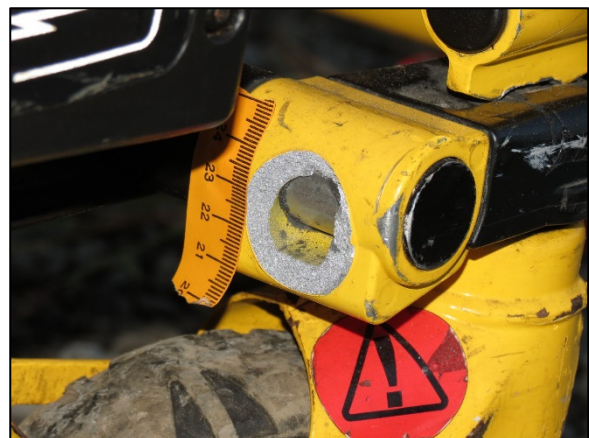
The fracture points were located at each end of the 89 cm (35 in) long securement bar where it was welded to the bracket on the cot (**Figures 11 and 12**). The fracturing of the rail clamp securement bar and the lack of anchoring of the head end wheels in the antler bracket allowed the cot to be displaced forward during the initial impact. The right portion of the head end struck the seat cushion of the rear-facing paramedic seat and the left corner of the head end contacted the storage shelves located at the front right of the patient compartment. The left corner of the head end of the cot was scuffed and abraded from this contact. The displacement of the cot resulted in fracturing and displacement of the pole used for hanging an intravenous fluid pouch that was located on the right-side foot end of the cot. The left-side rail of the cot also fractured and separated from the cot. The patient remained restrained on the cot throughout the crash.

**Figure 11:** Fracture site on front bracket of rail clamp securement bar.

**Figure 12:** Fracture site on rear bracket of rail clamp securement bar.
