Special Crash Investigations On-Site Child Restraint System Crash Investigation Vehicle: 2009 Pontiac G6 Location: California Crash Date: September 2016

16. Abstract This report documents the investigation of a child restraint system (CRS) used by a 2-year-old male occupant of a 2009 Pontiac G6 involved in a rollover crash. The crash occurred at 1330 hours in September 2016 on a curved, two-lane, State highway in rural California. The Pontiac was being driven westbound by an unbelted 54-year-old female. The second row was occupied by a 2-year-old male seated in a forward-facing CRS. The vehicle was traveling at an EDR-reported speed of 129 km/h (80 mph) when the driver lost control, struck an embankment, and overturned. As the Pontiac struck the embankment, it began a sharp clockwise rotation, tripped, and then began a left-side-leading rollover. The vehicle rolled six quarter-turns before coming to rest on its roof on the roadway. The driver was partially ejected and fatally injured. The 2-year-old remained restrained in the CRS and sustained minor injuries. The Pontiac was towed due to damage.

Special Crash Investigations
On-Site Child Restraint System Investigation
Case Number

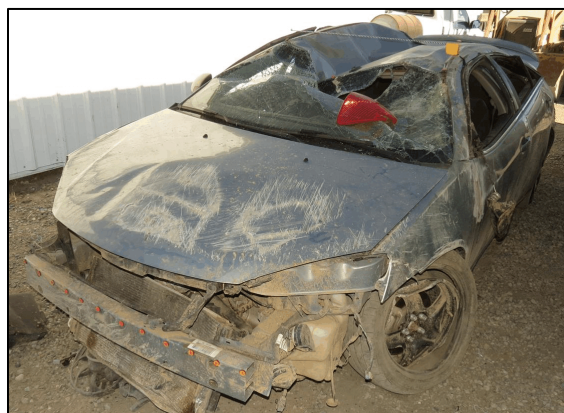
Figure 1. 2009 Pontiac G6

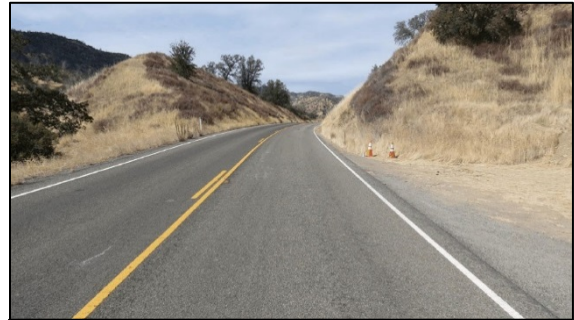
The crash site was an east/west, two-lane, undivided State roadway (**Figure 2**). The asphalt roadway was initially straight before transitioning to a right curve with a radius of 574 m (1,886 ft). The travel lanes were separated by solid/dashed yellow lines in the straight portion and double yellow lines in the curved portion. The roadway was bordered by white fog lines on either side and steep rising embankments. The roadway was dry at the time of the crash. The posted speed limit was 105

Figure 2. Westbound travel path

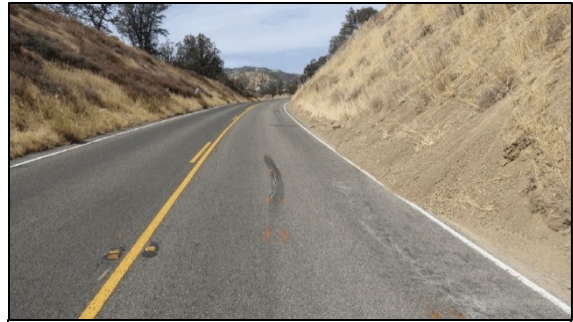
As the vehicle departed the roadway on the right, the front plane struck the dirt embankment (**Figure 3**). The EDR reported a maximum longitudinal delta-V of -38.1 km/h (-23.7 mph) at 170 ms and a maximum lateral delta-V of 21.7 km/h (13.5 mph) at 170 ms. The WinSMASH barrier option calculated a total delta-V of 12.0 km/h (7.4 mph). The longitudinal and lateral values were -10.0 km/h (6.2 mph) and 6.0 km/h (3.7 mph), respectively. The WinSMASH results were considered low. The vehicle sustained damage below the bumper that could not be included in the measured crush profile.

Figure 3. Area of embankment impact

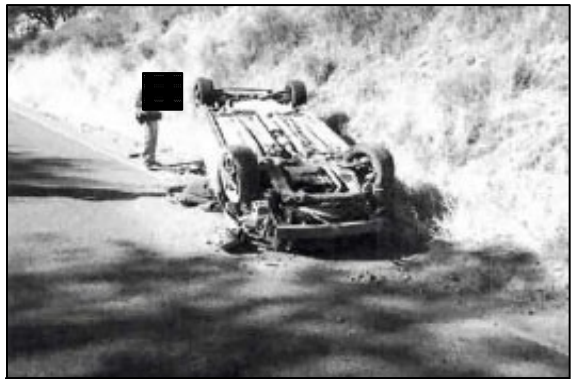
The driver's air bag deployed and the seat belt pretensioners actuated during the embankment impact. The Pontiac began a sharp clockwise rotation, tripped, and began a left-side-leading rollover. The vehicle rolled six quarter-turns before coming to rest on its roof on the north roadside facing east (**Figure 4**). The distance from trip to final rest was approximately 55 m (180 ft).

Figure 4. 2009 Pontiac G6, final rest (police photo)

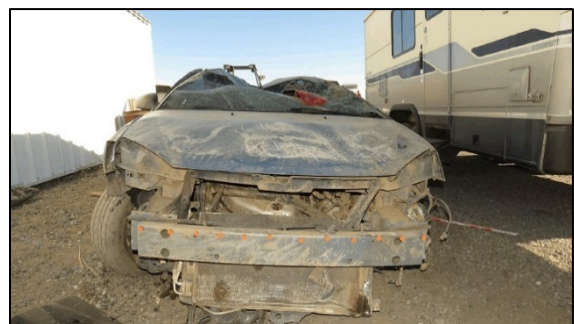
The Pontiac sustained moderate front plane damage from the impact to the dirt embankment during Event 1 (**Figure 5**). The direct damage began at the right bumper corner and extended 40.0 cm (15.7 in) to the left. The direct damage was also located along the width of the undercarriage and lower radiator. The Field L extended from bumper corner to bumper corner. Twelve measurements were taken at bumper backing bar level by the Nikon Total Station and the Faro Blitz program computed crush measurement in six increments as follows: $C_1 = 1.0$ cm (0.4 in), $C_2 = 0$ cm, $C_3 = 0$ cm, $C_4 = 0$ cm, $C_5 = 1$ cm (0.4 in), $C_6 = 1$ cm (0.4 in). The calculated principal direction of

Figure 5. Frontal damage, 2009 Pontiac G6

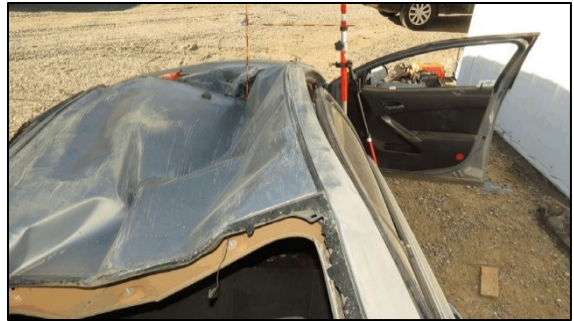
force was 330 degrees. The Collision Deformation Classification was 11FDEW1. During the rollover (Event 2), the Pontiac sustained direct damage to the top plane. The damage to the top plane included the hood and roof (**Figure 6**) and extended from roof side rail to roof side rail. The maximum vertical crush was located 23.0 cm (9.0) left of the roof side rail at the mid windshield header and measured 35.0 cm (13.7 in). The CDC was 00TDDO3. The trunk lid was damaged and appeared to have been pried open to access the trunk contents.

Figure 6. Rollover damage, 2009 Pontiac G6

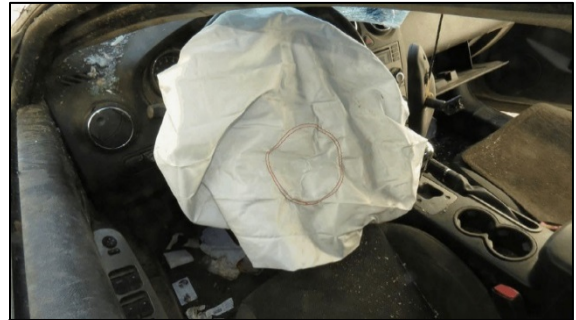
Figure 7. Driver's air bag, 2009 Pontiac G6

Both stages of the driver's frontal air bag deployed from the steering wheel hub during the impact with the dirt embankment (**Figure 7**). The air bag measured 48.0 cm (18.8 in) in width, and was configured with two vent ports and a single tether. There was no damage or contacts to the air bag. The passenger's frontal air bag and both left and right IC air bags did not deploy.

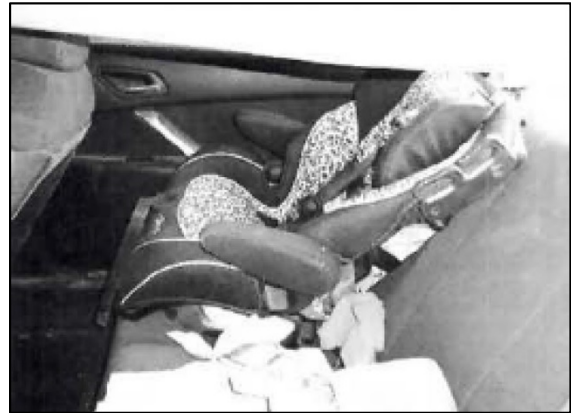
The Safety 1st Alpha Omega Convertible CRS was a 3-in-1 safety seat being used in a forward-facing orientation (**Figure 8**). It was installed in the second row right position using the vehicle's lap and shoulder belt. The seat had been removed from the vehicle prior to the SCI vehicle inspection.

The CRS was installed using the vehicle's lap and shoulder belt routed through the forward-facing belt path. The right arm was locked in the up position and could not be moved. There was no other damage to the CRS.

Figure 8. Safety 1st Alpha Omega Convertible CRS (police photo)

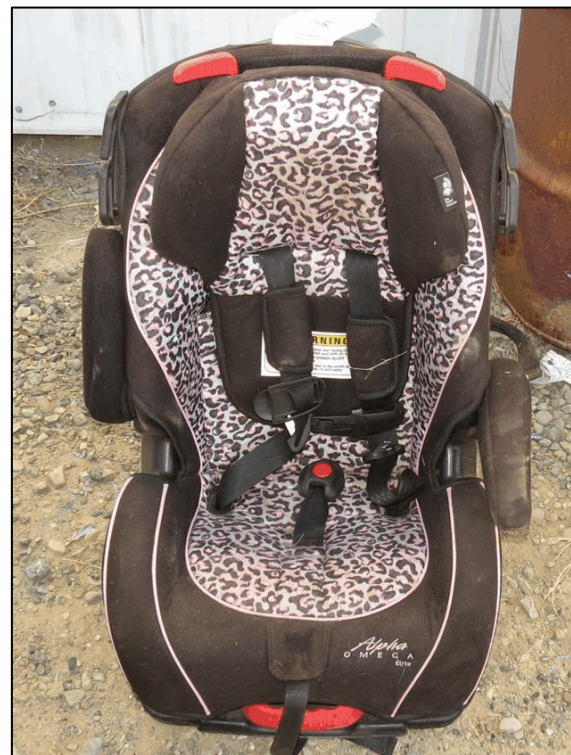
The model number was WCE2B830507 and the date of manufacture was 7/9/2015. The Safety 1st was configured with a 5-point harness system with buckle and retainer clip and two level harness slots (**Figure 9**). The seat was designed to be used with or without the internal harness. The occupant parameters for using the seat forward-facing with the harness are as follows.

Figure 9. Safety 1st Alpha Omega Elite CRS

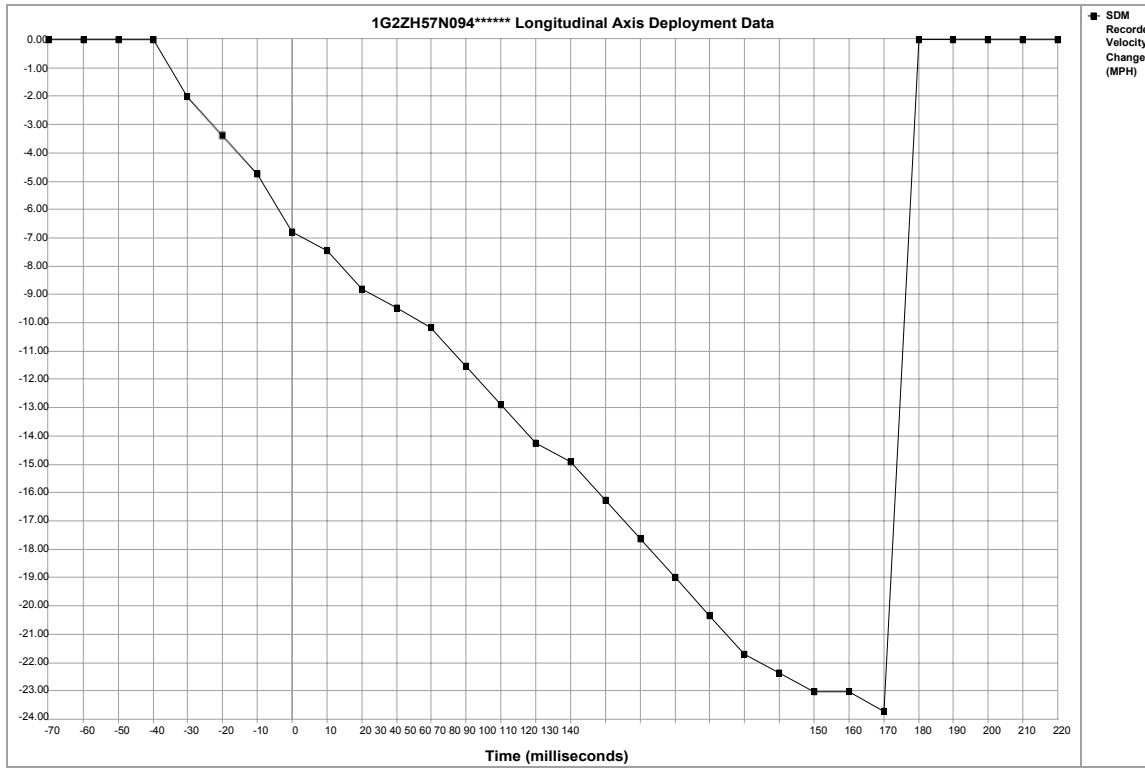
Time (milliseconds)	-70	-60	-50	-40	-30	-20	-10	0	10	20	30	40	50	60	70
SDM Longitudinal Axis Recorded Velocity Change (MPH)	0.00	0.00	0.00	0.00	-2.03	-3.39	-4.74	-6.78	-7.45	-8.81	-9.49	-10.17	-11.52	-12.88	-14.23
Time (milliseconds)	80	90	100	110	120	130	140	150	160	170	180	190	200	210	220
SDM Longitudinal Axis Recorded Velocity Change (MPH)	-14.91	-16.26	-17.62	-18.98	-20.33	-21.69	-22.36	-23.04	-23.04	-23.72	0.00	0.00	0.00	0.00	0.00

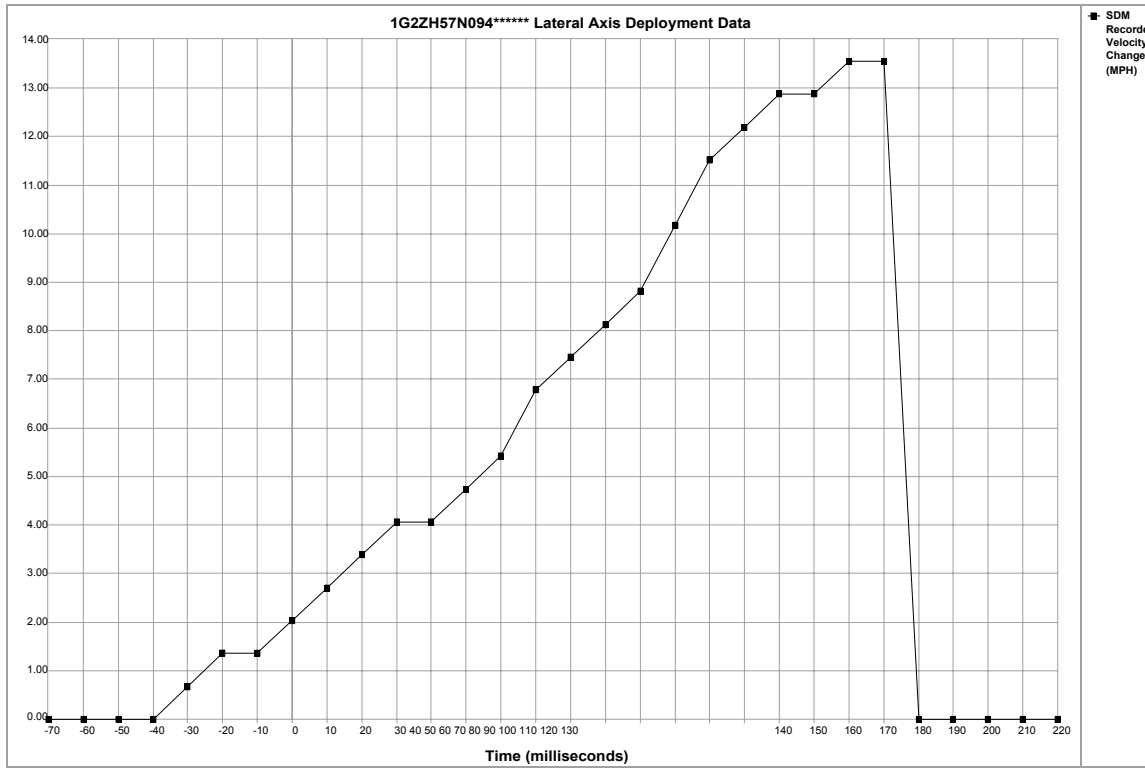
Time (milliseconds)	-70	-60	-50	-40	-30	-20	-10	0	10	20	30	40	50	60	70
SDM Lateral Axis Recorded Velocity Change (MPH)	0.00	0.00	0.00	0.00	0.68	1.36	1.36	2.03	2.71	3.39	4.07	4.07	4.74	5.42	6.78
Time (milliseconds)	80	90	100	110	120	130	140	150	160	170	180	190	200	210	220
SDM Lateral Axis Recorded Velocity Change (MPH)	7.45	8.13	8.81	10.17	11.52	12.20	12.88	12.88	13.55	13.55	0.00	0.00	0.00	0.00	0.00
