DOT HS 812 730

# **Special Crash Investigations Guardrail End Terminal Investigation**

## **Vehicle: 2010 Ford Fusion**

**Special Crash Investigations**  
**Case Number DS17008**  
**Guardrail End Terminal Investigation**  
**Vehicle: 2010 Ford Fusion**  
**Location: Missouri**  
**Crash Date: May 2017**

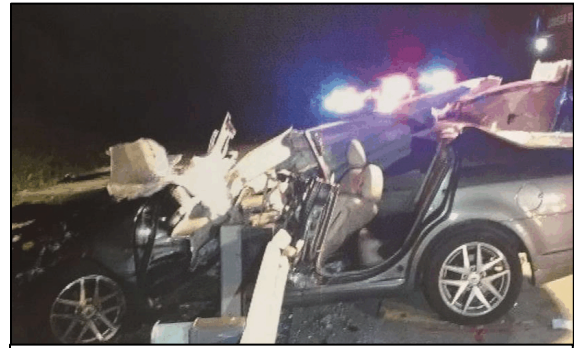
**Figure 1.** 2010 Ford Fusion, final rest looking east (state transportation photo)

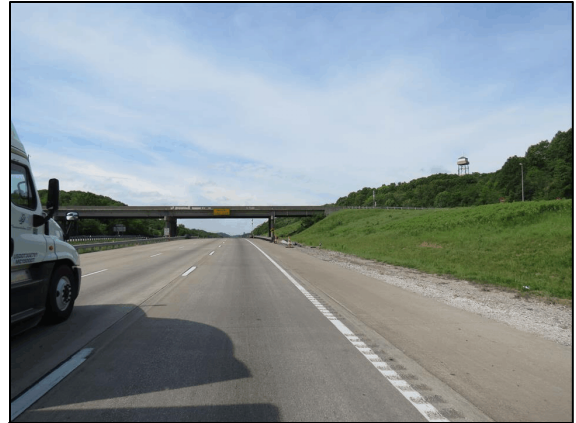
**Figure 2.** Westbound approach

The crash site was the westbound lanes of a three-lane, divided interstate highway in a suburban area of Missouri (**Figure 2**). The concrete roadway had a slight left curve with a radius of 2,358 m (7,737 ft). The roadway had a super elevation of 1.3 percent and a -2 percent grade. The travel lanes were separated by dashed white lines. The roadway was bordered on the right by a white fog line (with a rumble strip), concrete shoulder, and a metal W-beam guardrail. It was bordered on the left by a yellow fog line, concrete shoulder, and a metal W-beam guardrail. The roadway was dry and the lighting condition was dark at the time of the crash. The posted speed limit was 112 km/h (70 mph). The

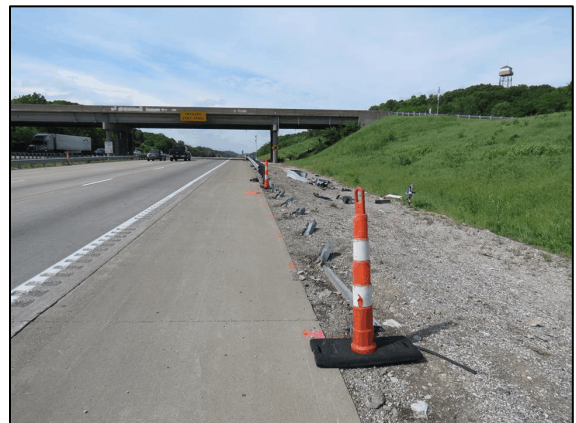
**Figure 3.** Point of impact area with guardrail end treatment, looking west

As the vehicle departed the shoulder on the right, the front plane struck the ET-Plus barrier end terminal (**Figure 3**). The WinSMASH program calculated at a barrier equivalent speed (BES) of 29 km/h (18 mph). The EDR reported a maximum longitudinal delta V of -34.62 km/h (-21.51 mph) and a maximum lateral delta V of 2.03 km/h (1.26 mph). The driver's frontal, inflatable side curtain and seat-mounted side air bags deployed and the driver's seat belt pretensioner actuated during this impact. The guardrail extruded to the field side for 8.8 m (29 ft) before kinking (**Figure 4**). The vehicle rotated clockwise 90 degrees and the left plane of the vehicle was struck and penetrated by the kinking guardrail (**Figure 5**). The EDR reported an unlocked event that included the impacts to the left side of the vehicle. The EDR-reported maximum longitudinal delta V was 2.94 km/h (1.82 mph). The maximum lateral delta V was -9.30 km/h (-5.78 mph). The vehicle traveled an

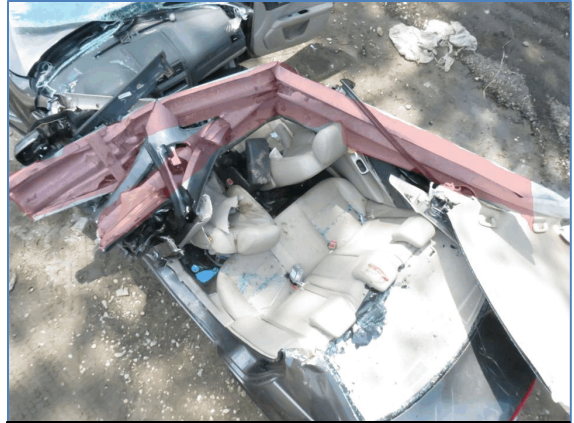
**Figure 5.** Kinked guardrail in 2010 Ford Fusion

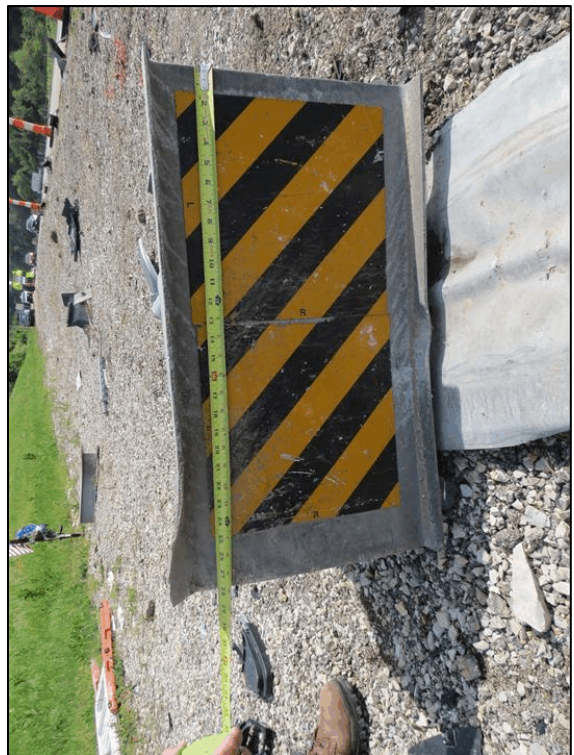
The guardrail end terminal in this crash was a Trinity ET-Plus 4-inch extruder-type end treatment (Figure 6). The head measured 71.0 x 38.0 cm (28.0 x 15.0 in) with a guide chute exit height of 29.2 cm (11.5 in). There were no indications of previous damage. An anchor cable was present and initially attached to post 1. The steel posts measured 15.2 x 10.1 cm (6.0 x 4.0 in) and were assembled with composite offset blocks and 187.9 cm (74.0 in) spacing. The guardrail height was 71.1 cm (28.0 in). During the crash the rail extruded 8.8 m (29.0 ft) to the field side. The anchor cable was disconnected as the guardrail head was displaced. Post 1 was displaced from its position. Posts 2-9 were deformed to the west along the path of the vehicle. The guardrail kinked in four places, beginning at post 6 and ending at post 10. The kinked guardrail penetrated the vehicle. There were four distinct sections, measuring 107.0 cm (42.1 in), 208.0 cm (81.8 in), 192.0 cm (75.5 in), and 162.0 cm (63.7 in) in length. The total length of rail damaged (including extruded rail) was 17.6 m (58 ft).

**Figure 6.** Trinity ET-Plus 4-inch end treatment

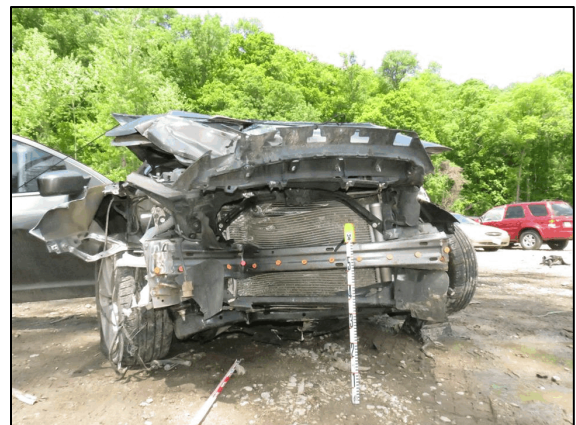
The Ford sustained moderate front plane damage from the impact with the guardrail end treatment (**Figure 7**). The direct damage began at the right bumper corner and extended 32.0 cm (12.5 in) to the left. The Field L extended from bumper corner to bumper corner. Thirteen measurements were taken at bumper backing bar level by the Nikon Total Station and the Faro Blitz program computed crush measurement in six increments as follows: C1 = 0 cm, C2 = 5.0 cm (1.9 in), C3 = 16.0 cm (6.2 in), C4 = 29.0 cm (11.4 in), C5 = 23.0 cm (9.0 in), C6 = 16.0 cm (6.6 in). The calculated principal direction of force was 0 degrees. The collision deformation classification (CDC) was 12FREE2.

**Figure 7.** Frontal damage, 2010 Ford Fusion

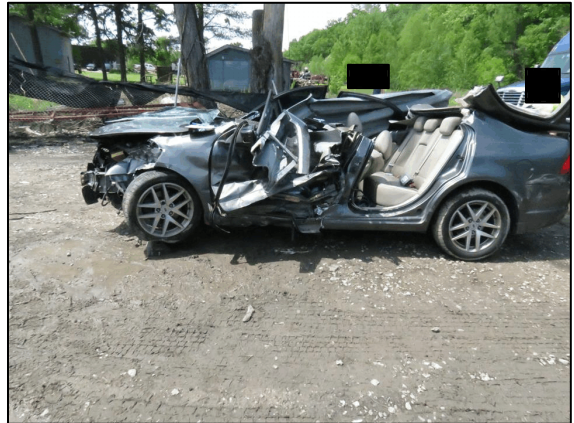
As the vehicle rotated and the guardrail penetrated the left side, the vehicle sustained moderate left plane damage (**Figure 8**). The type of damage sustained and damaged caused by extrication precluded obtaining crush measurements. The direct damage began at the left front corner and extended rearward 190.0 cm (74.8 in). The estimated CDC was 09LYEW3.

**Figure 8.** Left plane damage, 2010 Ford Fusion

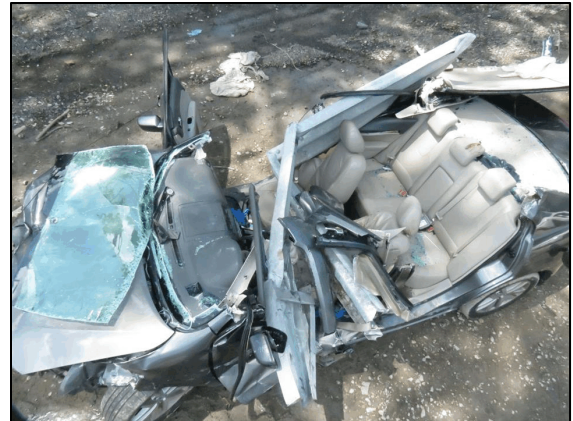
The Ford sustained major interior damage from intrusions, occupant contacts, integrity loss, and extrication efforts (**Figure 9**). The left door was deformed laterally. The driver seat was deformed longitudinally. The steering wheel rim was deformed forward 12.0 cm (4.7 in). Four segments of the guardrail beam intruded into both the front and second row. All the doors were jammed shut. The roof and left doors were removed during extrication.

**Figure 9.** Interior damage, 2010 Ford Fusion

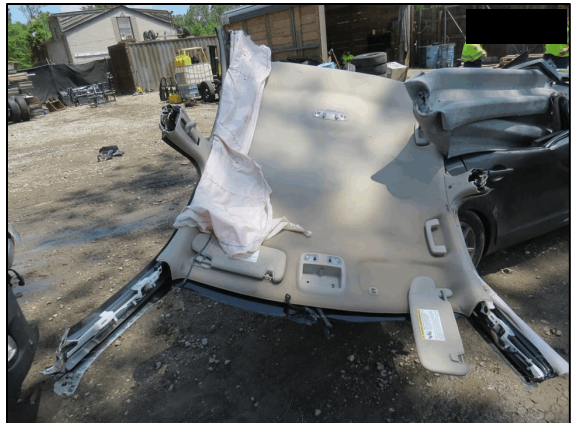
Both stages of the driver's frontal air bag deployed from the steering wheel hub during the impact with the guardrail end treatment. The left seat-mounted side air bag and left IC air bags also deployed during this impact (**Figure 10**). The frontal air bag and seat-mounted side air bag were entrapped by the intruding guardrail beams and could not be measured. The left IC air bag measured 38.0 x 150.0 cm (14.9 x 59.0 in).

**Figure 10.** Left IC air bag, 2010 Ford Fusion
