Air Bag Non-Deployment Crash Investigation

Vehicle: 2010 Dodge Charger

Location: California

Crash Date: November 2016

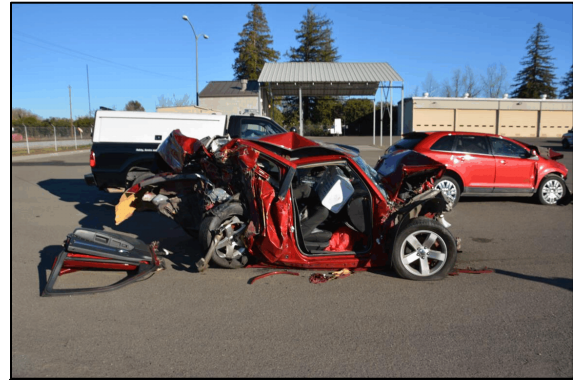
Figure 1. 2010 Dodge Charger

This report documents the on-site investigation of air bag non-deployments in a 2010 Dodge Charger involved in a head-on crash with a 2010 Ford Edge, followed by rear-end crash with a 2015 International tractor-trailer rig (**Figure 1**).

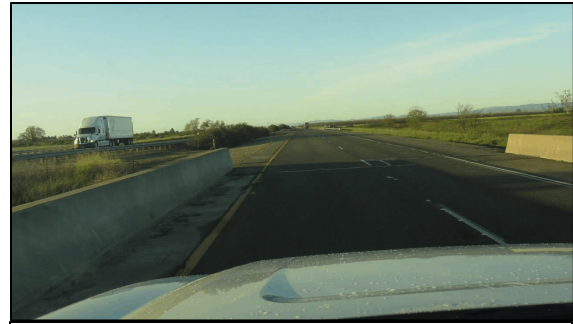
Figure 2. Southbound travel lanes

The crash site was in the southbound lanes of a divided interstate highway (**Figure 2**). The two straight travel lanes were separated from the northbound lanes by a depressed grass-covered median interspersed with bushes. The roadway was bordered on the right by a solid white fog line and an asphalt shoulder and was bordered on the left by a solid yellow line and an asphalt shoulder. It was dark at the time of the crash and there were no streetlights present. The posted speed limit was 112 km/h (70 mph). The weather at the nearest reporting station was 3 degrees C (38 degrees F), 93 percent humidity, clear visibility, clear skies, and calm winds. Crash diagrams are included at the end of this technical report.

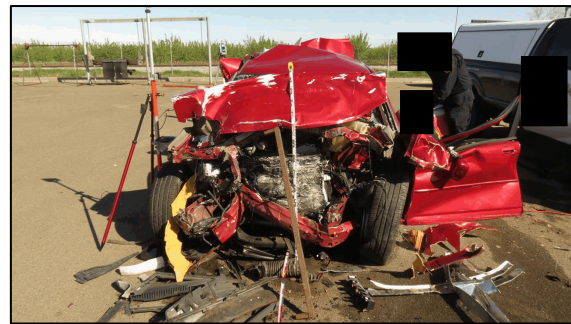
Figure 3. 2010 Dodge Charger, front plane damage

The Dodge sustained severe damage to the front plane during the impact with the Ford (Event 1) and possibly sustained some additional damage as the vehicle was displaced forward during the rear plane impact and struck the Ford a second time (Event 3). The direct damage began at the left bumper corner and extended 120.0 cm (47.2 in) to the right bumper corner (**Figure 3**). Fourteen measurements were taken at the bumper backing bar level by the Nikon Total Station and the Faro Blitz program computed crush measurement in six increments as follows: $C_1 = 95$ cm (37.4 in), $C_2 = 90$ cm (35.4 in), $C_3 = 99$ cm (38.9 in), $C_4 = 102$ cm (40.1 in), $C_5 = 103$ cm (40.5 in), $C_6 = 74$ cm (29.1 in). The Collision Deformation Classification (CDC) was 12FDEW5.

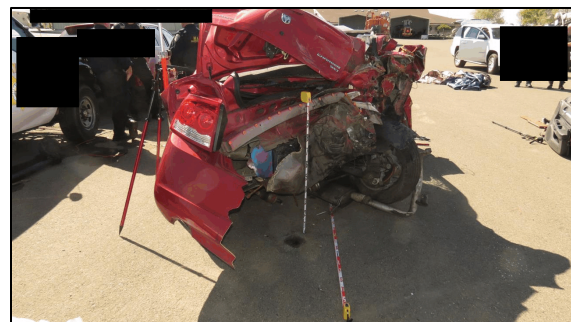
Figure 4. 2010 Dodge Charger, rear plane damage

The vehicle sustained severe damage to the rear plane during the impact with the International (Event 2). The direct damage began at the right bumper corner and extended 80 cm (31.4 in) to the left (**Figure 4**). Thirteen measurements were taken at the bumper backing bar level by the Nikon Total Station and the Faro Blitz program computed crush measurement in six increments as follows: $C_1 = 0$ cm, $C_2 = 14$ cm (5.5 in), $C_3 = 41$ cm (16.1 in), $C_4 = 64$ cm (25.1 in), $C_5 = 80$ cm (31.4 in), $C_6 = 86$ cm (33.8 in). The CDC was 06BZEW5.

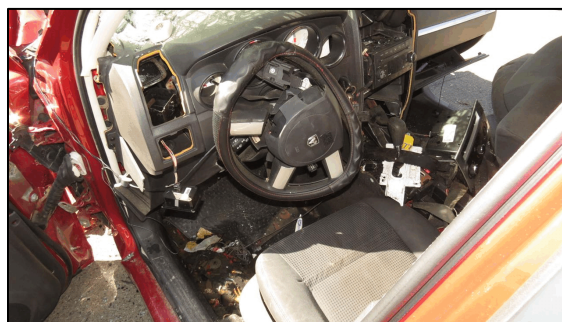
Figure 5. Steering wheel deformation, 2010 Dodge Charger

The Dodge sustained severe interior damage as a result of intrusion, occupant contacts, and integrity loss. The vehicle sustained longitudinal intrusions to the second row from the seat backs and the backlight header. There was a longitudinal intrusion to the front row from the right passenger seat back. All four doors were jammed shut; the left front door was pried open and the right front door was removed to extricate the driver. There was integrity loss for the backlight glazing and the side windows. The steering wheel rim was deformed forward from occupant contact (**Figure 5**). The driver's seat back was deformed rearward due to driver loading. There was loading evidence documented to the driver's seat belt. The instrument panel was damaged due to occupant contact and removal of the center instrument panel/console to access the ACM.

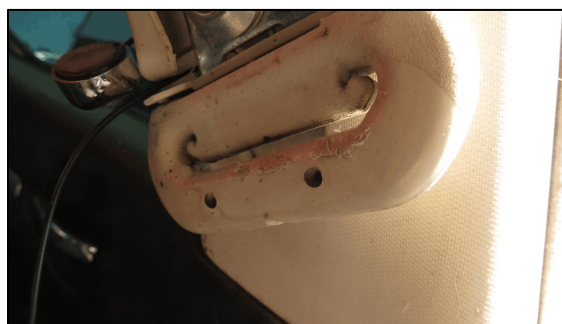
Figure 6. Upper anchor D-ring, 2010 Dodge Charger

The front row was equipped with driver and front right passenger lap and shoulder seat belts. The driver's belt was equipped with continuous loop belt webbing, a sliding latch plate, an emergency locking retractor (ELR), and an adjustable upper anchor that was adjusted to the full down position. The front right passenger's seat belt was equipped the same as the driver's, but had a switchable ELR/automatic locking retractor (ALR). Inspection of the driver's seat belt assembly revealed loading evident to the seat belt webbing and the D-ring (**Figure 6**).

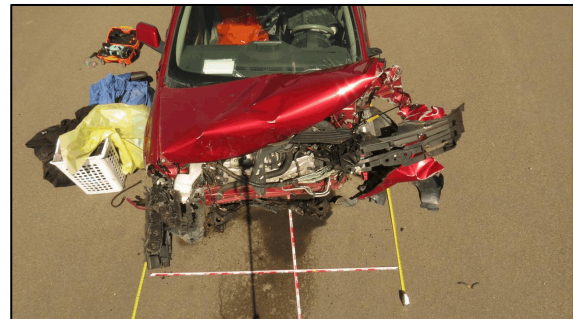
Figure 7. 2010 Ford Edge, frontal damage

The Ford sustained major damage to the front plane from the head-on impact with the Dodge (Event 1) and possibly sustained some additional damage as the vehicle was struck by the Ford a second time (Event 3). The direct damage began at the left bumper corner and extended 130 cm (51.1 in) to the right bumper corner (**Figure 7**). Twelve measurements were taken at the backing bar level by the Nikon Total Station and the Faro Blitz program computed crush measurement in six increments as follows: C1 = 44 cm (17.3 in), C2 = 46 cm (18.1 in), C3 = 46 cm (18.1 in), C4 = 42 cm (16.5 in), C5 = 30 cm (11.8 in), C6 = 17 cm (6.7 in). The CDC was 12FDEW3. The vehicle sustained minor damage to the rear bumper from the impact to the bridge rail (Event 4). The CDC was 09BYLS1.

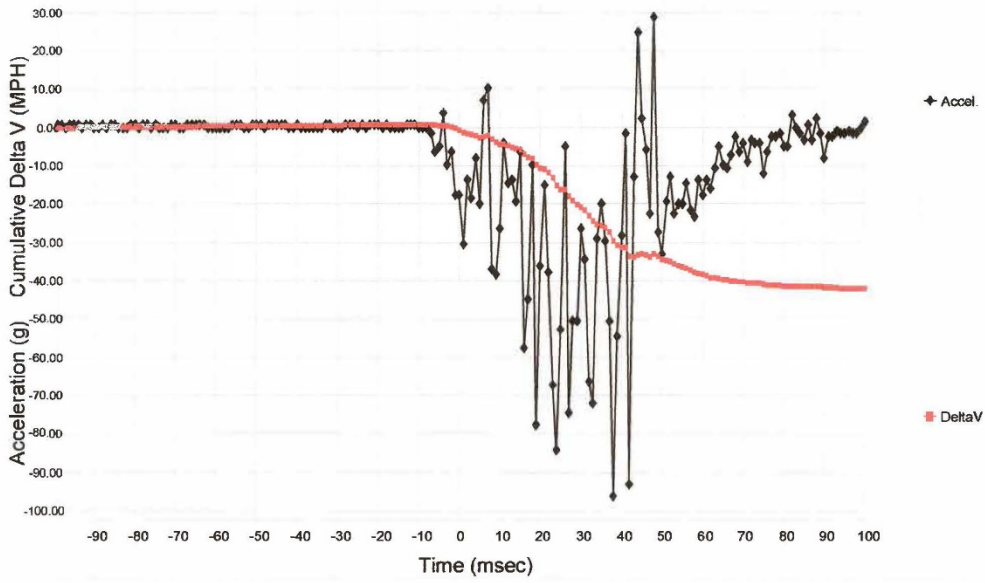
Longitudinal Crash Pulse (First Record)

The deployment events resulted from the impact with the front plane of the Dodge. The event was complete and locked. The maximum longitudinal delta-V was -67.45 km/h (-41.91) at 100 ms. The first stage driver's frontal air bag deployed at 8.0 ms, the second stage deployed at 18.0 ms. The seat belt pretensioner actuated at 8.0 ms.
