DOT HS 812 816

Special Crash Investigations On-Site Guardrail End Terminal Investigation Vehicle: 2016 Volkswagen Jetta Location: California Crash Date: February 2018

**Special Crash Investigations (SCI)
On-Site Guardrail End Terminal Investigation
Case Number: DS18005
Vehicle: 2016 Volkswagen Jetta
Location: California
Crash Date: February 2018**

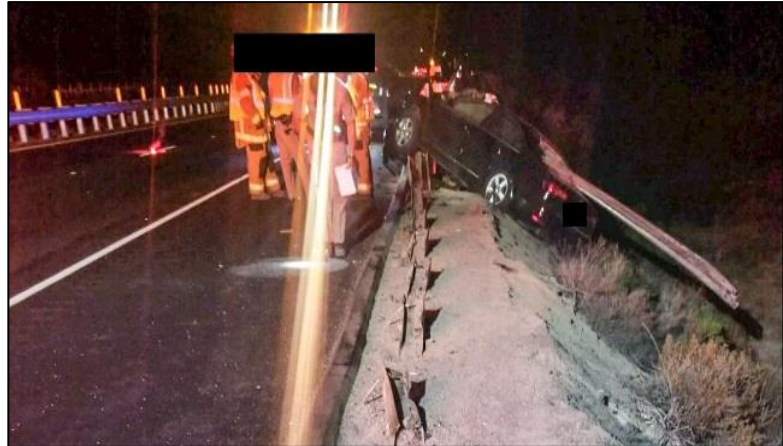
Figure 1. 2016 Volkswagen Jetta, final rest, looking east (California Department of Transportation image).

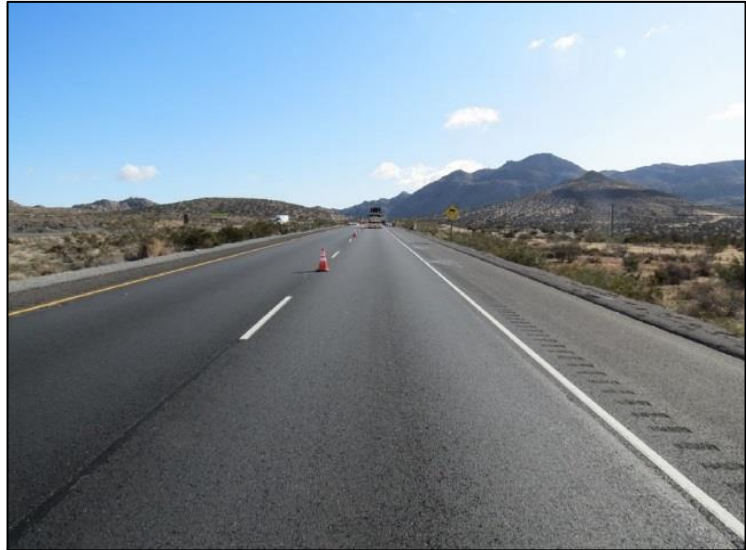
The crash site was the eastbound lanes of a two-lane divided interstate highway in a rural area of California (**Figure 2**). The asphalt roadway was straight and had a positive 1 percent grade. The travel lanes were separated by dashed white lines. The roadway was bordered on the right by a white fog line, asphalt shoulder with rumble strip, asphalt curb, and metal W-beam guardrail. It was bordered on the left by a yellow fog line, asphalt shoulder, and metal W-beam guardrail. The roadway was dry and it was daylight at the time of the crash. The posted speed limit was 112 km/h (70 mph). The weather at the nearest report station was 12 degrees C (55 degrees F), 59 percent humidity, clear visibility and the wind direction was southwest at 29.6 km/h (18.4 mph). A crash diagram is attached at the end of this technical report.

Figure 2. Eastbound approach.

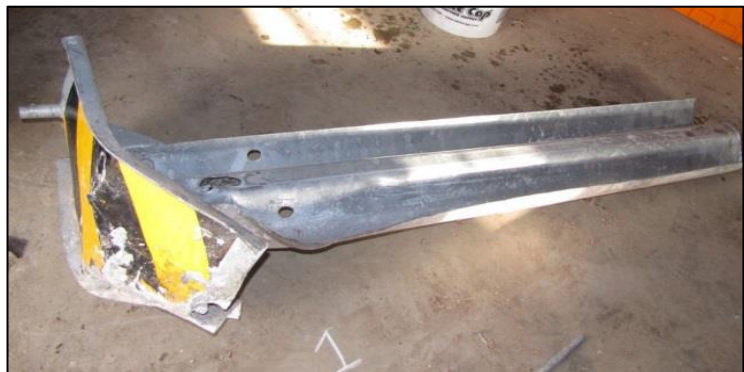
As the vehicle departed the shoulder on the right, the front plane struck the X-Lite barrier end terminal (**Figure 3**). The WinSMASH program calculated a barrier equivalent speed (BES) of 31 km/h (19.2 mph). The EDR reported a maximum longitudinal delta-V of -31.0 km/h (-19.2 mph) and a maximum lateral delta-V of -5.0 km/h (-3.1 mph). The driver's and

Figure 3. X-Lite barrier end terminal.

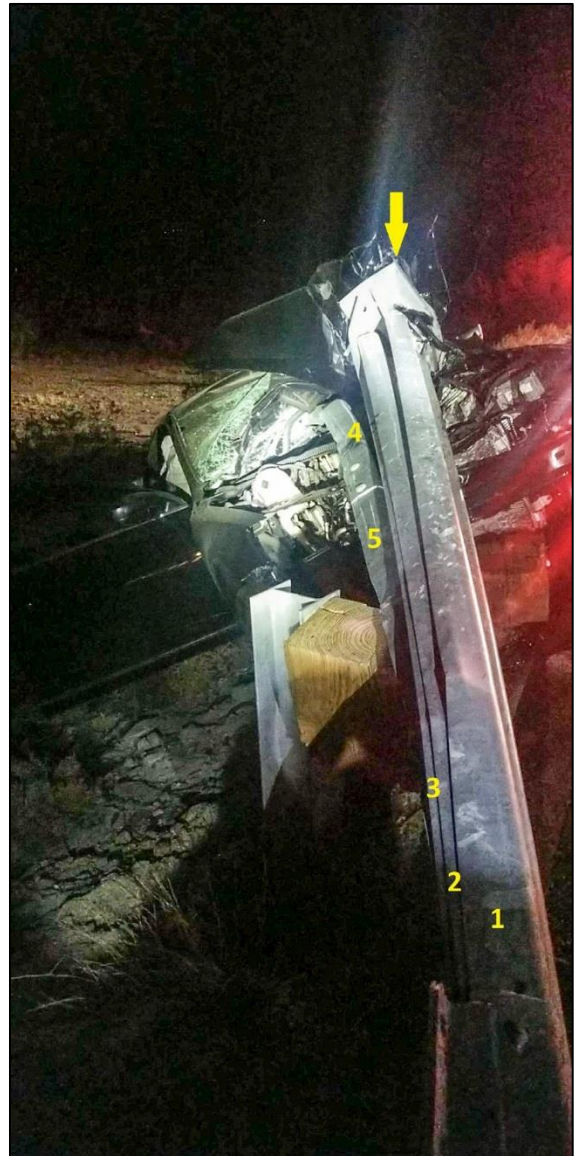
The guardrail end terminal in this crash was a Lindsay X-Lite tangent redirective gating guardrail terminal. It uses a fixed impact head on a W-beam rail section. During an end impact, the W-beam rails “telescope” back and energy is dissipated by friction. Special shear bolts are used at the W-beam splices to facilitate the telescoping action. When hit directly on the end, the vehicle pushes the first rail panel and the slider panel over the second rail panel (telescoping). The head measured 60 cm x 35 cm (24.0 x 14.0 in). It was designed with a ground strut between posts 1 and 2. A cable is attached to the slider bracket which is bolted to the second rail element. The first 9 steel posts measured 15 x 10 cm (6.0 x 4.0 in). The next 6 measured 15 x 15 cm (6.0 x 6.0 in). The posts were spaced approximately 190 cm (75.0 in) apart. The bolt slots for post 1 (leading) and post 2 (trailing) were aligned correctly. The guardrail height was 78 cm (31.0 in). During the crash, panels 1, 2, and 3 telescoped together and panel 4 penetrated the vehicle (**Figure 4**). Eleven posts were damaged and deformed as the vehicle overrode them. They were deformed in an easterly direction. The measured distance from the top of the posts to the ground was as follows:

- 1: 5 cm (1.9 in)
- 2: 2 cm (0.8 in)
- 3: 2 cm (0.8 in)

Figure 4. Struck terminal end, looking southwest (California Department of Transportation photo). Arrow shows end terminal position.

- 4: 4 cm (1.5 in)
- 5: 3 cm (1.3 in)
- 6: 5 cm (1.9 in)
- 7: 5 cm (1.9 in)
- 8: 11 cm (4.3 in)
- 9: 13 cm (5.1 in)
- 10: 13 cm (5.1 in)
- 11: 24 cm (9.4 in)

The total length of rail damaged was approximately 19.2 m (63.0 ft).

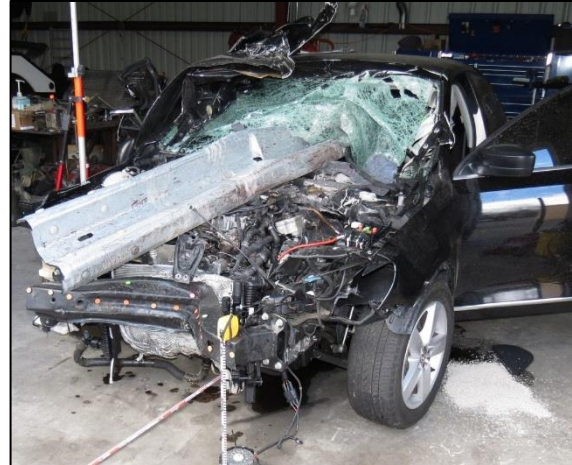
The Volkswagen sustained moderate front plane damage from the impact with the guardrail end terminal and the penetration of the passenger compartment (**Figure 5**). The direct damage began 26 cm (10.2 in) to the right of the left bumper corner and extended 50 cm (19.6 in) to the right. The Field L extended from bumper corner to bumper corner. Thirteen measurements were taken at bumper backing bar level by the Nikon Total Station, after adjusting for freespace, and the Faro Blitz program computed crush measurement in six increments as follows: $C_1 = 2$ cm (0.8 in), $C_2 = 15$ cm (5.9 in), $C_3 = 41$ cm (16.1 in), $C_4 = 30$ cm (11.8 in), $C_5 = 11$ cm (4.3 in), $C_6 = 6$ cm

Figure 5. Frontal damage, 2016 Volkswagen Jetta.

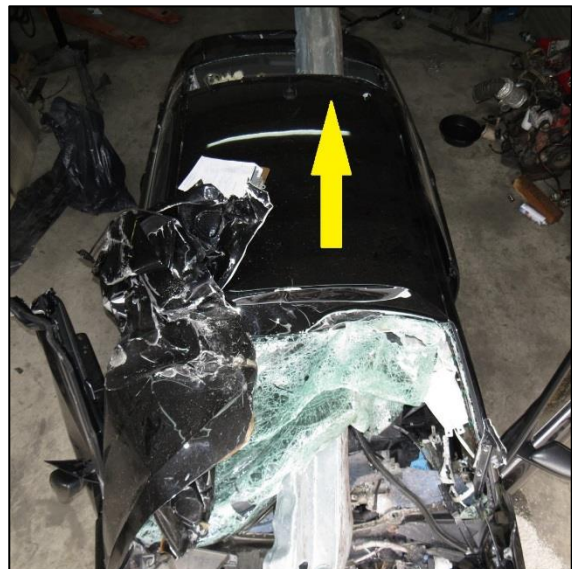
(2.3 in). The occupant compartment area was damaged by the hood after being displaced rearward by the end terminal and by being fully penetrated by one of the guardrail panels (**Figure 6**). The calculated principal direction of force, using the EDR longitudinal and lateral components, was 10 degrees. The collision deformation classification (CDC) was 12FYAW9.

Figure 6. 2016 Volkswagen Jetta, guardrail panel intrusion. Arrow indicates guardrail exiting vehicle through backlight.

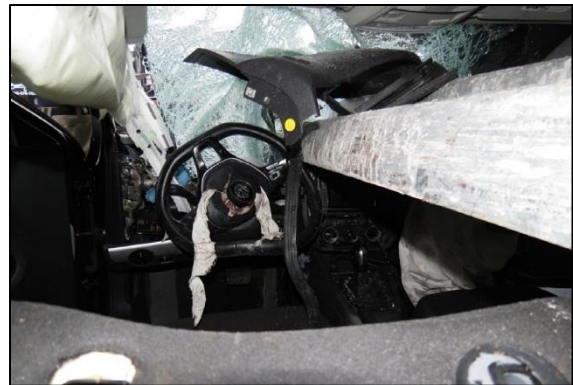
The Volkswagen sustained major interior damage from intrusion and occupant contacts (**Figure 7**). The damage included the windshield and backlight. The steering wheel was deformed due to occupant loading.

Figure 7. 2016 Volkswagen Jetta, interior damage.

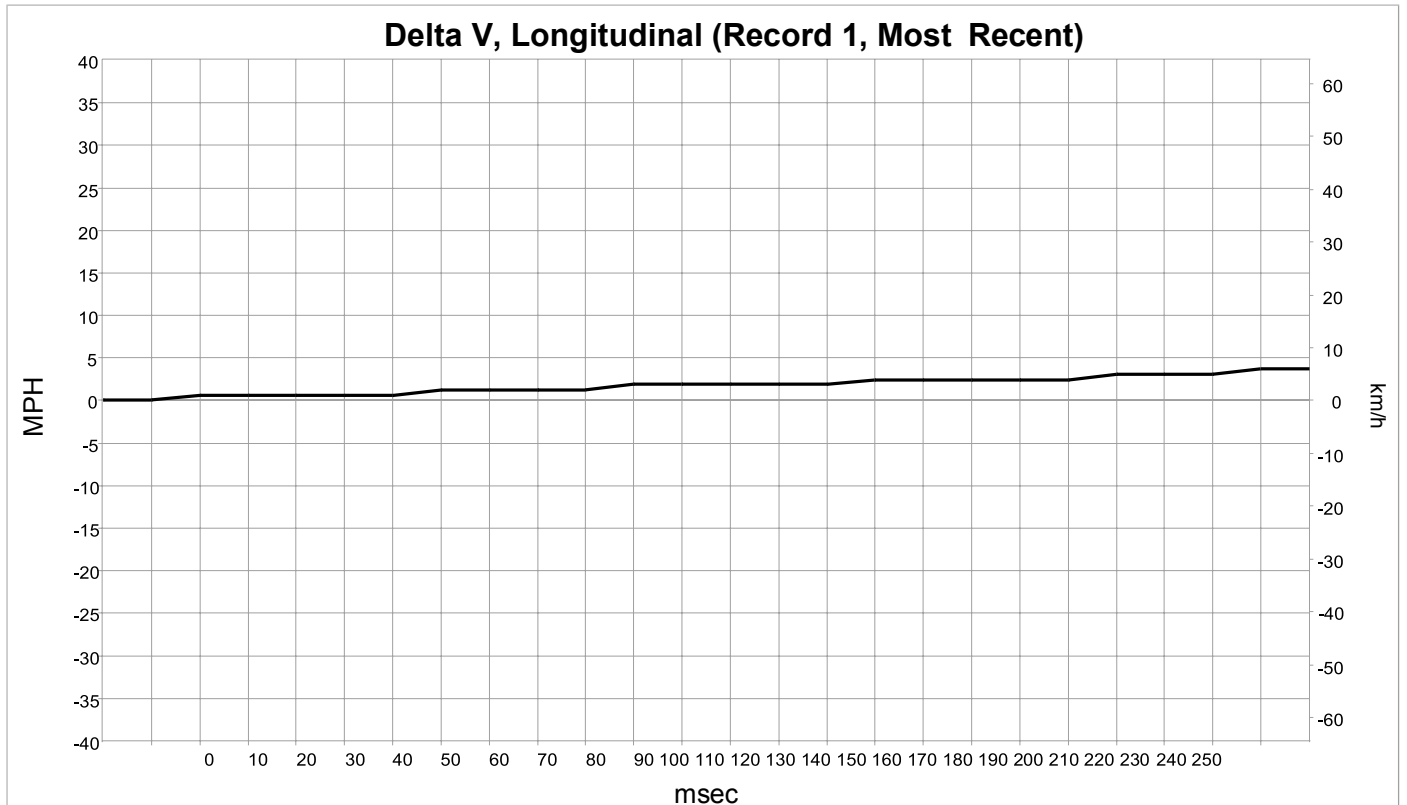
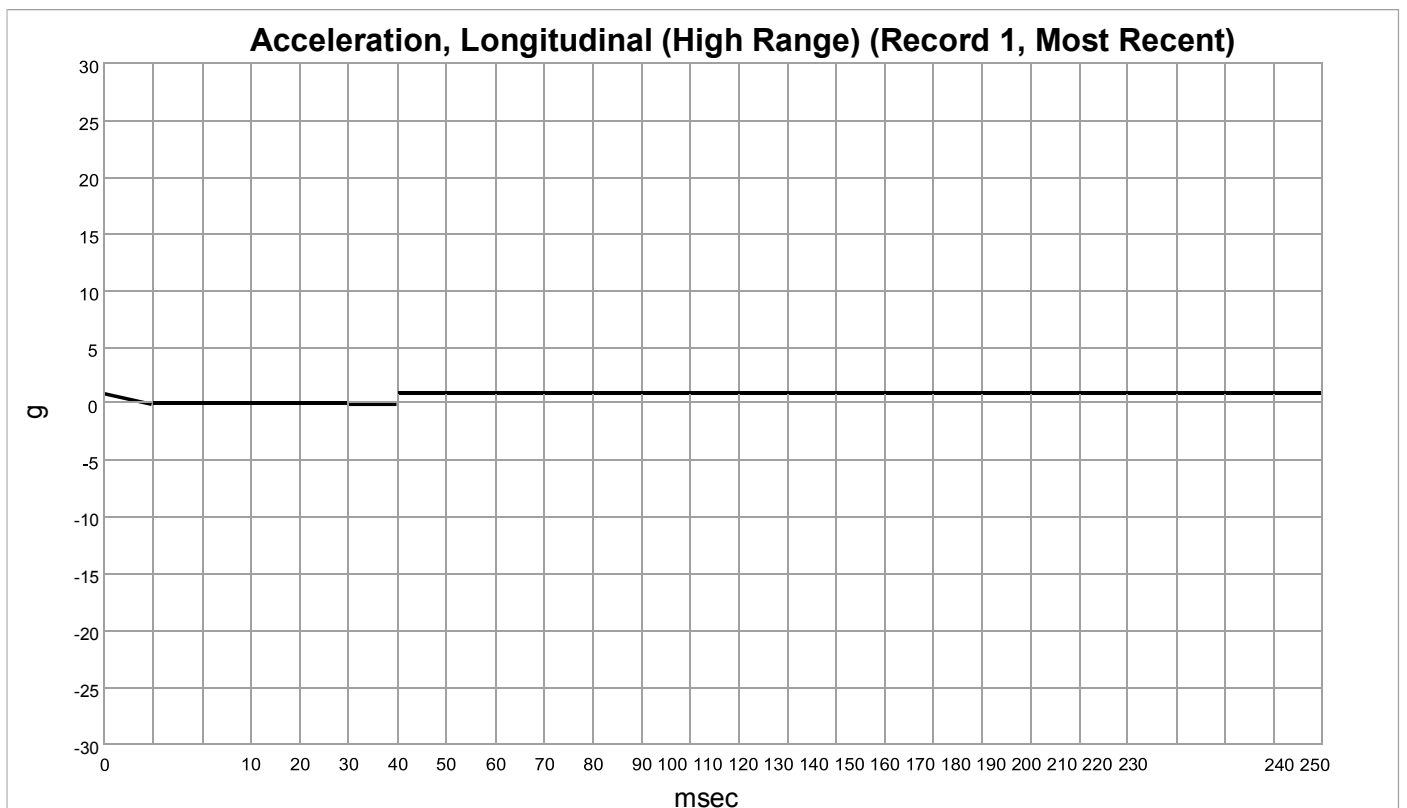
Longitudinal Crash Pulse (Record 1, Most Recent)

Time (msec)	Delta-V, Longitudinal (MPH [km/h])	Longitudinal Acceleration High Range (g)
0	0.0 [0]	0.60
10	0.0 [0]	0.47
20	0.6 [1]	0.38
30	0.6 [1]	0.42
40	0.6 [1]	0.47
50	0.6 [1]	0.49
60	0.6 [1]	0.50
70	1.2 [2]	0.55
80	1.2 [2]	0.59
90	1.2 [2]	0.64
100	1.2 [2]	0.67
110	1.9 [3]	0.66
120	1.9 [3]	0.60
130	1.9 [3]	0.55
140	1.9 [3]	0.57
150	1.9 [3]	0.57
160	2.5 [4]	0.57
170	2.5 [4]	0.53
180	2.5 [4]	0.53
190	2.5 [4]	0.54
200	2.5 [4]	0.57
210	3.1 [5]	0.60
220	3.1 [5]	0.64
230	3.1 [5]	0.68
240	3.7 [6]	0.74
250	3.7 [6]	0.80

The third event (Record 1) occurred 447 ms after the second. The maximum longitudinal delta-V was 8.0 km/h (5.0 mph). The maximum lateral delta-V was -6.0 km/h (-3.7 mph). The calculated principal direction of force was 140 degrees.

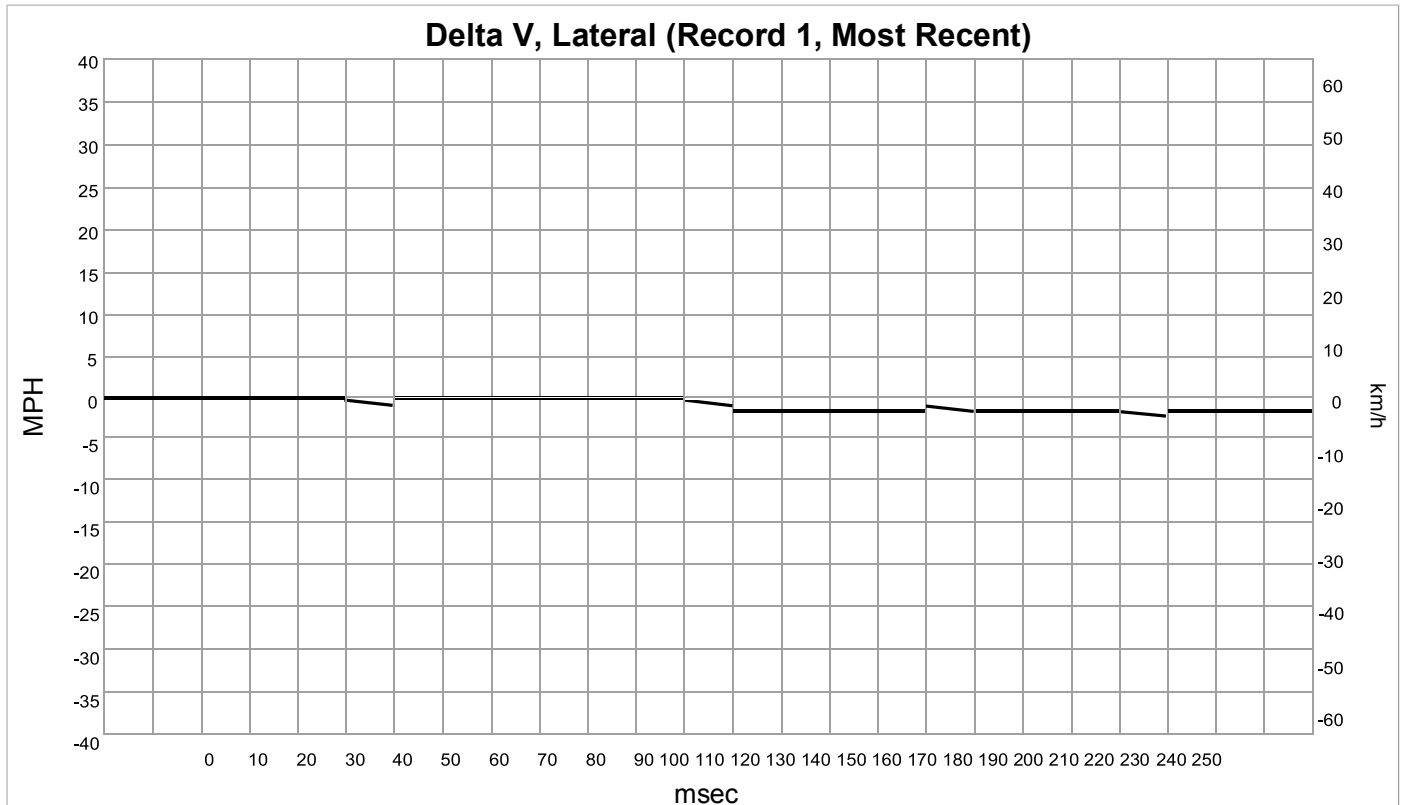
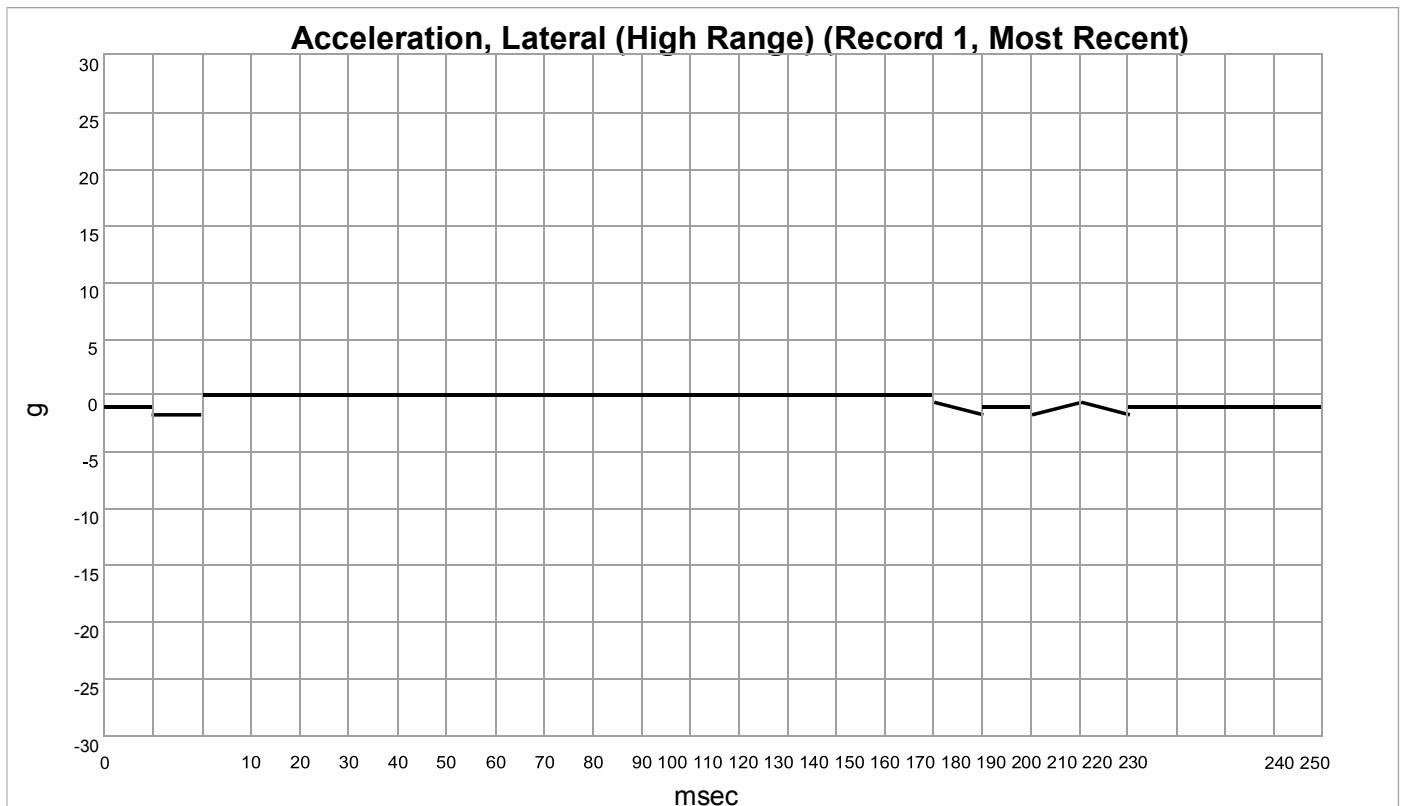
Lateral Crash Pulse (Record 1, Most Recent)

Time (msec)	Delta-V, Lateral (MPH [km/h])	Lateral Acceleration High Range (g)
0	0.0 [0]	-0.67
10	0.0 [0]	-0.61
20	0.0 [0]	-0.37
30	0.0 [0]	-0.20
40	0.0 [0]	-0.11
50	0.0 [0]	-0.16
60	-0.6 [-1]	-0.38
70	-0.6 [-1]	-0.42
80	-0.6 [-1]	-0.33
90	-0.6 [-1]	-0.39
100	-0.6 [-1]	-0.36
110	-0.6 [-1]	-0.28
120	-0.6 [-1]	-0.25
130	-1.2 [-2]	-0.36
140	-1.2 [-2]	-0.35
150	-1.2 [-2]	-0.36
160	-1.2 [-2]	-0.38
170	-1.2 [-2]	-0.46
180	-1.9 [-3]	-0.57
190	-1.9 [-3]	-0.50
200	-1.9 [-3]	-0.40
210	-1.9 [-3]	-0.56
220	-2.5 [-4]	-0.71
230	-2.5 [-4]	-0.78
240	-2.5 [-4]	-0.74
250	-2.5 [-4]	-0.71

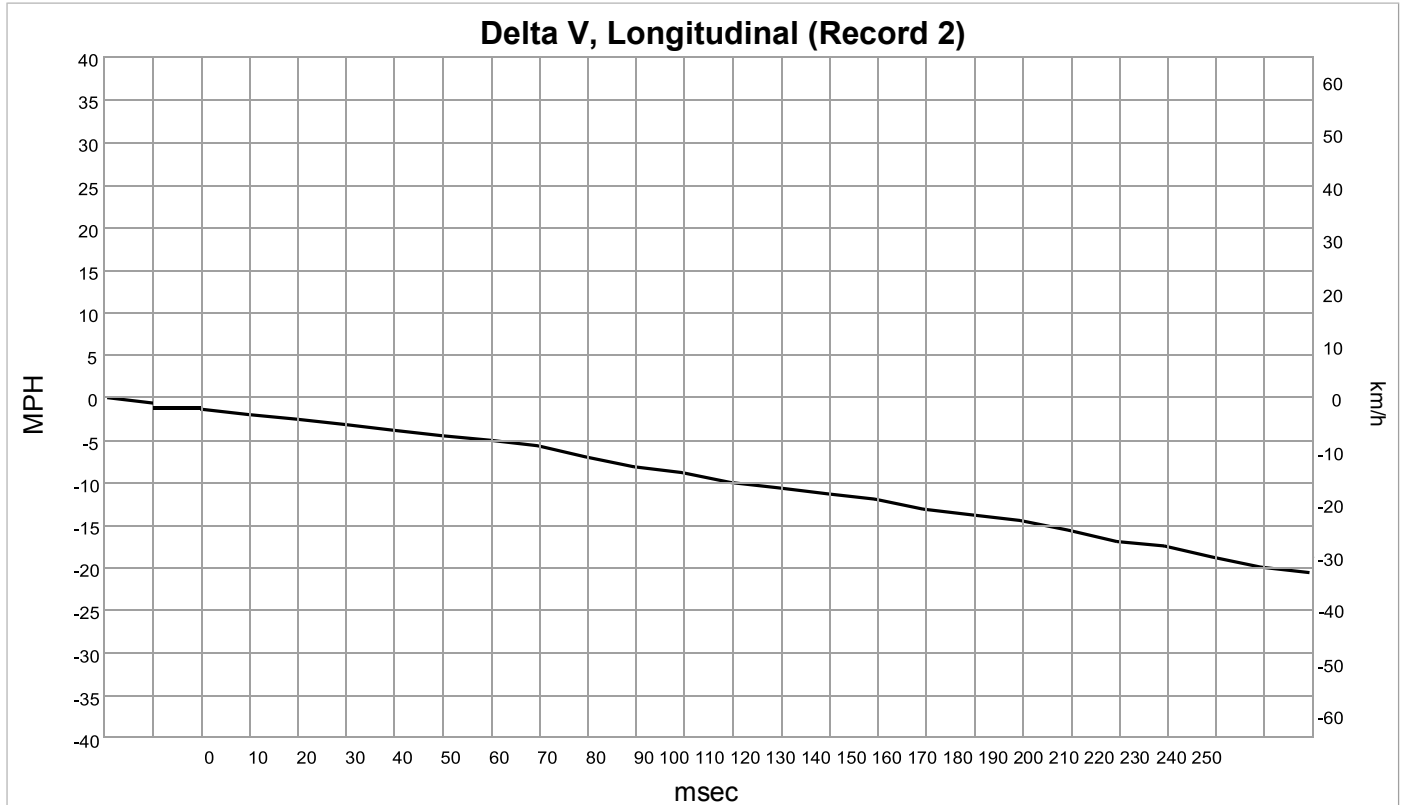
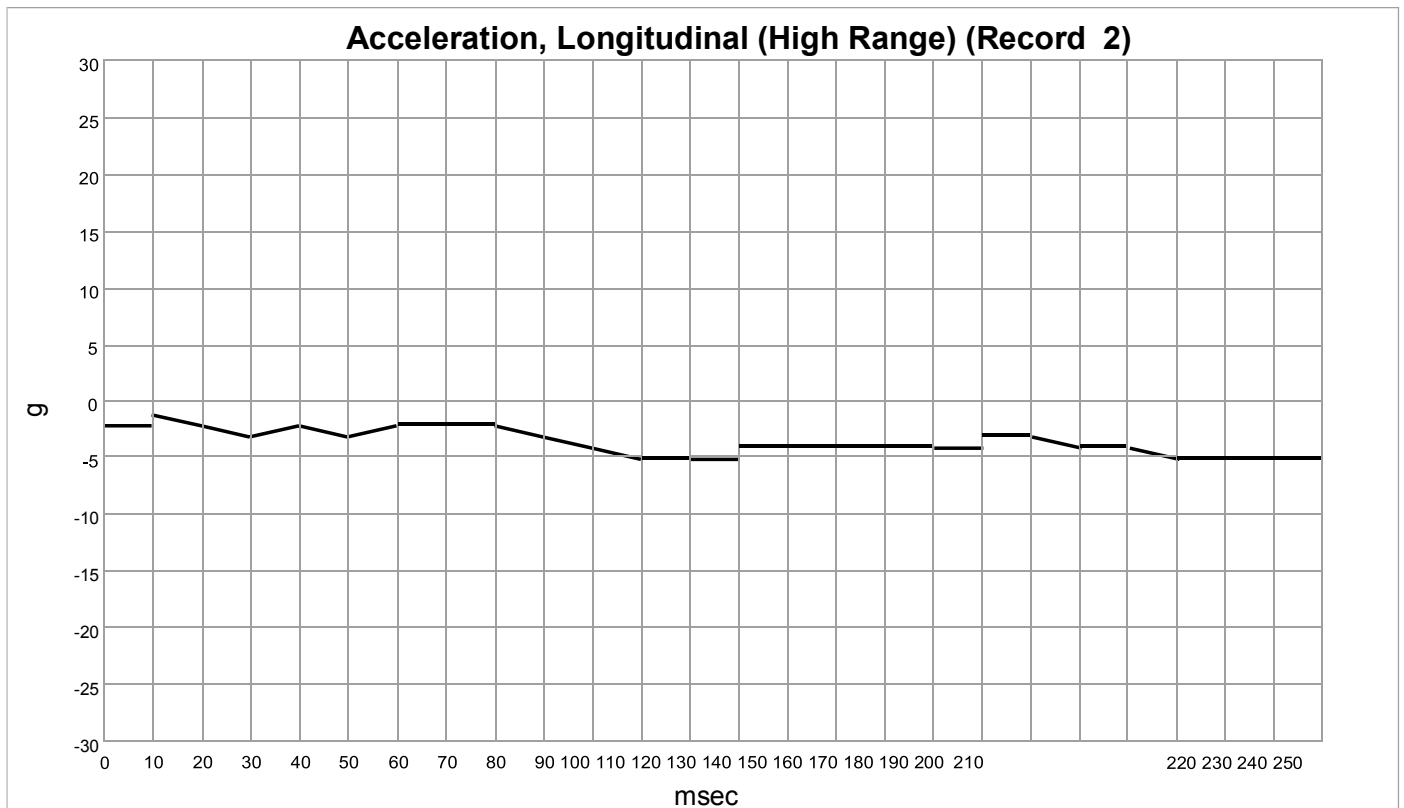
Longitudinal Crash Pulse (Record 2)

Time (msec)	Delta-V, Longitudinal (MPH [km/h])	Longitudinal Acceleration High Range (g)
0	-0.6 [-1]	-1.55
10	-1.2 [-2]	-1.13
20	-1.2 [-2]	-1.71
30	-1.9 [-3]	-2.83
40	-2.5 [-4]	-2.45
50	-3.1 [-5]	-2.57
60	-3.7 [-6]	-2.32
70	-4.3 [-7]	-1.91
80	-5.0 [-8]	-2.46
90	-5.6 [-9]	-2.64
100	-6.8 [-11]	-4.22
110	-8.1 [-13]	-5.42
120	-8.7 [-14]	-4.64
130	-9.9 [-16]	-3.83
140	-10.6 [-17]	-3.96
150	-11.2 [-18]	-3.98
160	-11.8 [-19]	-3.60
170	-13.0 [-21]	-3.76
180	-13.7 [-22]	-3.08
190	-14.3 [-23]	-3.36
200	-15.5 [-25]	-3.71
210	-16.8 [-27]	-4.22
220	-17.4 [-28]	-4.52
230	-18.6 [-30]	-4.76
240	-19.9 [-32]	-4.82
250	-20.5 [-33]	-4.79

The second event (Record 2) occurred 870 ms after the first. The maximum longitudinal delta-V was -38.0 km/h (-23.6 mph). The maximum lateral delta-V was -15.0 km/h (-9.3 mph). The calculated principal direction of force was 20 degrees.

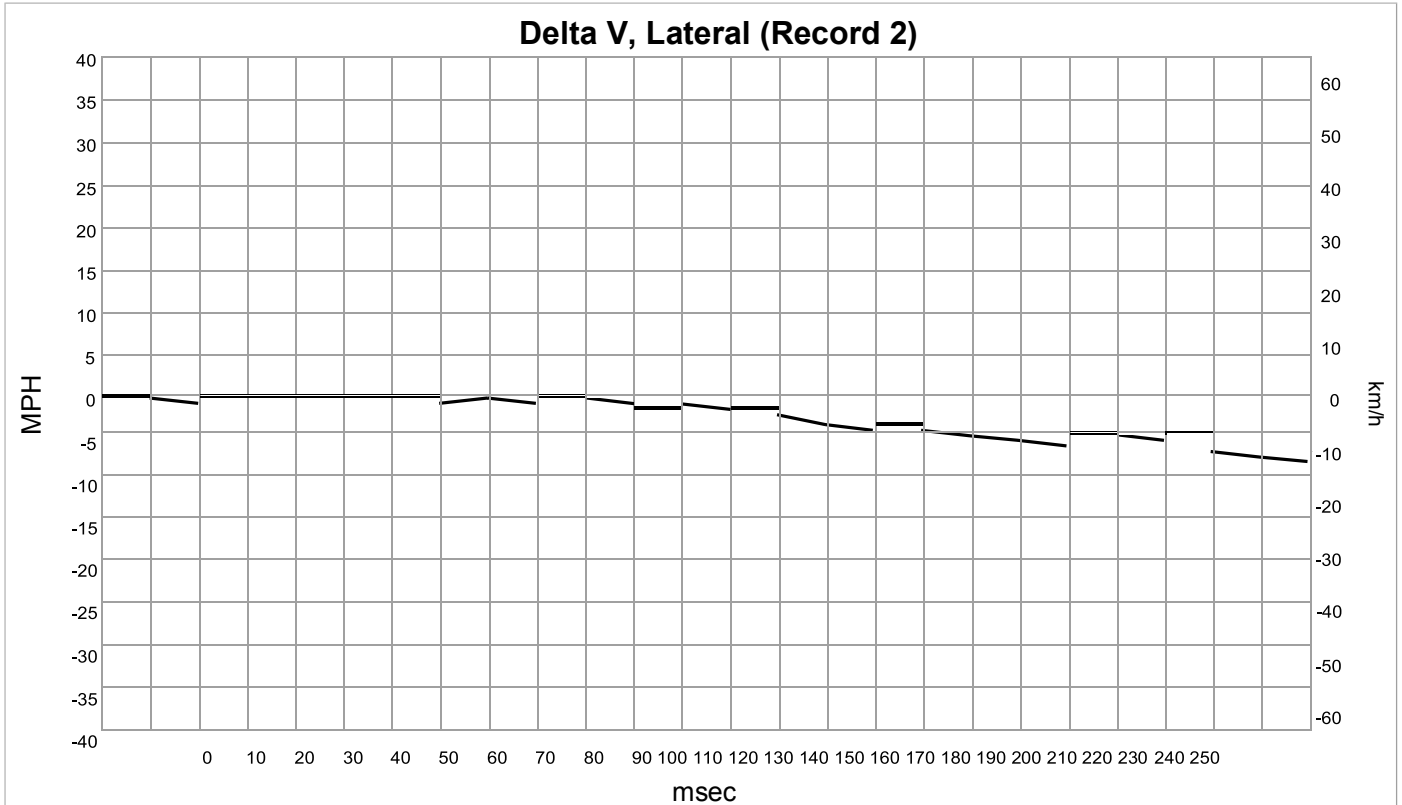
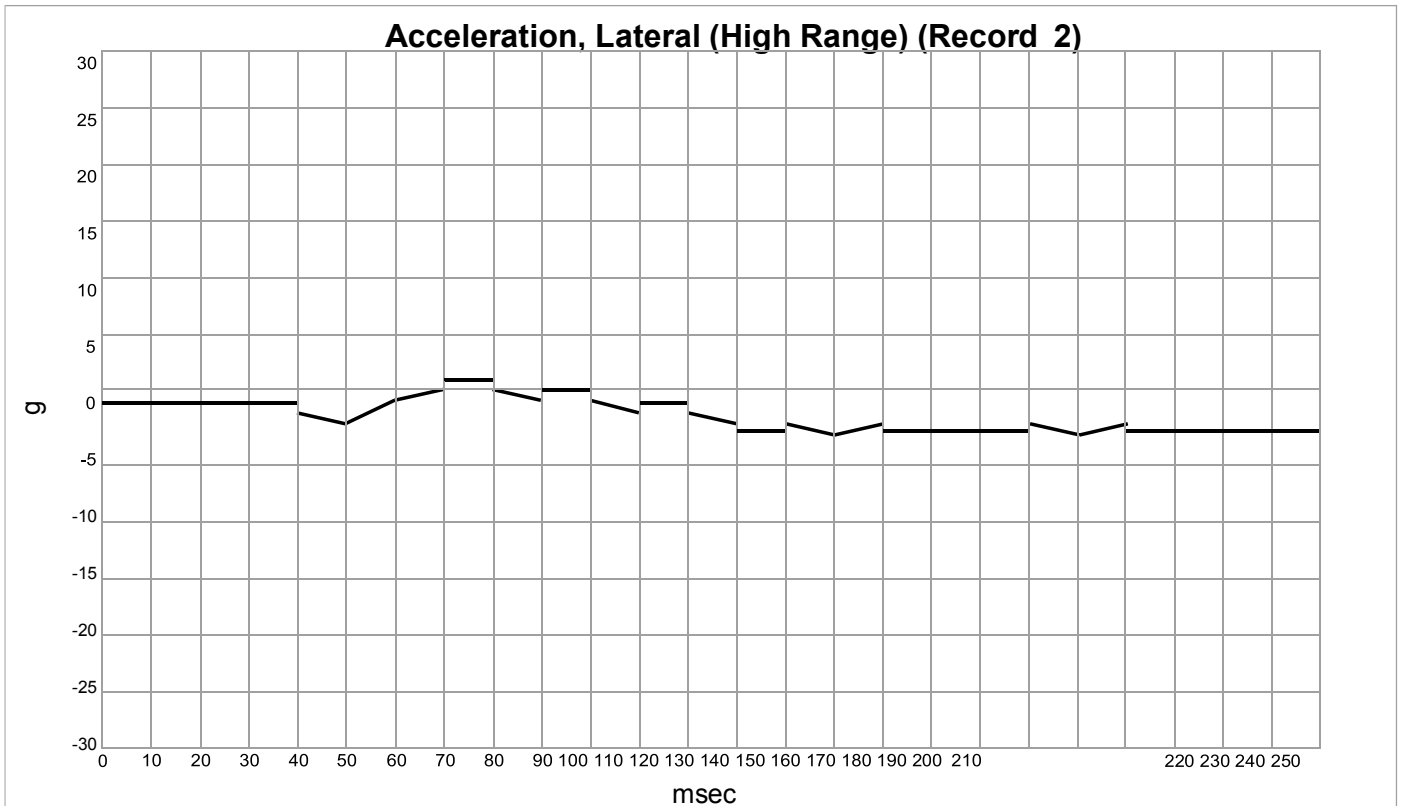
Lateral Crash Pulse (Record 2)

Time (msec)	Delta-V, Lateral (MPH [km/h])	Lateral Acceleration High Range (g)
0	0.0 [0]	-0.78
10	0.0 [0]	-0.69
20	-0.6 [-1]	-1.09
30	-0.6 [-1]	-0.76
40	-0.6 [-1]	-0.59
50	-0.6 [-1]	-1.87
60	-0.6 [-1]	0.25
70	-0.6 [-1]	0.53
80	0.0 [0]	0.55
90	-0.6 [-1]	0.12
100	-0.6 [-1]	-0.27
110	-1.2 [-2]	-1.29
120	-1.2 [-2]	-0.85
130	-1.9 [-3]	-1.50
140	-1.9 [-3]	-1.74
150	-3.1 [-5]	-2.56
160	-3.7 [-6]	-2.25
170	-3.7 [-6]	-2.10
180	-4.3 [-7]	-1.92
190	-5.0 [-8]	-2.37
200	-5.6 [-9]	-2.67
210	-5.6 [-9]	-2.12
220	-6.2 [-10]	-1.89
230	-6.2 [-10]	-1.82
240	-6.8 [-11]	-1.92
250	-7.5 [-12]	-1.81

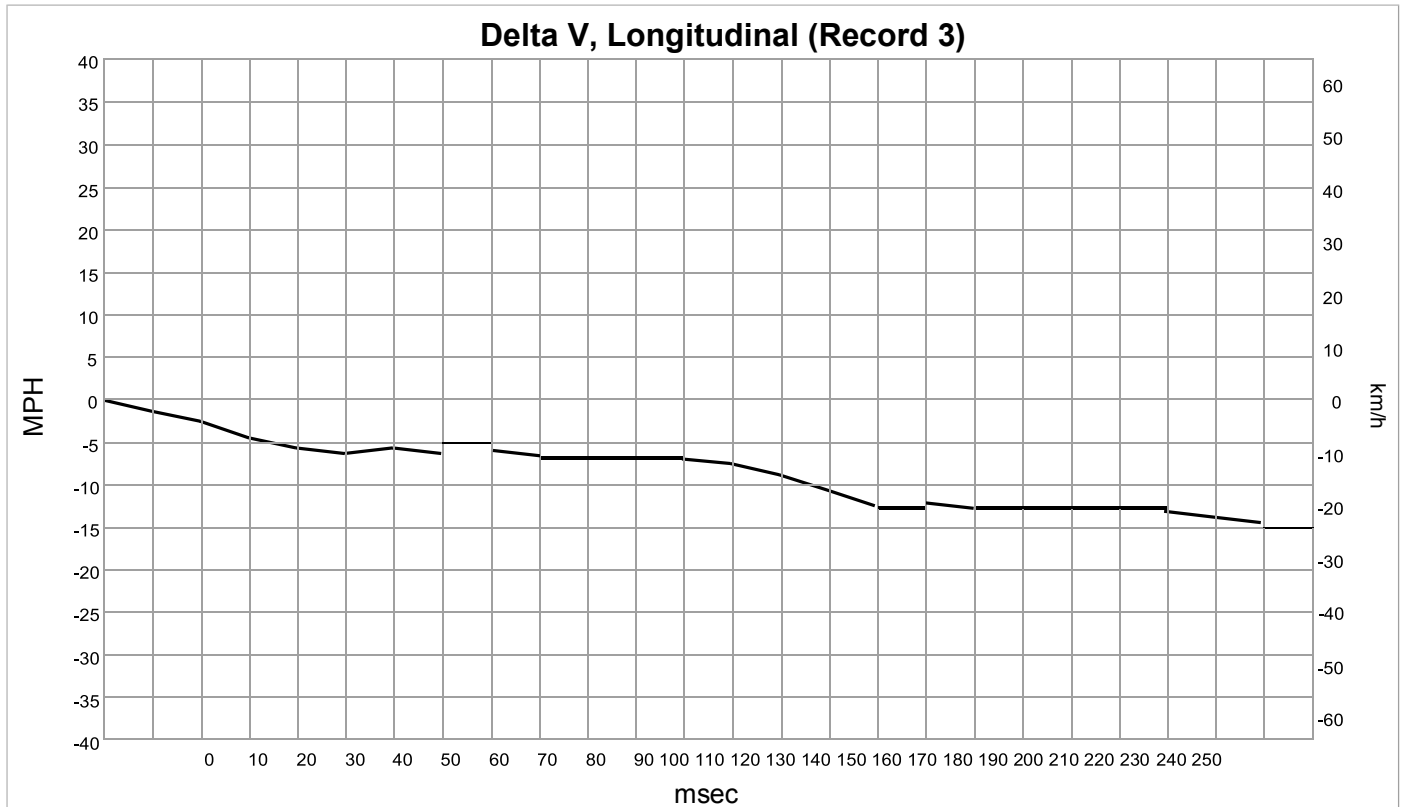
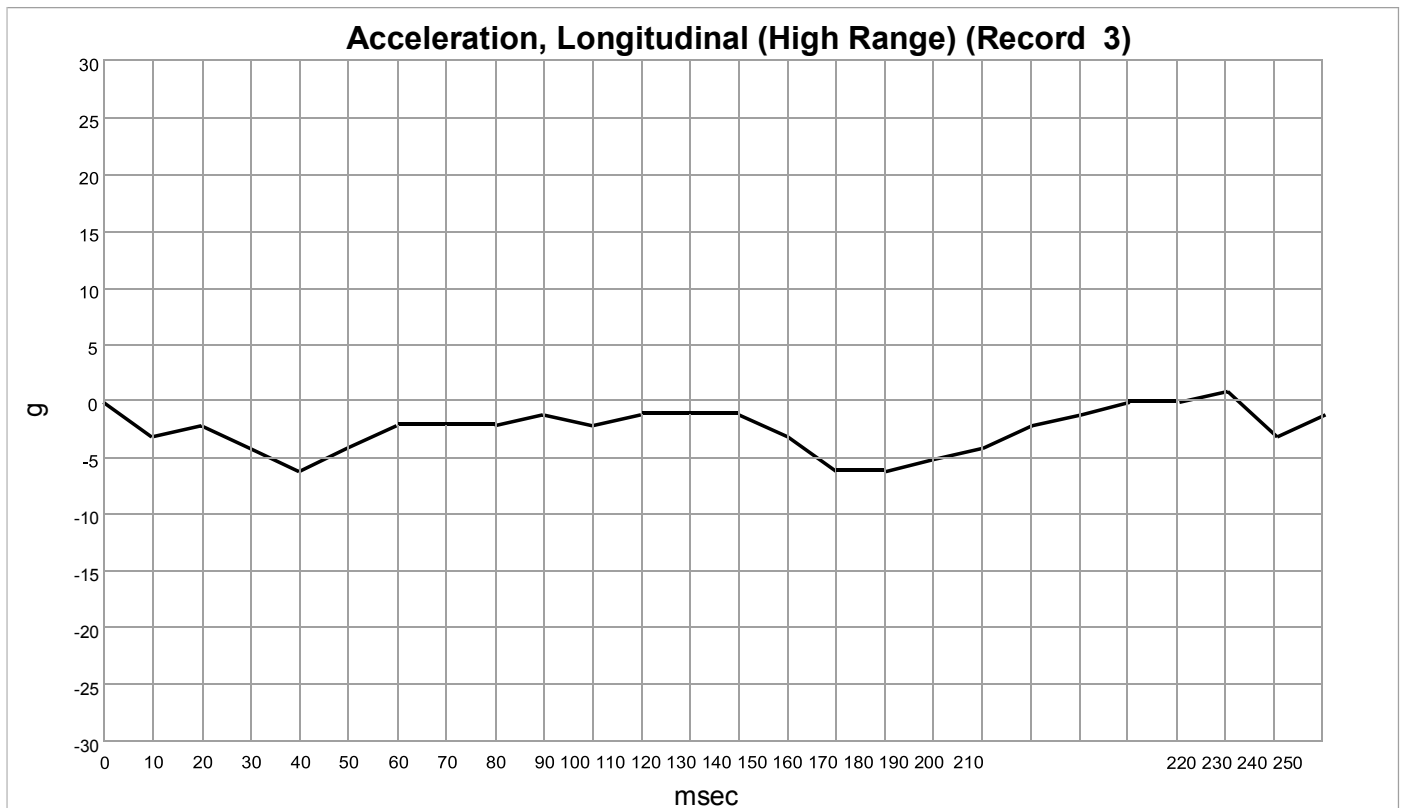
Longitudinal Crash Pulse (Record 3)

Time (msec)	Delta-V, Longitudinal (MPH [km/h])	Longitudinal Acceleration High Range (g)
0	0.0 [0]	0.00
10	-1.2 [-2]	-2.90
20	-2.5 [-4]	-2.24
30	-4.3 [-7]	-4.42
40	-5.6 [-9]	-6.35
50	-6.2 [-10]	-4.48
60	-5.6 [-9]	-2.46
70	-6.2 [-10]	-1.90
80	-6.2 [-10]	-1.59
90	-6.8 [-11]	-1.39
100	-6.8 [-11]	-1.54
110	-6.8 [-11]	-0.79
120	-6.8 [-11]	-0.61
130	-7.5 [-12]	-0.95
140	-8.7 [-14]	-3.12
150	-10.6 [-17]	-5.64
160	-12.4 [-20]	-6.44
170	-12.4 [-20]	-4.82
180	-13.0 [-21]	-3.67
190	-13.0 [-21]	-2.39
200	-13.0 [-21]	-0.92
210	-13.0 [-21]	-0.06
220	-13.0 [-21]	-0.02
230	-13.7 [-22]	0.52
240	-14.3 [-23]	-3.37
250	-14.3 [-23]	-1.47

The first event (Record 3) resulted from the impact with the guardrail end terminal and was a deployment event. The maximum longitudinal delta-V was -34.0 km/h (-21.1 mph). The maximum lateral delta-V was -4.0 km/h (-2.5 mph). The calculated principal direction of force was 10 degrees. The Bosch CDR report is included at the end of this report and the EDR-reported data not discussed elsewhere in this report was summarized as follows.

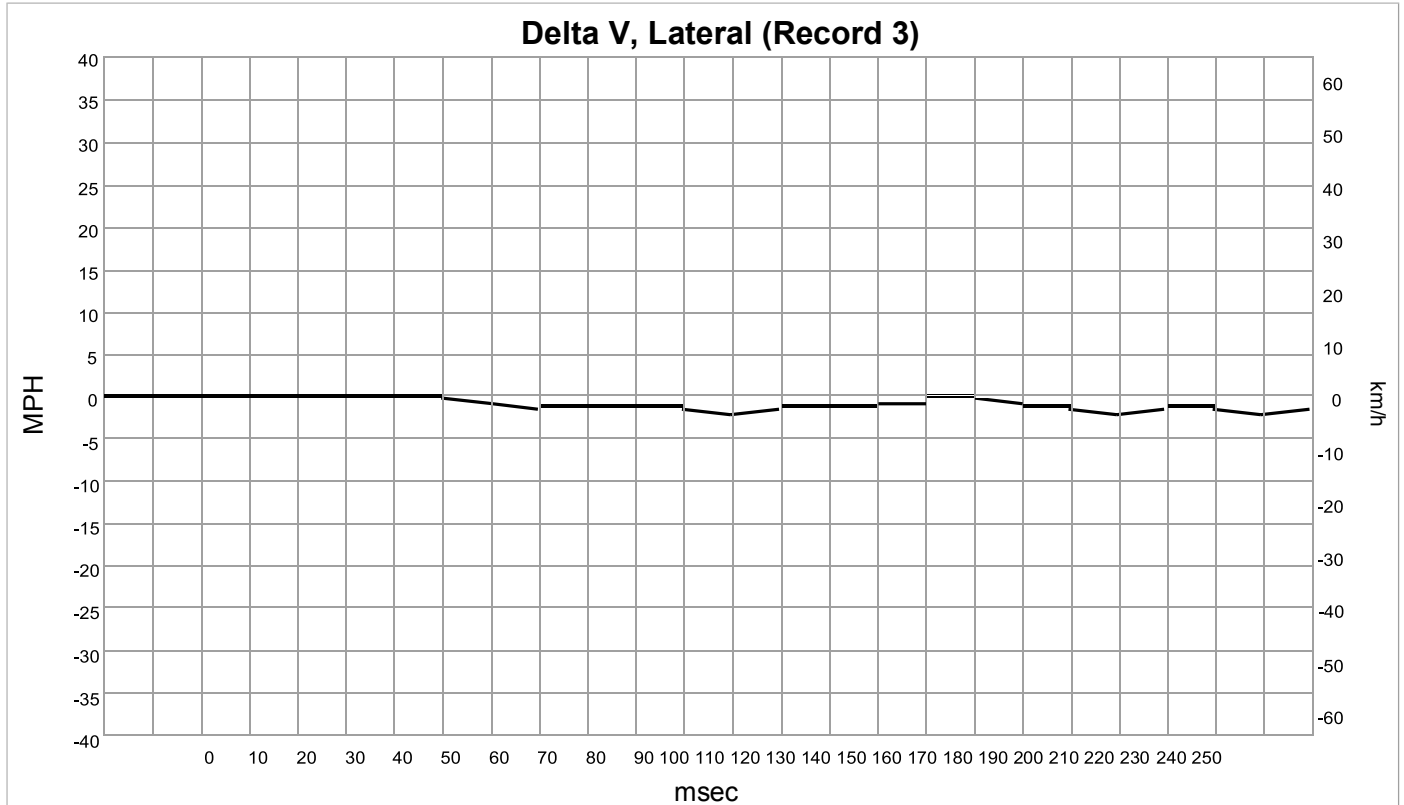
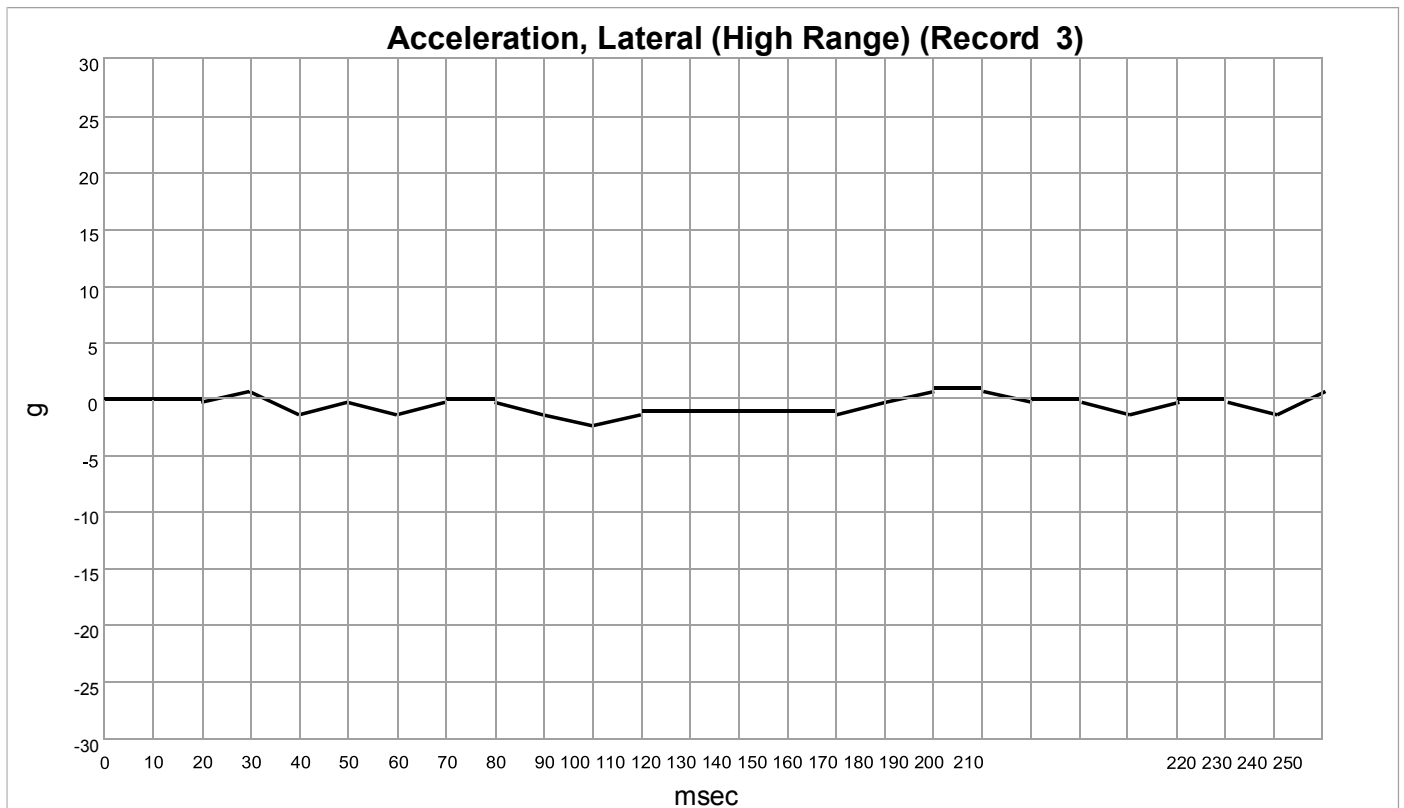
Lateral Crash Pulse (Record 3)

Time (msec)	Delta-V, Lateral (MPH [km/h])	Lateral Acceleration High Range (g)
0	0.0 [0]	0.25
10	0.0 [0]	0.00
20	0.0 [0]	0.35
30	0.0 [0]	0.69
40	0.0 [0]	-0.95
50	0.0 [0]	0.01
60	0.0 [0]	-0.53
70	0.0 [0]	0.02
80	-0.6 [-1]	-0.04
90	-1.2 [-2]	-1.15
100	-1.2 [-2]	-1.76
110	-1.2 [-2]	-0.92
120	-1.2 [-2]	-0.51
130	-1.9 [-3]	-0.70
140	-1.2 [-2]	-1.27
150	-1.2 [-2]	-0.98
160	-1.2 [-2]	0.33
170	-0.6 [-1]	1.35
180	-0.6 [-1]	0.55
190	-1.2 [-2]	0.44
200	-1.2 [-2]	-0.08
210	-1.9 [-3]	-0.87
220	-1.2 [-2]	0.21
230	-1.2 [-2]	0.10
240	-1.9 [-3]	-0.59
250	-1.2 [-2]	0.62
