DOT HS 812 825

# **Special Crash Investigations Child Restraint System Crash Investigation Vehicle: 2015 Toyota Camry Location: Colorado Date: May 2017**

**Special Crash Investigations**  
**On-Site Child Restraint System Investigation**  
**Case Number: DS17018**  
**Vehicle: 2015 Toyota Camry**  
**Location: Colorado**  
**Crash Date: May 2017**

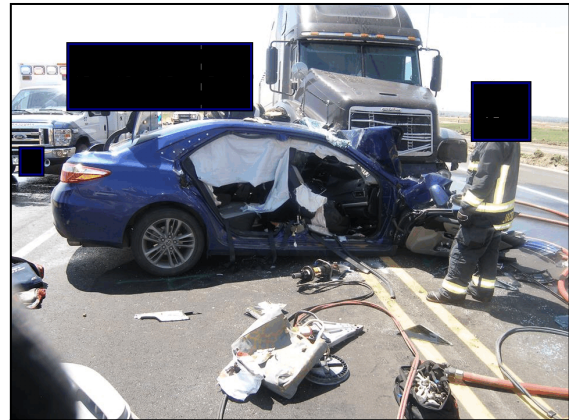
**Figure 1.** 2015 Toyota Camry at final rest, looking south (police photo).

The Freightliner and Toyota continued northbound for 58 m (191 ft) before coming to rest on the centerline. The Toyota had rotated clockwise and was facing west at final rest (**Figure 3**). The driver of the Toyota was trapped in her vehicle. She was not responsive and was declared deceased on scene. The 9-month-old sustained "B" (Evident - Non incapacitating)

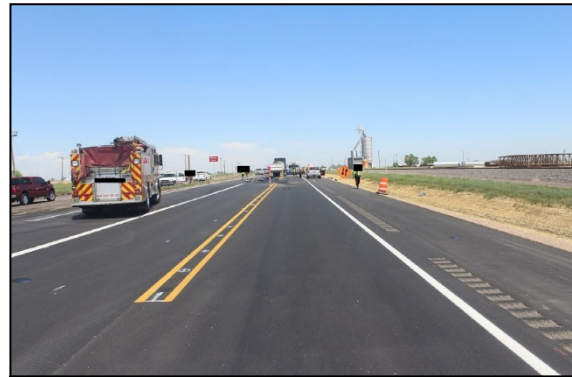
**Figure 2.** Northbound approach for Freightliner (police photo).

The Toyota was traveling southbound at an EDR-reported of 67 km/h (41.6 mph) at 4.75 seconds before impact. Based on EDR report data for accelerator pedal and engine throttle percentages, it would appear that the vehicle was in cruise control. The driver of the Toyota was under the influence of multiple drugs, including amphetamines, oxycodone, and oxymorphone. The Toyota may have been drifting to the right. At 2.25 seconds prior to impact, the vehicle had slowed to 65 km/h (40 mph) and the driver steered to the left while entering the northbound travel lane. At 0.75 seconds prior to impact, the vehicle had slowed to 62 km/h (38 mph) and the driver steered sharply to the right. The Freightliner was traveling northbound (**Figure 2**) at a police-reported speed of 48 km/h (30 mph). The driver of the Freightliner saw the Toyota enter his travel lane. He began braking and steering to the left.

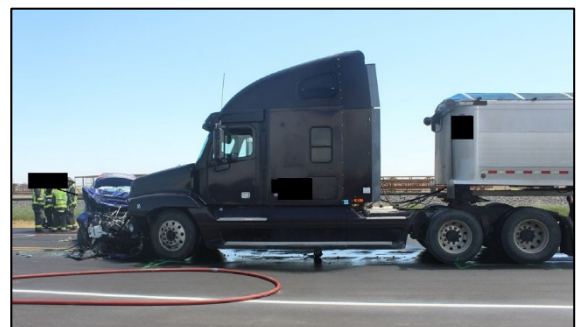
**Figure 3.** Vehicles at final rest, looking east (police photo).

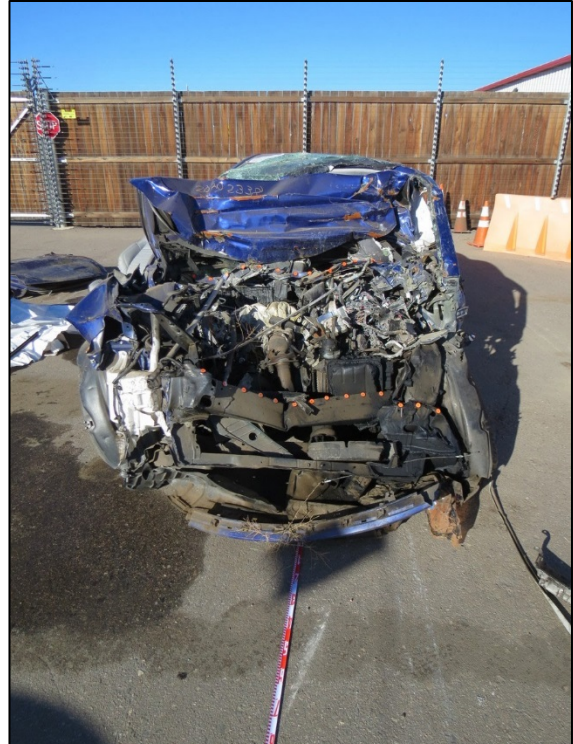
The Toyota sustained severe frontal damage from the impact with the front plane of the Freightliner (**Figure 4**). The Field L extended from bumper corner to bumper corner. Fourteen measurements were taken at the backing bar level by the Nikon Total Station and the Faro Blitz program computed crush measurement in six increments as follows: C<sub>1</sub> = 69 cm (24.8 in), C<sub>2</sub> = 73 cm (28.7 in), C<sub>3</sub> = 75 cm (29.5 in), C<sub>4</sub> = 66 cm (25.9 in), C<sub>5</sub> = 57 cm (22.4 in), C<sub>6</sub> = 37 cm (14.5 in). The vehicle sustained substantial above bumper override crush. Crush at the radiator support was measured as follows: C<sub>1</sub> = 156 cm (61.4 in), C<sub>2</sub> = 153 cm (60.2 in), C<sub>3</sub> = 142 cm (55.9 in), C<sub>4</sub> = 141 cm (55.5 in), C<sub>5</sub> = 141 cm (55.5 in), C<sub>6</sub> = 127 cm (50.0 in). The averaged crush was as follows: C<sub>1</sub> = 113 cm (44.4 in), C<sub>2</sub> = 113 cm (44.4 in), C<sub>3</sub> = 109 cm (42.9 in), C<sub>4</sub> = 104 cm (40.9 in), C<sub>5</sub> = 99 cm (38.9 in), C<sub>6</sub> = 82 cm (32.2 in). The Collision Deformation Classification was 12FDEW6. The calculated Principal Direction of Force was 353 degrees. Damage from the center line markers could not be located.

**Figure 4.** 2015 Toyota Camry, frontal damage.

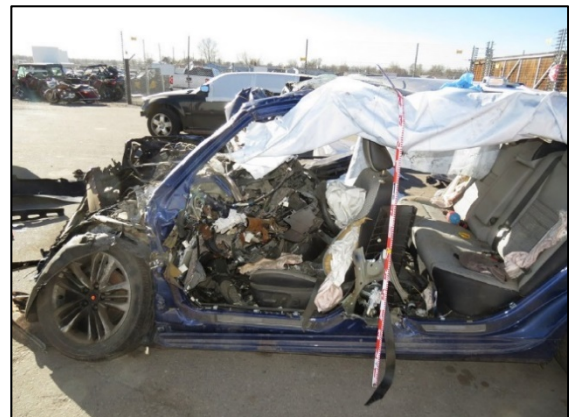
The Toyota sustained severe damage from vehicle intrusions and extrication efforts. All the doors and the front row right seat were removed during the extrication of the driver. There was longitudinal intrusion of the windshield header, instrument panel, steering wheel, toe pan, A- pillar, and the vehicle’s hood into the front row (**Figure 5**). The driver’s seat was deformed rearward and intruded into the second row left seat position.

**Figure 5.** 2015 Toyota Camry, front row intrusion.

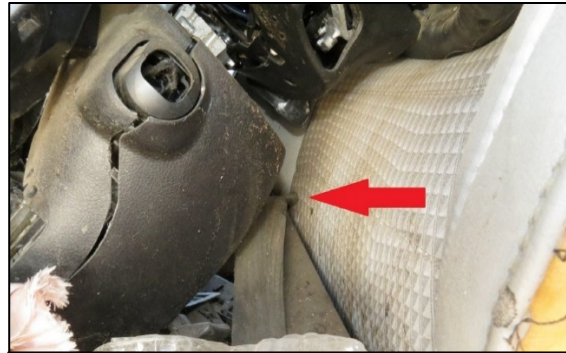
cm (28.3 in) above the floor anchor during the driver extrication. The latch remained inserted in the receiver (**Figure 6**), indicating that the belt was in use at the time of crash. The front right seat belt was cut at 106 cm (41.7 in) above the floor anchor, presumably to assist in removing the seat.

**Figure 6.** 2015 Toyota Camry, driver's seat belt latch.

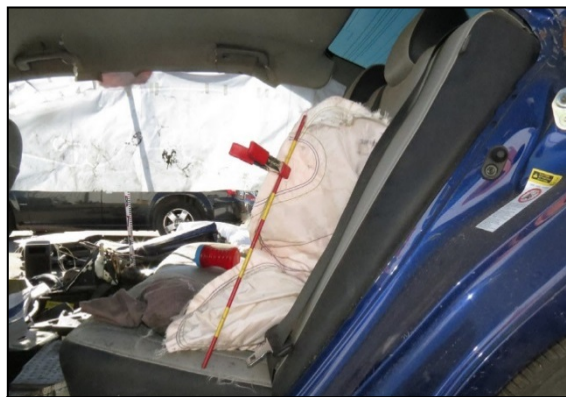
The driver's frontal and knee air bags were entrapped due to passenger compartment intrusion. The driver's and front right passenger seat-mounted side air bags deployed from their respective seat backs. The air bags measured 64 cm (25.1 in) in height and 29 cm (11.4 in) in width. The second row outboard seat side air bags deployed from the seat back (**Figure 7**). The air bag measured 53 cm (20.8 in) in height and 20 cm (7.8 in) in width. Both the left and right IC air bags deployed during the crash. The air bags measured 177 cm (69.6 in) in length, 54 cm (21.2 in) in height, and had an 8 cm (3.1 in) tether at the leading end.

**Figure 7.** 2015 Toyota Camry, second row left seat-back mounted side air bag.

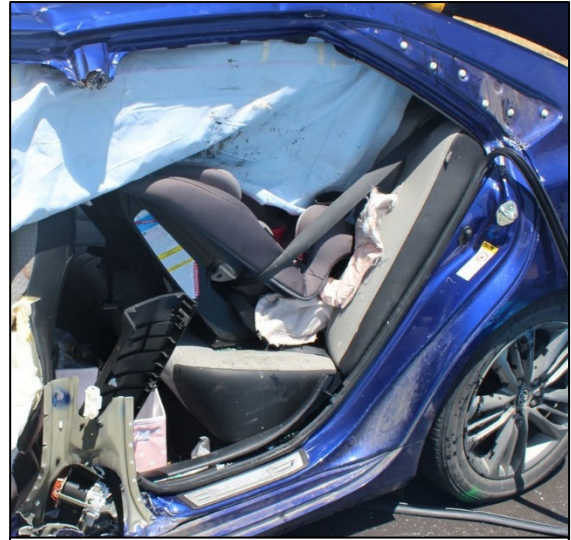
The Safety 1st Grow and Go 3-in-1 CRS was installed rear-facing in the second row left position using the lower anchors and the vehicle's lap and shoulder belt. On-scene police images show the CRS secured in its position in the Toyota (**Figure 8**). The user's manual indicated that the lower anchors should not be used in combination with the vehicle lap or lap and shoulder belt; therefore, the CRS was installed unconventionally.

**Figure 8.** 2015 Toyota Camry, Safety 1st Grow and Go CRS (police photo).

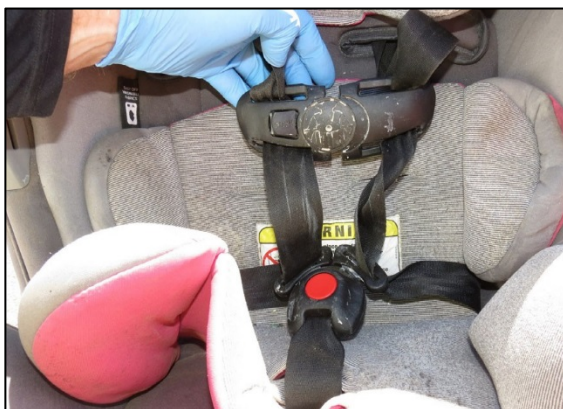
It is not known if the 9-month-old child in this seat position met the occupant parameters. Examination of the vehicle's seat belt during the SCI inspection indicated the belt retractor and buckle functionality was normal. The internal harness was examined and it revealed loading and twisting (**Figure 9**). The buckle and latch functioned with some difficulty. The CRS shell was deformed as it was compressed between the driver's seat back and the second row seat (**Figure 10**).

**Figure 9.** 2015 Toyota Camry, Safety 1st Grow and Go CRS.

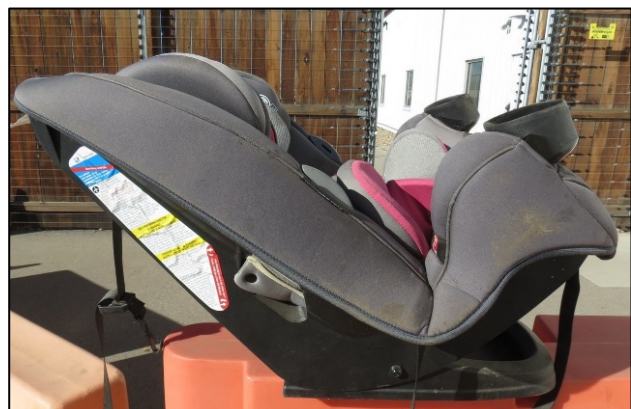
**Figure 10.** 2015 Toyota Camry, Safety 1st Grow and Go CRS.

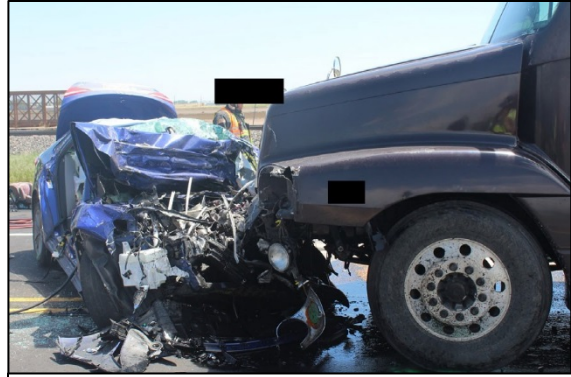
The Freightliner sustained moderate front plane damage during the impact with the Toyota (**Figures 11-12**). The estimated Truck Deformation Classification (TDC) was 12FDEW1. The vehicle was towed from the scene due to damage.

**Figure 11.** 2001 Freightliner ST120 tractor (police photo).

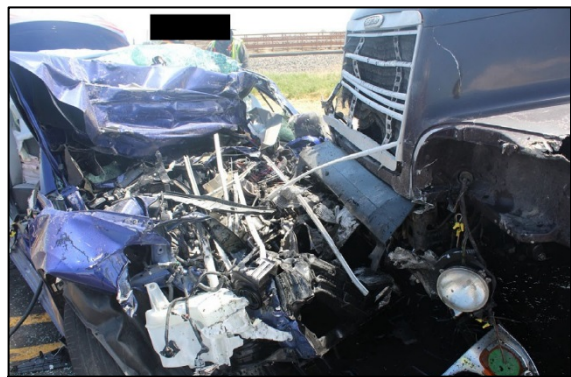
**Figure 12.** 2001 Freightliner ST120 tractor (police photo).
