**Special Crash Investigations
Remote Vehicle Fire/Child
Restraint System Investigation
Vehicle: 1998 Subaru Forester
Location: Montana
Crash Date: March 2013**

Special Crash Investigations
Remote Vehicle Fire/Child Restraint System Investigation
Case Number: DS16030
Vehicle: 1998 Subaru Forester
Location: Montana
Crash Date: March 2013

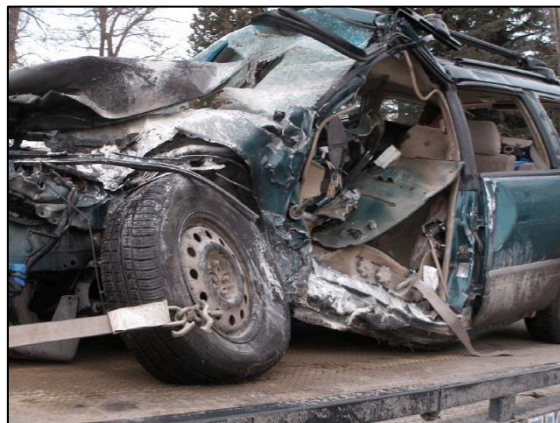
Figure 1. 1998 Subaru Forester (police photo).

This report documents the remote investigation of the post-impact fire in a 1998 Subaru Forester (**Figure 1**) involved in a two-vehicle crash and the child occupant of the Subaru who was seated in a child restraint system (CRS). The investigation was intended to determine the events leading to the fire, how quickly the fire spread to the occupant compartment, the magnitude of the fire, how quickly EMS and other responders arrived on-scene, occupant restraint usage, demographics, injury data, and CRS data. The crash was identified during a review of Fatality Analysis Reporting System (FARS) crash reports. The criteria for the crash type include an impact not involving the rear plane, fire that spreads to the occupant compartment, and at least one occupant seated in a CRS. The Special Crash Investigations (SCI) team obtained a police report and the case was initiated by the SCI group of the National Highway Traffic Safety Administration in December 2016.

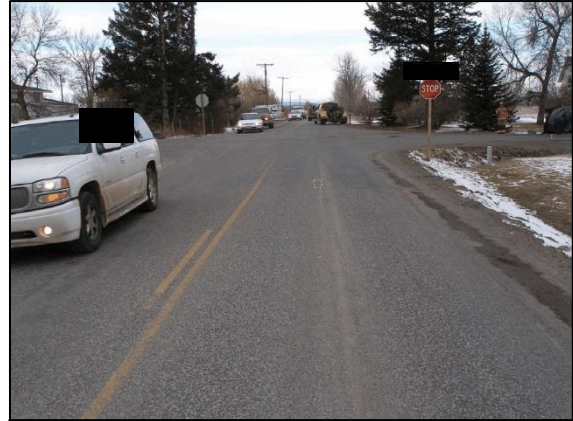
Figure 2. Westbound approach (police photo).

The Subaru was traveling westbound approaching the intersection (**Figure 2**). According to the police report, there were two warning signs prior to the intersection, a yellow “Stop Ahead” sign and then a “Limited Sight Distance Ahead” sign. The Dodge pickup was traveling northbound approaching the intersection (**Figure 3**). Approximately 22 m (74 ft) east of the intersection, the driver of the Subaru began braking but was unable to stop in time and entered the intersection.

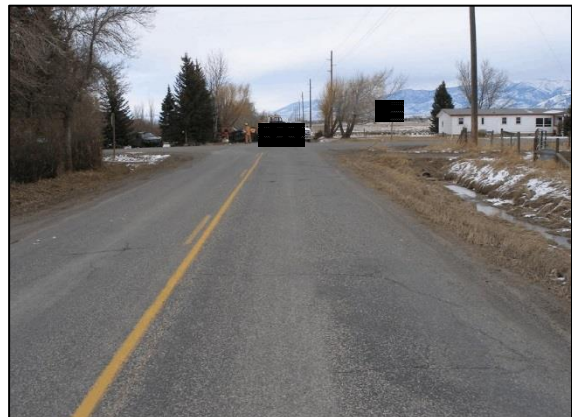
Figure 3. Northbound approach (police photo).

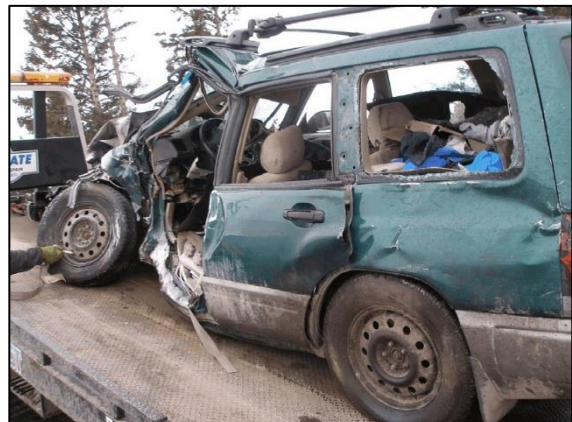
Figure 4. Left side, 1998 Subaru Forester (police photo).

The Subaru sustained severe damage to the left plane from the impact with the Dodge (**Figure 4**). The damage began at the left front bumper corner and extended rearward to the driver's door. The estimated collision deformation classification (CDC) was 10LYAW3.

The Subaru sustained moderate interior damage from intrusion. Both left doors were jammed shut; the left front door was removed by EMS during the extrication of the driver. The windshield was fractured and all the left side glazing was disintegrated.

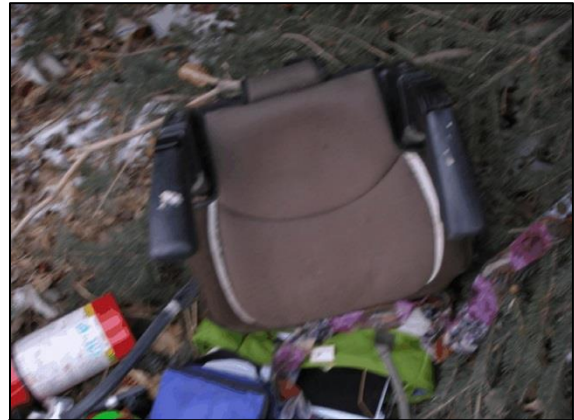
The Goodbaby Evenflo Big Kid CRS was a belt-positioning booster seat with removable backrest (**Figure 5**). Data for this CRS and its use was obtained from the police report and a single police image. At the time of the crash, the CRS was being used without the backrest. According to the police, the CRS and vehicle's lap and shoulder seat belt were being used as designed.

Figure 5. Goodbaby Evenflo Big Kid CRS (police photo).

The occupant parameters for using the seat without the backrest are as follows:

Weight: 18-49 kg (40-110 lbs)

Age: the child must be at least 4 years old

The 7-year-old male child using the CRS met the age parameter. It is not known if he met the weight parameter.

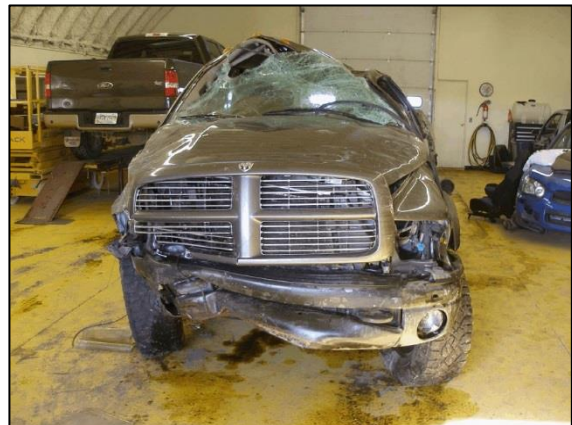
The Dodge sustained moderate front plane damage from the impact with the Subaru (**Figure 6**). The CDC was 01FZEW1. The vehicle sustained moderate top plane damage during the rollover (**Figure 7**).

Figure 6. Frontal damage, 2004 Dodge Ram (police photo).

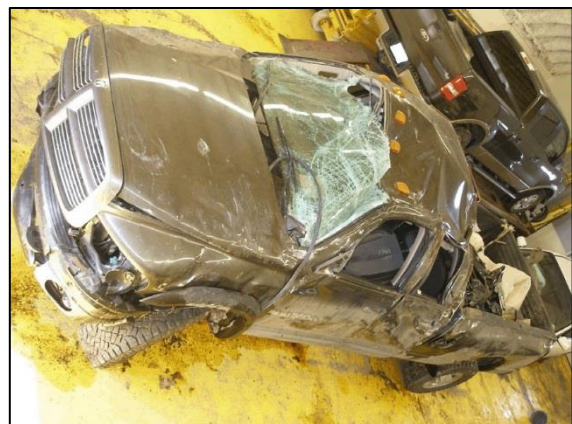
The CDC for the rollover was 00TDYO3. The Dodge struck a tree during the rollover sequence. The location of the damage was probably to the rear plane but this was inconclusive.

Figure 7. Top damage, 2004 Dodge Ram (police photo).
