**National Highway
Traffic Safety
Administration**

DOT HS 812 861

**Special Crash Investigations
On-Site Air Bag
Non-Deployment Investigation
Vehicle: 2018 Toyota Corolla
Location: California
Crash Date: May 2018**

**SPECIAL CRASH INVESTIGATIONS
ON SITE AIR BAG NON-DEPLOYMENT CRASH INVESTIGATION
OFFICE OF DEFECTS INVESTIGATION
CASE NO.: DS18025
VEHICLE: 2018 TOYOTA COROLLA
LOCATION: CALIFORNIA
CRASH DATE: MAY 2018**

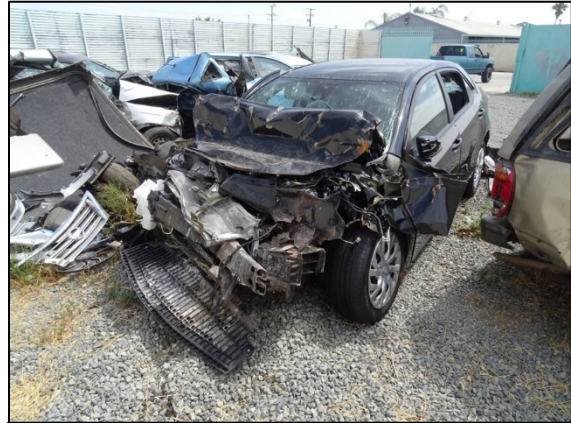
Figure 1. 2018 Toyota Corolla, front damage.

Based on the extent of damage and impact configuration there should have been frontal air bag deployments in the Toyota.

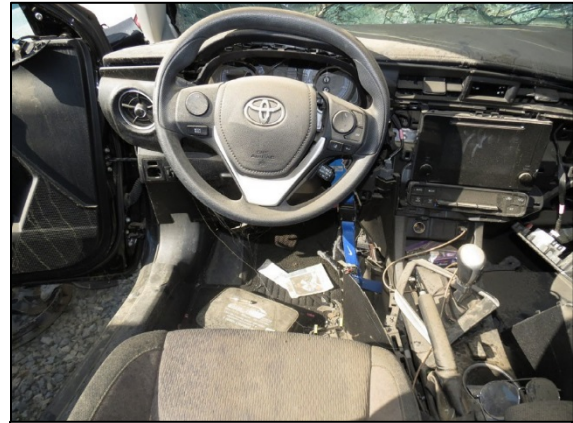
Figure 2. Driver's air bag, 2018 Toyota Corolla.

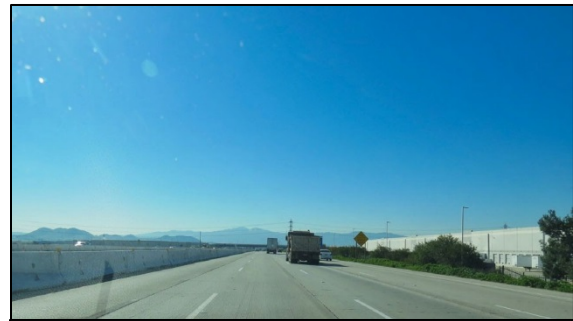
The crash site was in the southbound lanes of a divided interstate highway (**Figure 3**). The concrete roadway was straight and level. There were four travel lanes that were separated by dashed white lines and raised ceramic markers. The roadway was bordered on the west by a solid white line and an asphalt shoulder followed by a descending dirt embankment with shrubs and trees. On the east, the roadway was bordered by a solid yellow line and a concrete median barrier. This crash occurred during morning hours and there were no streetlights at or around the crash scene. The posted speed limit was 105 km/h (65 mph). The roadway was dry and the weather at the nearest reporting station was 15.5 °C (60 °F), 80 percent humidity, cloudy, and the winds were out of the west northwest at 9.6 km/h (6 mph). A crash diagram is attached at the end of this technical report.

Figure 3. Southbound view.

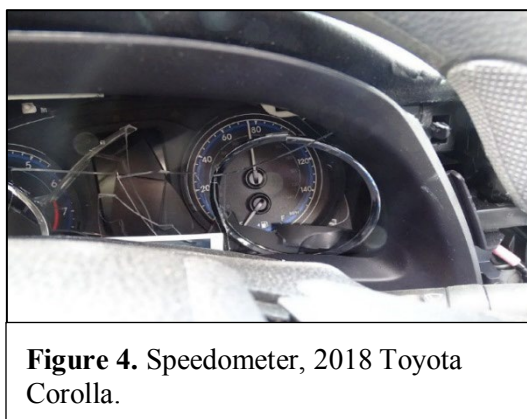
It should be noted that the vehicle speedometer was locked at 121 km/h (75 mph) (**Figure 4**). This was likely due to damage as opposed to a power loss since other display items were in their power off positions.

Figure 4. Speedometer, 2018 Toyota Corolla.

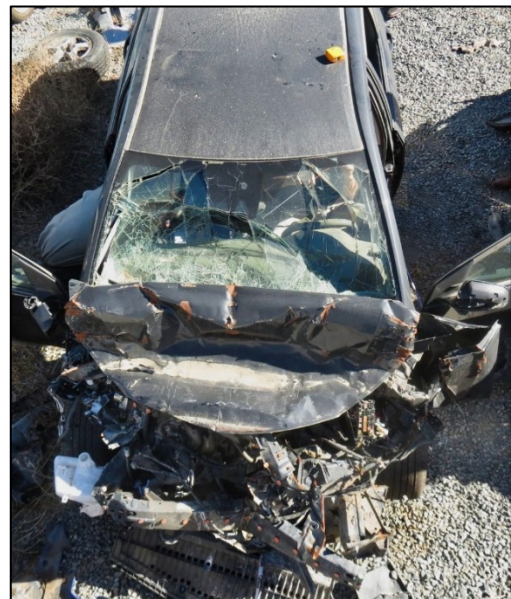
The Toyota sustained severe frontal damage from the impact with the rear plane of the Ford (**Figure 5**). The Field L extended from bumper corner to bumper corner. Fourteen measurements were taken at the backing bar level by the Nikon Total Station and the Faro Blitz program computed crush measurement in six increments as follows: C1 = 8 cm (3.1 in), C2 = 25 cm (9.8 in), C3 = 60 cm (23.6 in), C4 = 55 cm (21.6 in), C5 = 49 cm (19.2 in), C6 = 30 cm (11.8 in). The vehicle also sustained above bumper override crush. Crush at the radiator support was measured as follows: C1 = 36 cm (14.1 in), C2 = 34 cm (13.3 in), C3 = 42 cm (16.5 in), C4 = 35 cm (13.7 in), C5 = 41 cm (16.1 in), C6 = 67 cm (26.3 in). The averaged crush was as follows: C1 = 24 cm (9.4 in), C2 = 25 cm (9.8 in), C3 = 51 cm (20.0 in), C4 = 45 cm (17.7 in), C5 = 49 cm (19.2 in), C6 = 49 cm (19.2 in). The Collision

Figure 5. Frontal damage, 2018 Toyota Corolla.

Deformation Classification (CDC) was 12FDEW3. There was no evidence of the light contact to the Freightliner in Event 2.

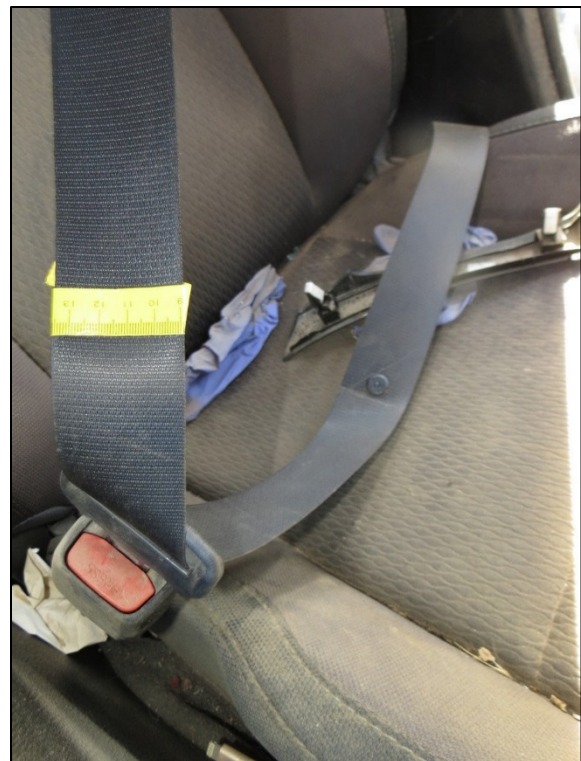
Figure 6. Driver's safety belt, 2018 Toyota Corolla.

The front row was equipped with driver and front right passenger lap and shoulder safety belts. The driver's belt was equipped with continuous loop belt webbing, a sliding latch plate, an emergency locking retractor (ELR), and an adjustable upper anchor that was adjusted to the full down position. The front right passenger's safety belt was equipped the same as the driver's, but had a switchable ELR/automatic locking retractor (ALR). Both front row safety belts exhibited loading evidence (**Figures 6-7**). Driver loading of the safety belt webbing caused scuff marks and stretch marks at the latch plate. Passenger loading of the safety belt webbing caused scuff marks and stretch marks measuring 42 cm (16.5 in) located 104 cm (40.9 in) above the stop button. Both safety belts were equipped with retractor pretensioners that did not actuate.

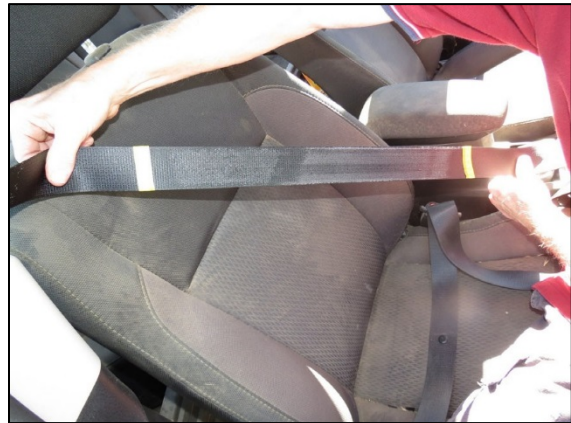
Figure 7. Front right passenger safety belt, 2018 Toyota Corolla.

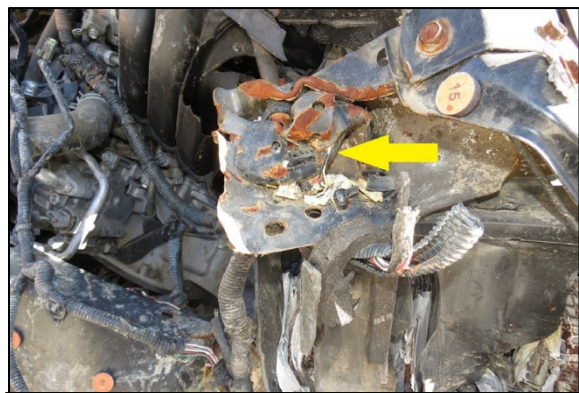
The vehicle was configured with an air bag sensor assembly, front impact sensors, side impact sensors (front doors), and side impact sensors (front and rear). The dual front impact sensors were located the vehicle body above the backing bar on the frame rails. The sensors share power with additional vehicle components. The left sensor wiring was damaged during the crash (**Figure 8**). The left wiring assembly was not removed from the vehicle. During the inspection, there was a fuse inventory conducted. It was determined that all the fuses in the engine compartment location were intact.

Figure 8. Left air bag sensor at left front corner, 2018 Toyota Corolla.

Based on the extent of damage and impact configuration there should have been frontal air bag deployments in the Toyota.

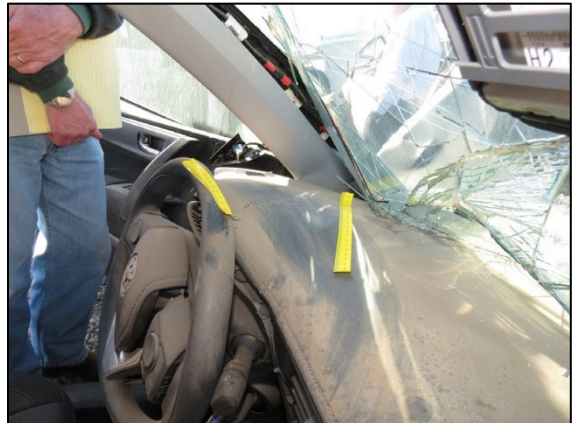
The 23-year-old female driver was seated in an unknown posture and was using the lap and shoulder safety belt. Just prior to impact, the driver began braking. At impact, the driver was displaced forward, loading and stretching the safety belt. The driver continued forward and engaged the steering wheel rim with her chest and loaded the lower instrument panel with her knees. She wrapped around the steering wheel and her head flexed forward, first causing the atlantoaxial dislocation and causing the brain and facial injuries as she struck the top of the instrument panel (**Figure 9**).

Figure 9. Driver steering wheel and instrument panel contacts, 2018 Toyota Corolla.

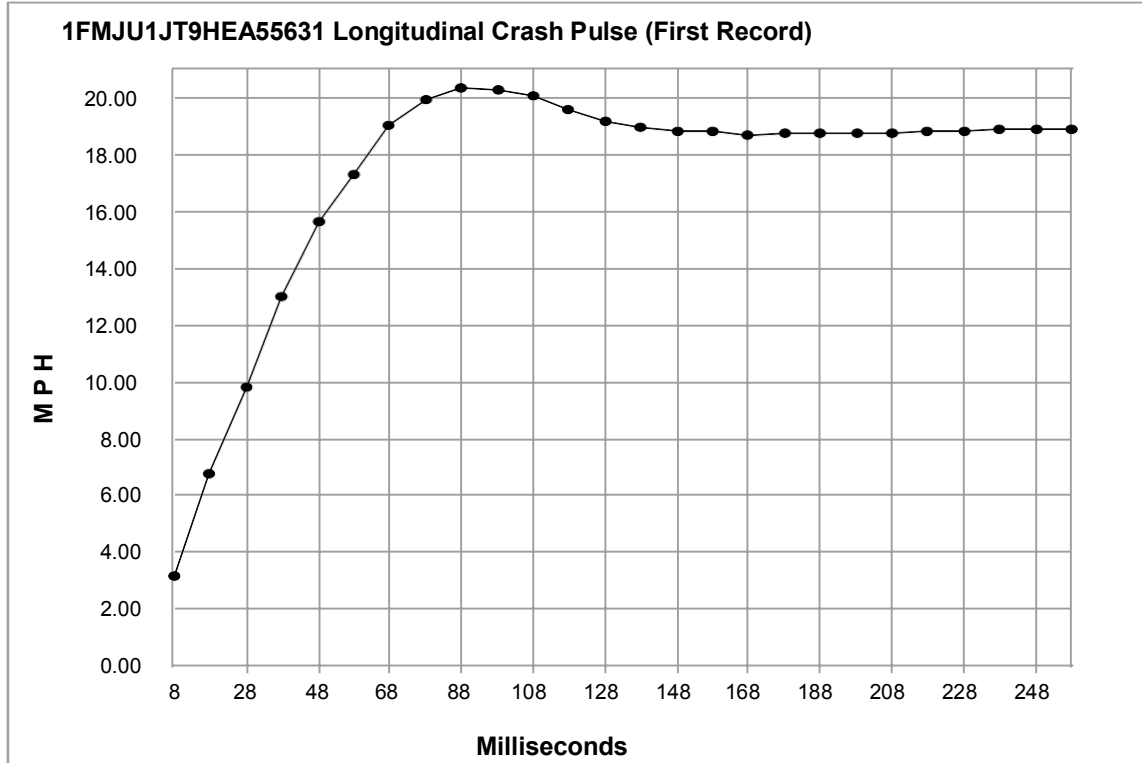
Longitudinal Crash Pulse (First Record)

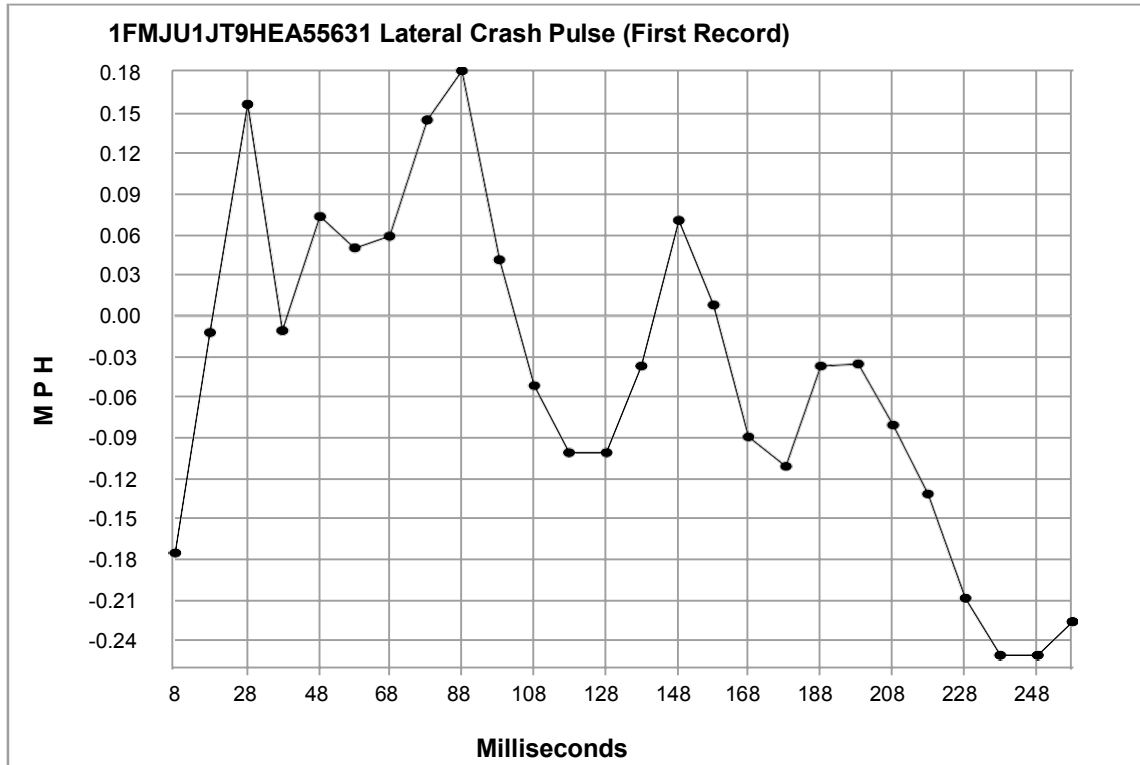
Lateral Crash Pulse (First Record)

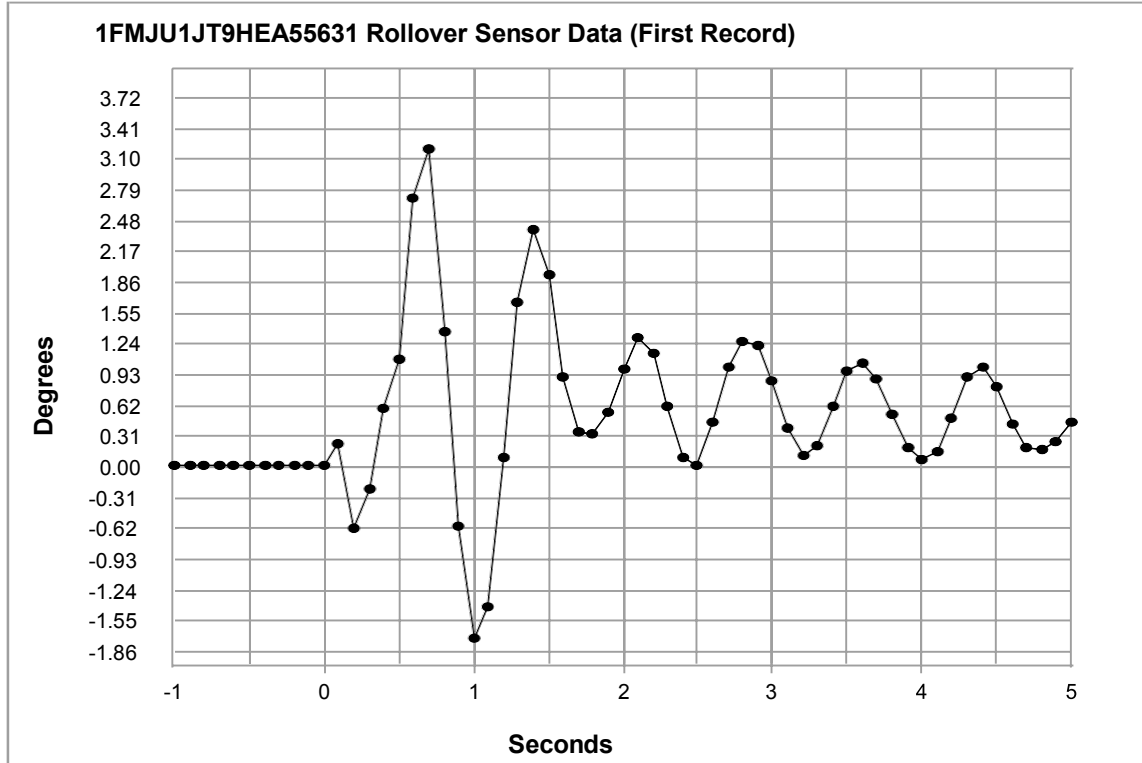
Rollover Sensor Data (First Record)
