DOT HS 812 877

Special Crash Investigations On-Site Rollover Investigation Vehicle: 2016 Toyota Rav4 Location: Texas Crash Date: February 2018

**Special Crash Investigations
On-Site Rollover Investigation
Case Number - IN18004
Vehicle - 2016 Toyota Rav4
Location - Texas
Crash Date - February 2018**

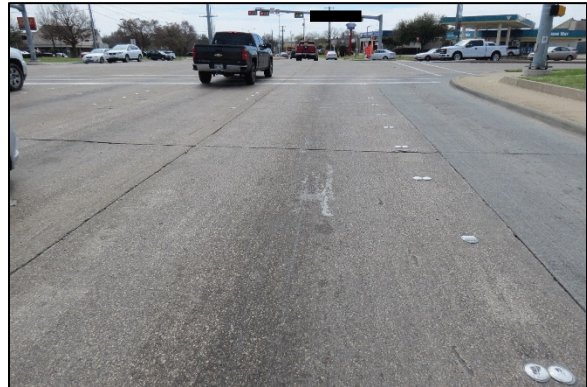
Figure 2: Southbound approach of the Rav4 to intersection.

The Rav4 was traveling south in the center through lane (**Figure 2**) approaching the intersection at an event-data-recorder reported speed range of 63 km/h (39.1 mph) to 60 km/h (37.3 mph) at -4.95 to 0 sec prior to algorithm enable (AE). The steering input was reported as 25.5 degrees¹ at AE, indicating the driver steered right to avoid the crash immediately prior to impact. The vehicle's service brake was reported as "OFF" during the entire pre-crash recording except at 0 sec, where it was reported as "ON." The Rav4's EDR- reported speed, percentage accelerator pedal, percentage throttle, engine rpm, service brake status, yaw rate, and steering input are presented in the table below. The Corolla was traveling west in the center through lane (**Figure 3**) approaching the intersection. According to the police crash report, the Corolla entered the intersection on a red traffic signal.

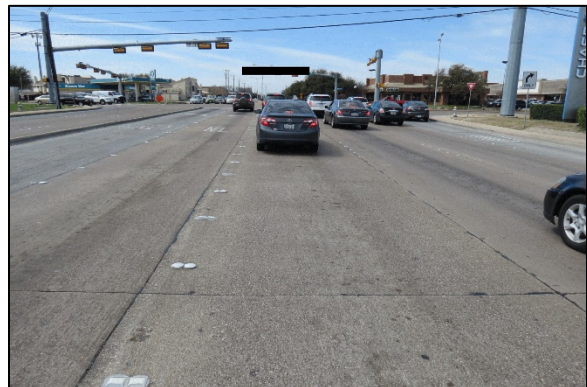
Figure 3: Westbound approach of the Corolla.

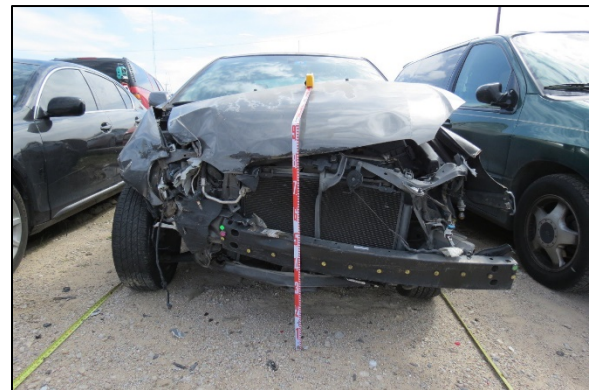
Figure 4: Front plane damage to the Corolla from impact with left plane of the Rav4.

The front plane of the Corolla (**Figure 4**) struck the left plane of the Rav4 (**Figure 5**, event 1). The force direction on the Rav4 was in the 10 o'clock sector and the impact activated the driver's seat belt pretensioner, deployment of the driver's seat-mounted side impact air bag, and both IC air bags. The Corolla's driver's frontal air bag also deployed. The damage algorithm of the WinSMASH program calculated the Rav4's total delta V as 14 km/h (8.7 mph). The longitudinal and lateral velocity changes were -10 km/h (-6.2 mph) and 9 km/h (5.6 mph), respectively. The total delta V for the Corolla was 19 km/h (11.8 mph). The longitudinal and lateral velocity changes were -10 km/h (-6.2 mph) and -16 km/h (-9.9 mph), respectively. The results were considered low for both vehicles based on the damage they sustained.

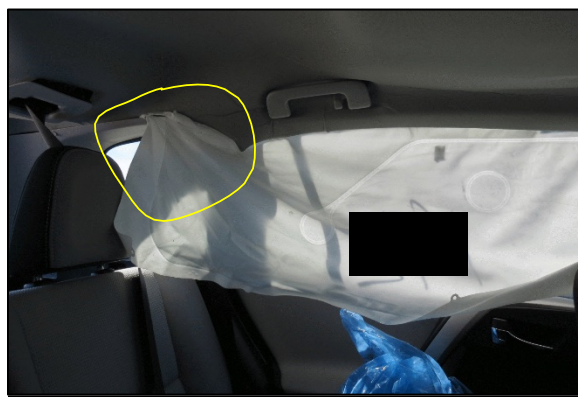
Figure 6: Rear of left IC air bag, not fully extended from roof liner.

The IC air bags were located along the roof side rails behind the headliner and the deflated IC air bags extended from the A-pillar to the D-pillar. The left IC air bag was 185 cm (72.8 in) wide, 47 cm (18.5 in) high, and extended 17 cm (6.7 in) below the beltline. There was a 6 cm (2.4 in) gap between the front of the IC and the base of the A-pillar. There was no discernable evidence of occupant contact to the IC, though there were 5 cm (2 in) and 3 cm (1.9 in) cuts in the interior fabric of the IC, starting 7 cm (2.8 in) forward of the B-pillar and 13 cm (5.1 in) above the belt line. Also, the rear portion of the air bag near the left C-pillar did not fully deploy as indicated by condition of the air bag material at the roof side rail (**Figure 6**). The right IC air bag was of the same approximate dimensions as the left. The front portion of the IC had been cut by emergency responders.
