**Special Crash Investigations  
On-Site Crash Avoidance –  
Forward Collision Warning  
Investigation  
Vehicle: 2015 Chevrolet Tahoe  
Location: Texas  
Crash Date: December 2016**

**Special Crash Investigations**  
**On-Site Crash Avoidance - Forward Collision Warning Investigation**  
**Case Number - IN17012**  
**Location - Texas**  
**Vehicle - 2015 Chevrolet Tahoe**  
**Crash Date - December 2016**

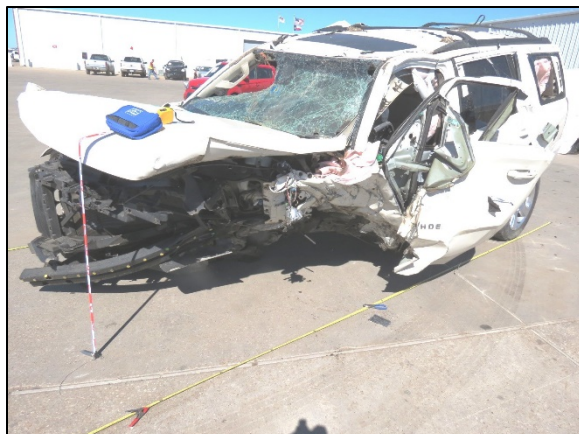
**Figure 1:** The damaged 2015 Chevrolet Tahoe

This report documents a single-vehicle crash investigation with the lane departure warning (LDW) system of a 2015 Chevrolet Tahoe (Figure 1). This crash investigation was initiated by the National Highway Traffic Safety Administration in January 2017 through a review of reports in the Fatality Analysis Reporting System (FARS). It was assigned to the Special Crash Investigation Team at the Indiana University Transportation Research Center. Permission for an inspection of the vehicle was obtained from the insurance company in February 2017. This crash occurred in Texas in December 2016 in the morning hours and was investigated by a local police agency. The crash scene and Chevrolet were inspected in February 2017.

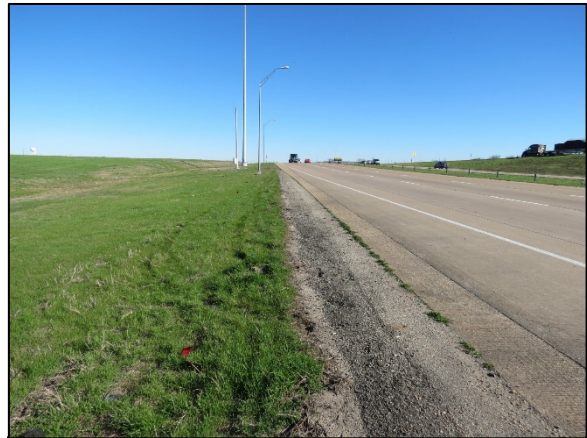
**Figure 2:** View southeast from the area of roadway departure back to Chevrolet's approach environment

The Chevrolet was travelling northwest (**Figure 2**) in the second through lane from the right prior to departing the right side of the roadway and sustaining two crash events. It was determined based on analysis of the vehicle's event data recorder (EDR) report and the crash scene evidence that the initial algorithm enable (AE)<sup>1</sup> most likely occurred on an embankment following the vehicle's departure from the right side of the roadway and travel across a ditch (**Figure 3**). The location of AE was located approximately 63 m (207 ft) northeast of the vehicle's departure point from the right side of the roadway and travel across a ditch (**Figure 3**). The location of AE was located approximately 63 m (207 ft) northeast of the vehicle's departure point from the right side of the roadway and travel across a ditch (**Figure 3**). Using the 5 seconds of EDR-reported pre-crash data it was determined that the vehicle traveled a total distance of approximately 156 m (512 ft) to the area of AE. A timeline and likely on-roadway path of the vehicle was established by working backward from the area of AE along the off-roadway approach path, which was based on the physical evidence documented at the SCI crash scene inspection. At -5.0 to -4.0 sec prior to AE the vehicle was traveling northwest in the second through lane from the right at an EDR-reported speed of 110 km/h (68 mph) with the brake switch reported as "Off." At -3.0 sec the vehicle was traveling 112 km/h (70 mph) with the brake switch reported as "Off." The vehicle departed the right side of its travel lane approximately midway between -4.0 and -3.0 sec prior to AE. The lane line was a broken white line in good condition and the vehicle was equipped with an LDW system; however, there was insufficient information to determine if the system

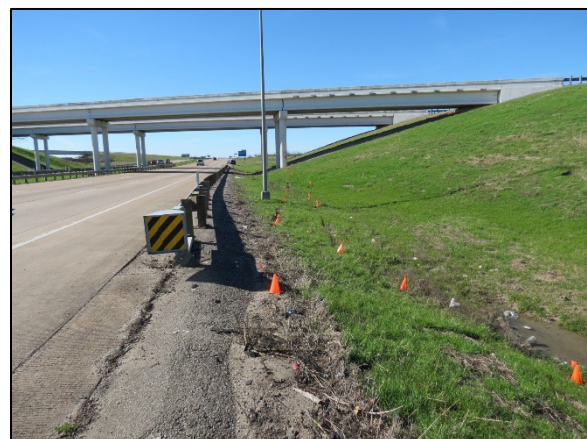
**Figure 3:** View northwest to Chevrolet's off-road travel path

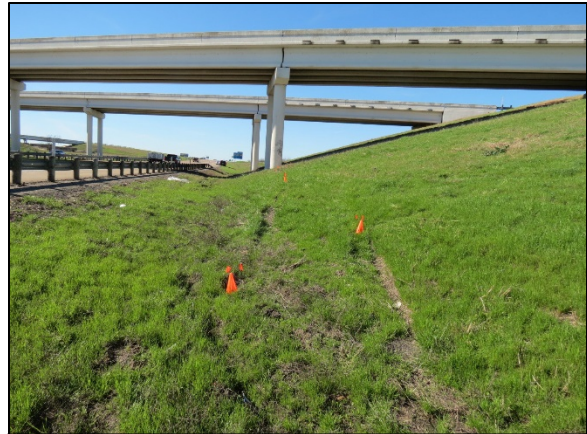
**Figure 4:** View northwest to area of AE on the embankment

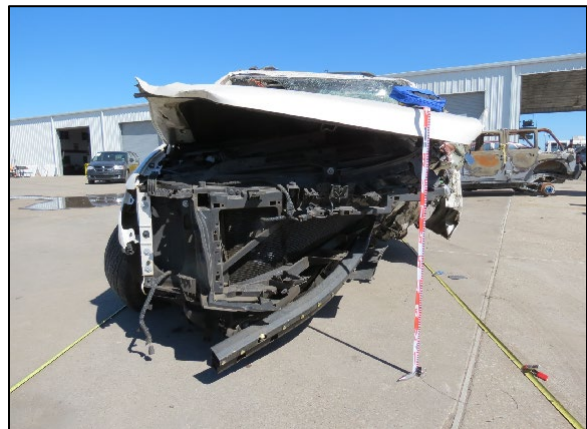
**Figure 5:** Damage to the front plane from the impact with the bridge support pillar

The vehicle began to rollover, right side leading (Event 1), as it was airborne for a distance of approximately 15 m (49 ft). The front plane (**Figure 5**) then struck a 94 cm (37.0 in) diameter concrete bridge support pillar (**Figure 6**, Event 2) as the vehicle landed. The vehicle was rolled to the right less than a full quarter turn at the time of this impact as indicated by the crush pattern on the vehicle. The front plane crush was severe below the hood level, but the hood was not similarly crushed (**Figure 7**), indicating that the vehicle was rolled to the right approximately a half quarter turn when this impact occurred. As a result, the force direction was non-horizontal and WinSMASH calculated the delta V as 43 kmph and the barrier equivalent speed (BES) as 42 kmph. The vehicle’s EDR reported the maximum longitudinal and lateral velocity changes as -87 km/h (-54 mph) and 20 km/h (12 mph),

*Exterior Damage Event 2:* The front plane sustained direct and induced damage when it struck the 94 cm (37.0 in) diameter concrete bridge support pillar during the rollover. There was also direct damage to the undercarriage, left fender, left sill, and left front door (**Figure 8**) since the vehicle was rolled to the right approximately a half quarter turn when this impact occurred. The direct damage to the front plane began at the left corner of the front bumper and extended 64 cm (25.2 in) to the right. The Field L was 82 cm (32.3 in). The crush measurements were taken on the bumper bar and the maximum residual crush was 80 cm (31.5 in) occurring at the left front bumper corner. The crush values were:  $C_1 = 80$  cm (31.5 in),  $C_2 = 47$  cm (18.5 in),  $C_3 = 32$  cm (12.6 in),  $C_4 = 19$  cm (7.5 in),  $C_5 = 10$  cm (3.9 in),  $C_6 = 0$  cm.

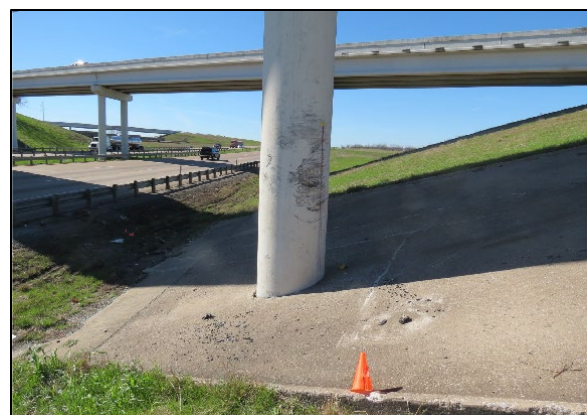
**Figure 6:** Impact with concrete bridge support pillar looking west

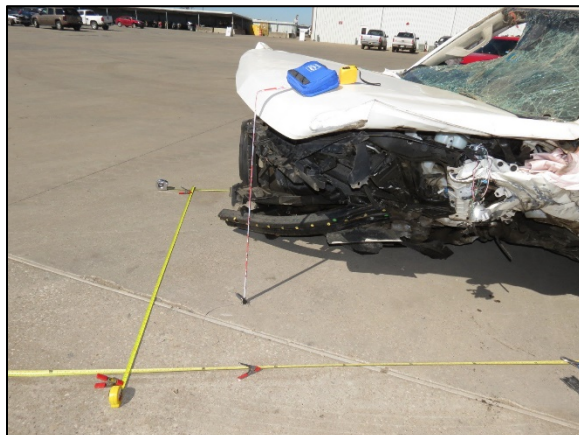
**Figure 7:** Crush to Chevrolet's bumper bar and hood

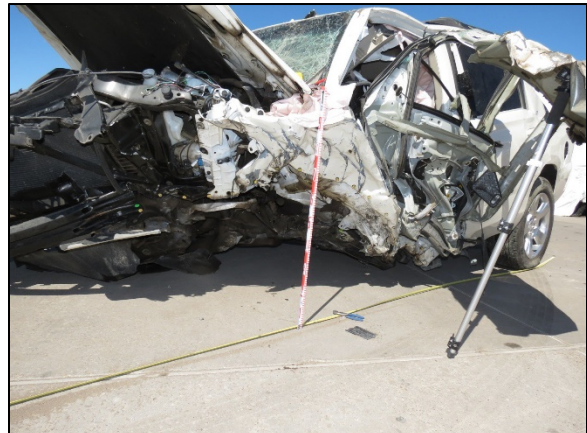
**Figure 8:** Damage to the undercarriage, fender, sill and left front door of the Chevrolet

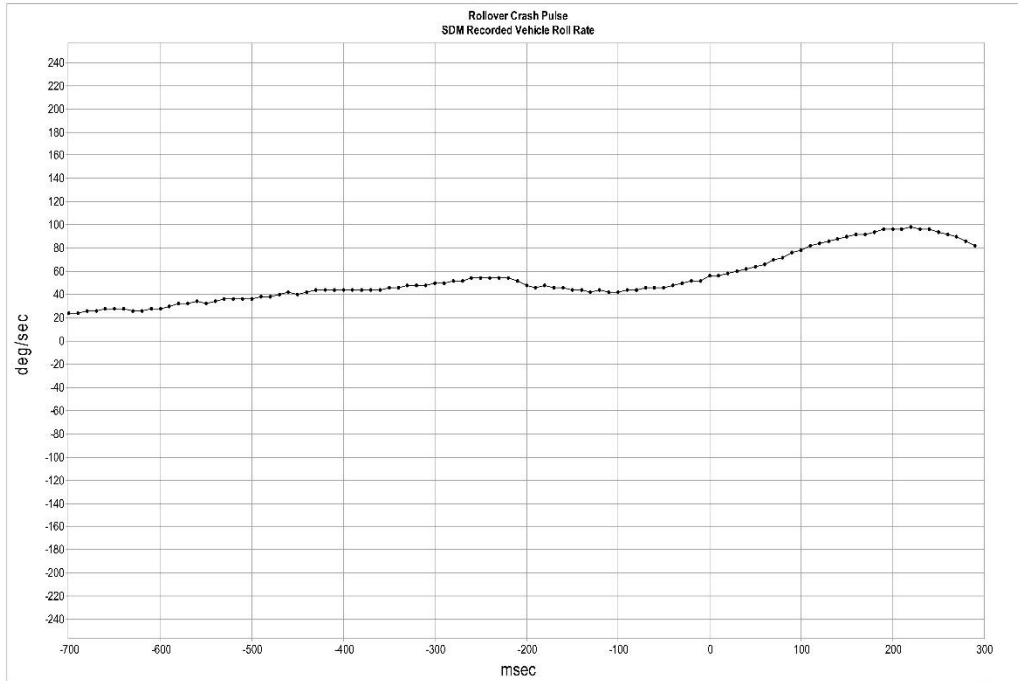
### Rollover Crash Pulse (Event Record 3)

Time (msec)	SDM Recorded Vehicle Roll Rate (deg/sec)	Time (msec)	SDM Recorded Vehicle Roll Rate (deg/sec)
-700	24	-200	48
-690	24	-190	46
-680	26	-180	48
-670	26	-170	46
-660	28	-160	46
-650	28	-150	44
-640	28	-140	44
-630	26	-130	42
-620	26	-120	44
-610	28	-110	42
-600	28	-100	42
-590	30	-90	44
-580	32	-80	44
-570	32	-70	46
-560	34	-60	46
-550	32	-50	46
-540	34	-40	48
-530	36	-30	50
-520	36	-20	52
-510	36	-10	52
-500	36	0	56
-490	38	10	56
-480	38	20	58
-470	40	30	60
-460	42	40	62
-450	40	50	64
-440	42	60	66
-430	44	70	70
-420	44	80	72
-410	44	90	76
-400	44	100	78
-390	44	110	82
-380	44	120	84
-370	44	130	86
-360	44	140	88
-350	46	150	90
-340	46	160	92
-330	48	170	92
-320	48	180	94
-310	48	190	96
-300	50	200	96
-290	50	210	96
-280	52	220	98
-270	52	230	96
-260	54	240	96
-250	54	250	94
-240	54	260	92
-230	54	270	90
-220	54	280	86
-210	52	290	82

*Event Record 3:* The event severity status was reported as a rollover and was likely recorded as the vehicle was being righted for removal from the crash scene. It was reported as a deployment event, but there was no data reported on deployments of air bags, which had previously deployed during Events 1 and 2.
